INSTRUCTION TO SERVICE

ITS60421		DATE: March 17, 2022
SECTION:	292-Electrical Harnesses	
WRITTEN BY:	Aditya Gadepalli	
SUBJECT:	MCI Main Distribution Panel Protection	
ISSUE:	<p>This is to inform you that your vehicle may contain a defect that could affect the safety of a person. The Main Distribution Panel (MDP) in the battery compartment has experienced failures that may result in thermal events and/or uncommanded vehicle shutdown.</p> <p>Due to the current global parts shortage, the components required to conduct the related recall repair instructions are not currently available. This is specific to repair instructions ITS60272 (J4500), ITS-60335 (J3500), ITS 60283 (D Coach), and ITS60298 (D45CRT and D4520 coach).</p> <p>In the interim period, prior to these repair instructions being incorporated on the buses identified above, MCI recommends conducting an immediate inspection of the MDP, MCI P/N: 07-08-7940, and regular interval inspections every three months for signs of thermal stress or corrosion following this inspection procedure</p>

SUMMARY:	Due to the Main Distribution Panel failures resulting from supplier quality and environmental issues, it is recommended the MDP be

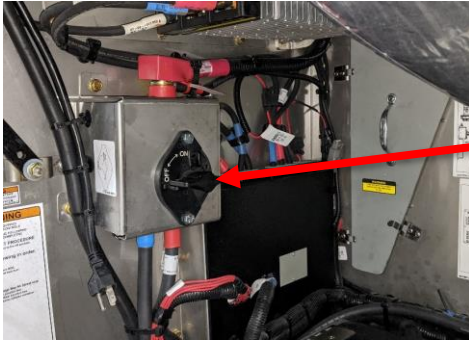
Turn off
MDS.

1. Set park brake and chock wheels.
2. Turn the main battery disconnect switch to the "OFF" position.
3. **Follow steps 4 to 8 on J4500, J3500, D45CRTLE, and D4520 coach models.**
4. Locate the Main Battery Disconnect Switch and ensure it is in the off position.

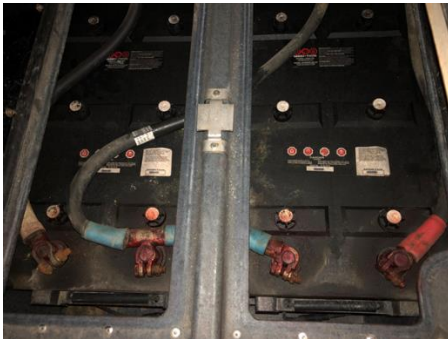
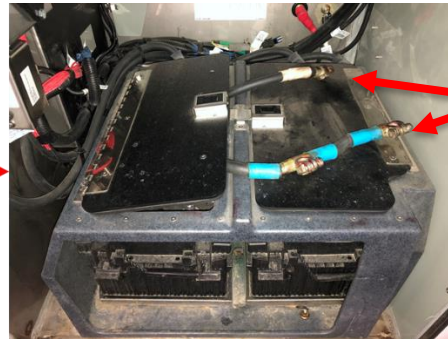
Disconnect all
battery cables.

5. Disconnect GND, 12V, and 24V battery cables from the coach batteries. Ensure the battery cables do not come in contact with each other or the coach.

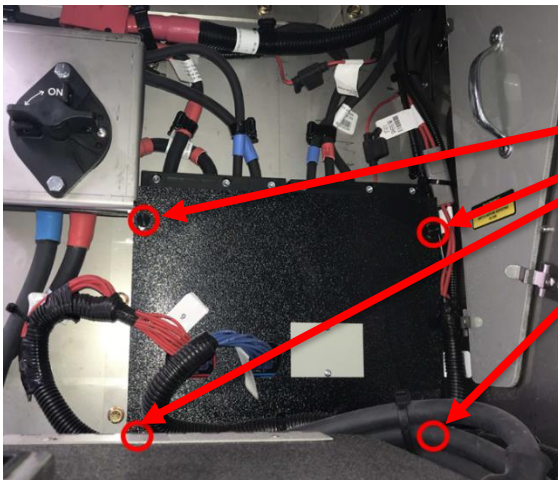
Remove and save 4
thumb screws.

6. Locate the MDP compartment mounted on the rear wall in the battery compartment. Remove and save the 4 thumb screws to release the MDP cover.

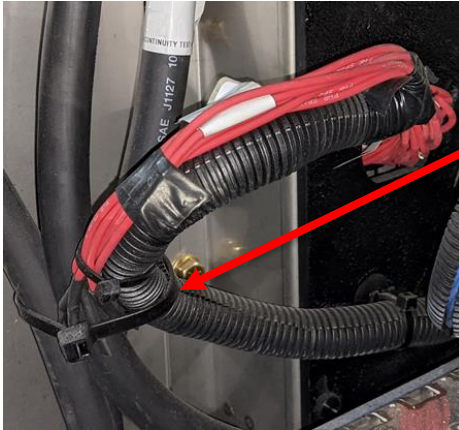
Remove BT-P162 tyrap on battery cables.

7. Remove tyrap that secure BT-P162 to the Main Disconnect Switch cables.

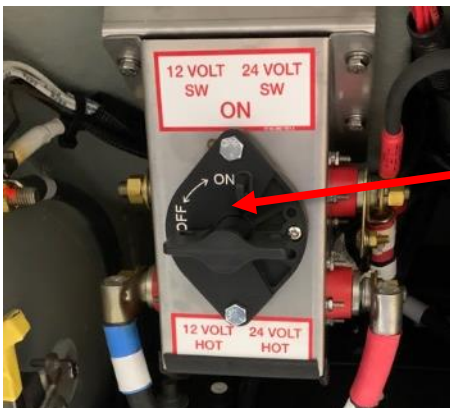
Turn off MDS.

10. Locate the Main Battery Disconnect Switch and ensure it is in the off position.

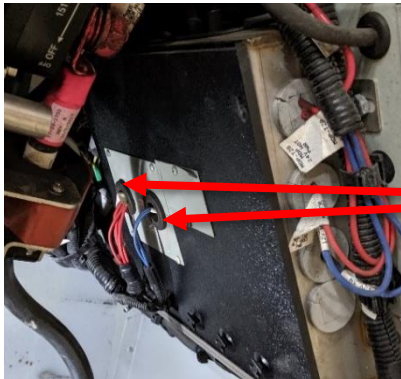
Disconnect the wires

14. Disconnect the two connectors, BT-P162 and BT-P161, from the main distribution panel.

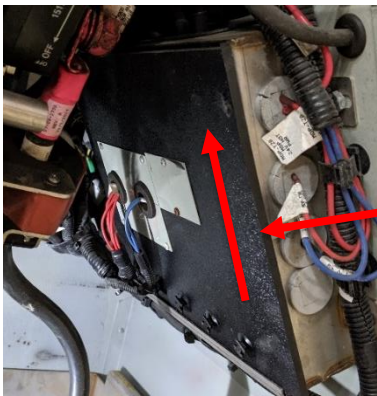
Slide the cover out

15. Slide out and save the battery compartment cover out of the bracket.

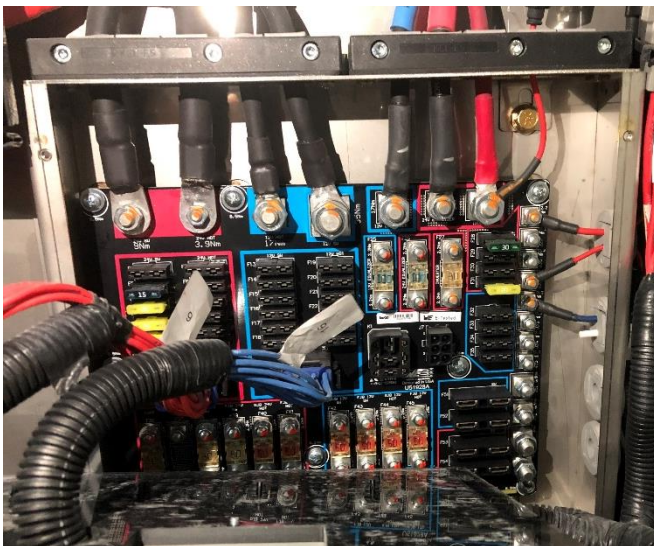
16. Inspect the front of the MDP for corrosion at all connectors and verify the retaining nuts for all the power cables are properly torqued. If corrosion is found, consult your local MCI representative for more heavier duty inspection and cleaning ITS-60422.

NOTE: Refer to the step 35 for power stud torque specifications of the MDP.

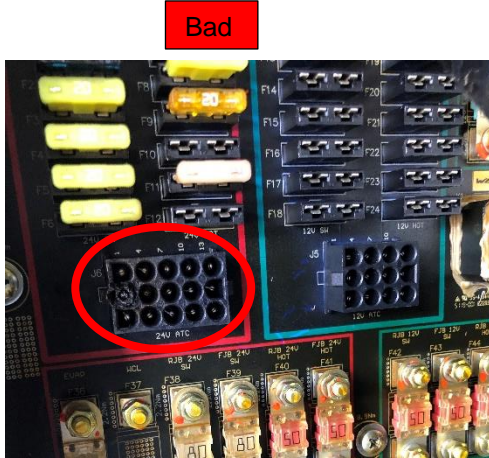
17. If no corrosion is found, inspect for heat damage on the BT-P162 connector. If heat damage is observed, perform steps 18 to 21. Otherwise, skip to step 22.

Perform steps 18 to 21

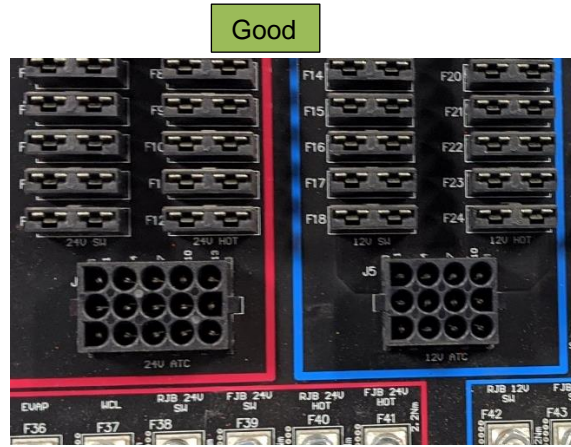
Skip to step 22

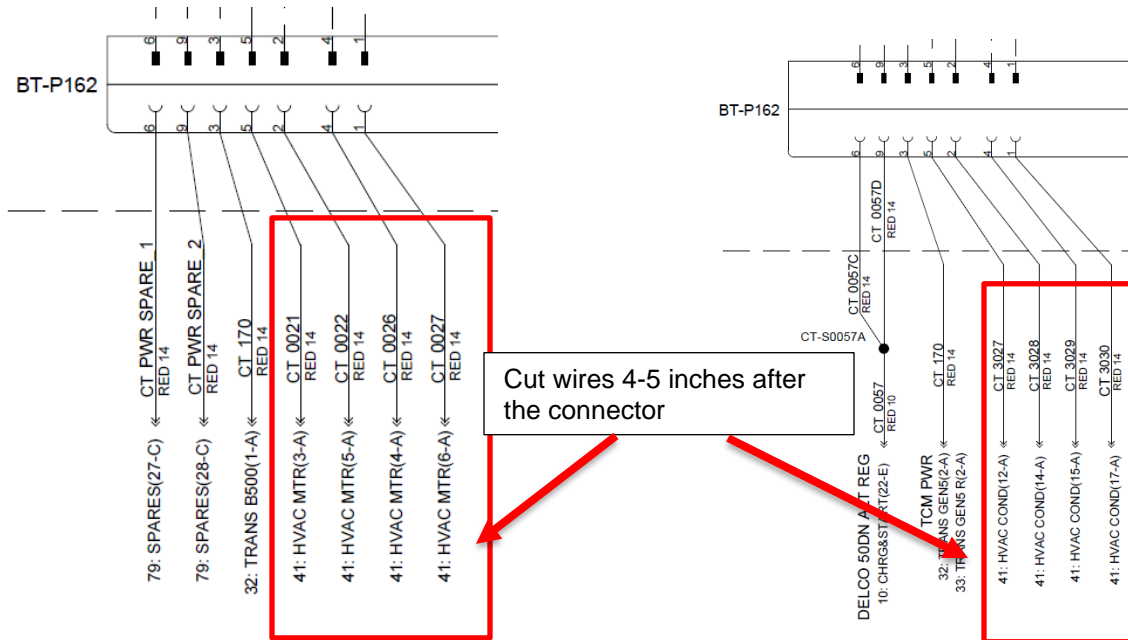
Schematic of J4500, J3500, D45CRTLE and D4520 coach models

Schematic of D4000, D4500, D4005, D4005, and D4000 ISTV coach models

18. Cut HVAC wires CT0021, CT0022, CT0026, and CT0027 4-5 inches from the 24V BT-P162 connector.

NOTE: Heatshrink and tie back the wire attached to the pins to avoid corrosion.

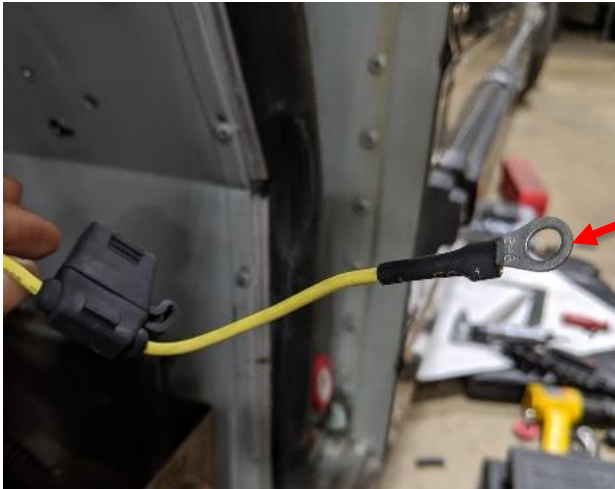
Crimp inline fuse holder to the HVAC wires

19. Crimp HHG in-line fuse holders, MCI P/N: T19-1168, to the HVAC wires using splice connector, MCI P/N: 19-11-431, black heat shrink, MCI P/N: 19-11-1465, and a 1/2" ring terminal at the end, MCI P/N: 19-11-393.

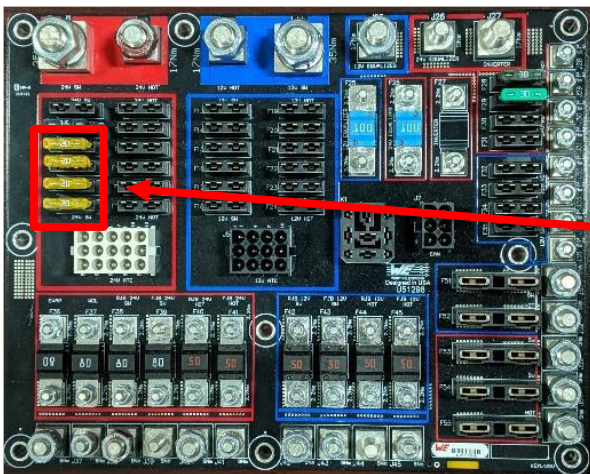
Remove 20A fuses and install in in-line fuse holders

20. Remove 20A fuses from the MDP and install them in the in-line fuse holders.

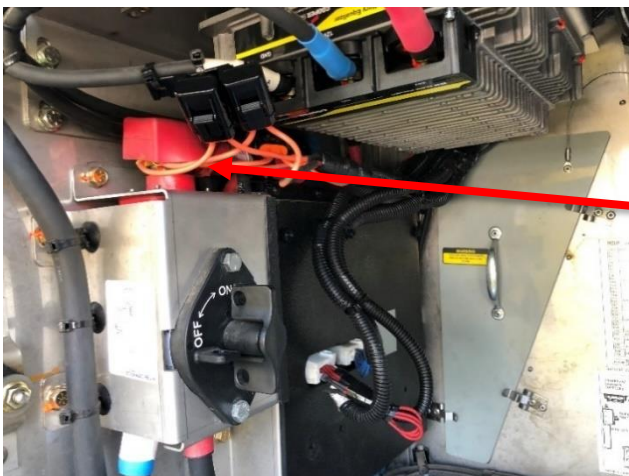
Connect the modified HVAC wires to 24V SW stud on MDS

J4500/J3500/D45CRT-
Le/D4520 coach models

21. Connect the modified HVAC wires to either 24V SW stud on the MDS as shown below for various coach models. Torque the nut to 300 In-lbs.

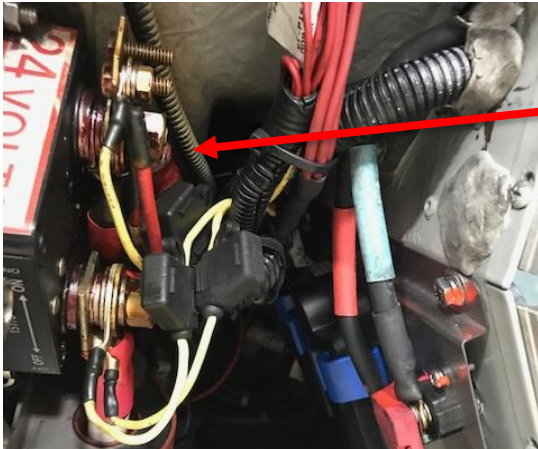
Connect the modified HVAC wires to 24V SW stud on MDS

D4000, D4500, D4005, D4005, and D4000 ISTV coach models

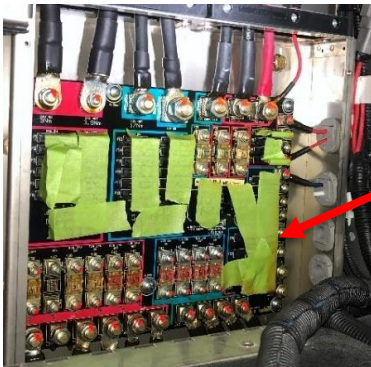
Cover open connectors and fuse slots.

22. Cover all open connectors and fuse slots with masking tape.

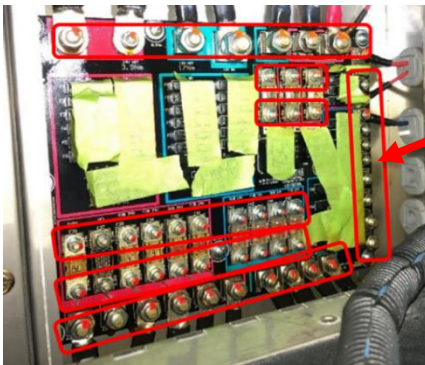
Spray anticorrosive on MDP studs.

23. Using short sprays, apply the corrosion inhibitor, MCI P/N: 23-02-0119, on all power and fuse studs. Wipe off any excessive corrosion inhibitor from the fuse windows using a dry rag.

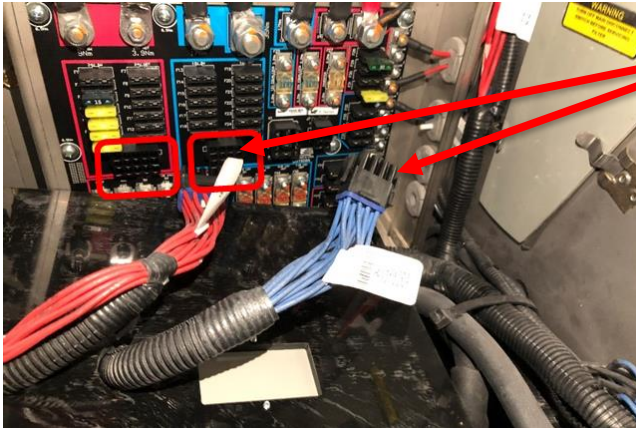
Connect BT-P161 and BT-P162.

25. Route through the MDP cover holes and secure connectors BT-P161 and BT-P162 to the MDP board.

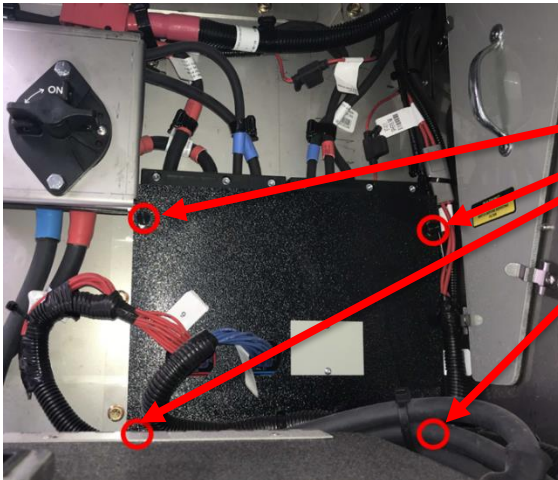
Install 4 thumb screws.

26. Secure the MDP cover using the 4 thumb screws, MCI P/N: 07-08-9231.

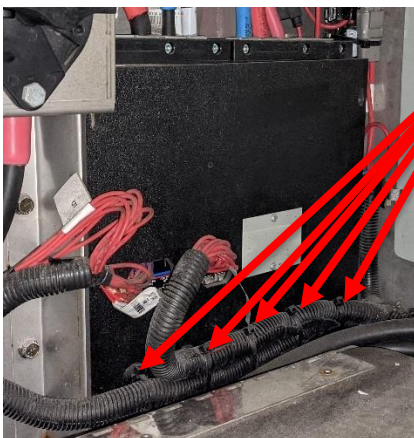
Secure harness using 5 tyraps.

27. Secure the BT-P161/BT-P162 harnesses to the MDP cover using 5 tyraps, MCI P/N: 19-11-258, and existing mounts.

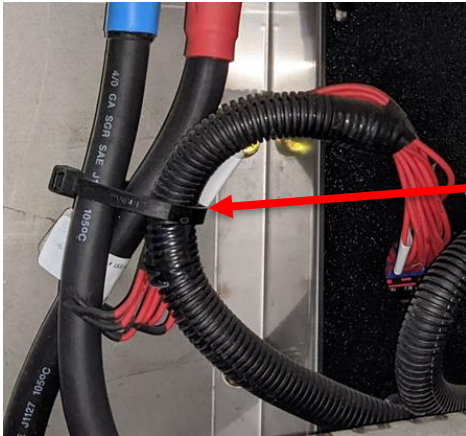
Loosely secure BT-162 to MDS Cables.

28. Loosely secure the BT-P162 branch to the MDS battery cables, allowing a smooth curve on the harness.
Ensure there is no side strain at the connector.

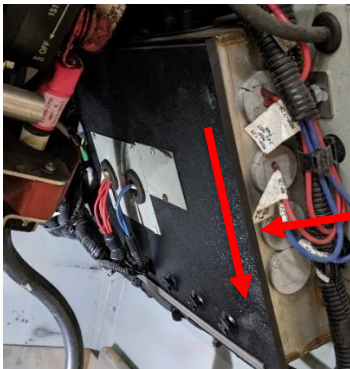
Slide the cover in

29. Perform steps 30 to 34 on D4000, D4500, D4005, D4005, and D4000 ISTV coach models.
30. Slide in and discard the battery compartment cover out of the bracket.

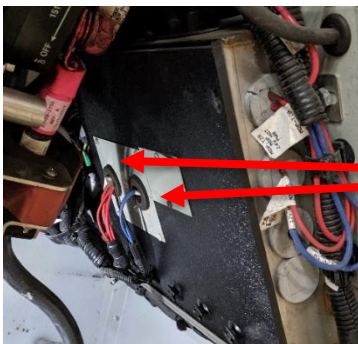
Connect the wires

31. Connect the two connectors, BT-P162 and BT-P161, to the main distribution panel.

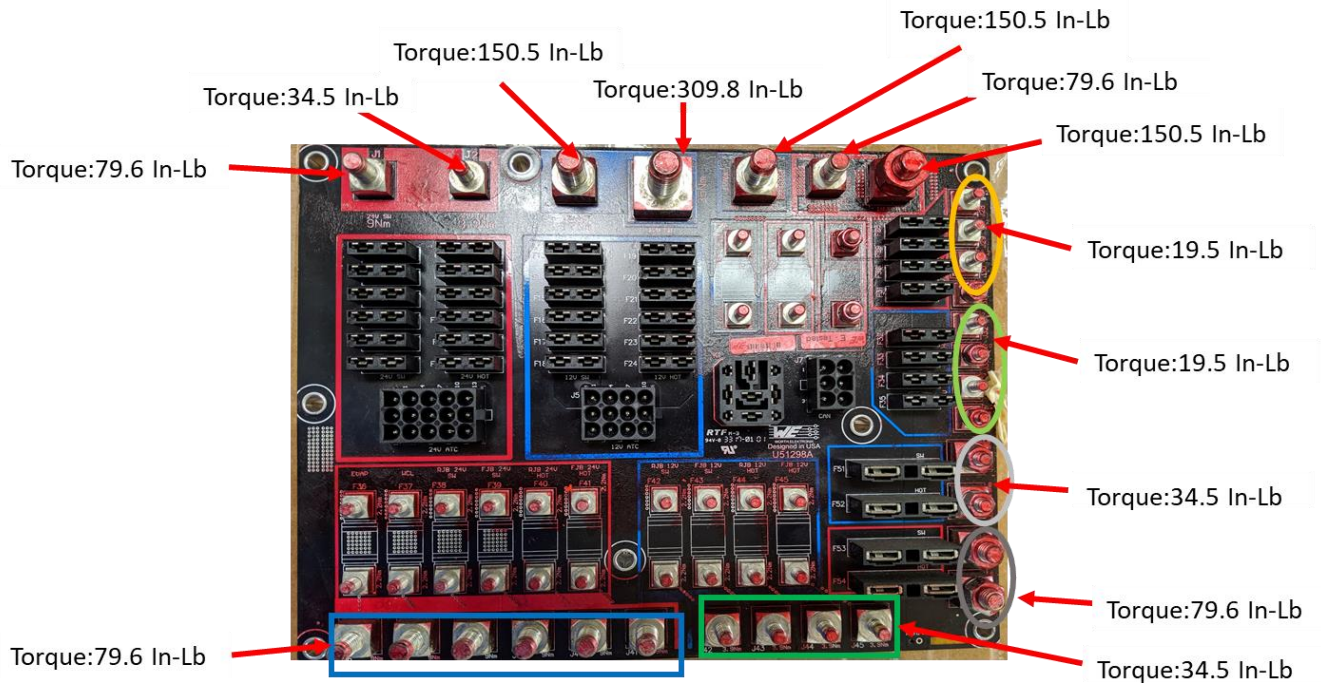
35. Following are the torque values for the MDP studs:
