## Mack MMD Models - Coolant Hose Obstructs Access To Oil Filter

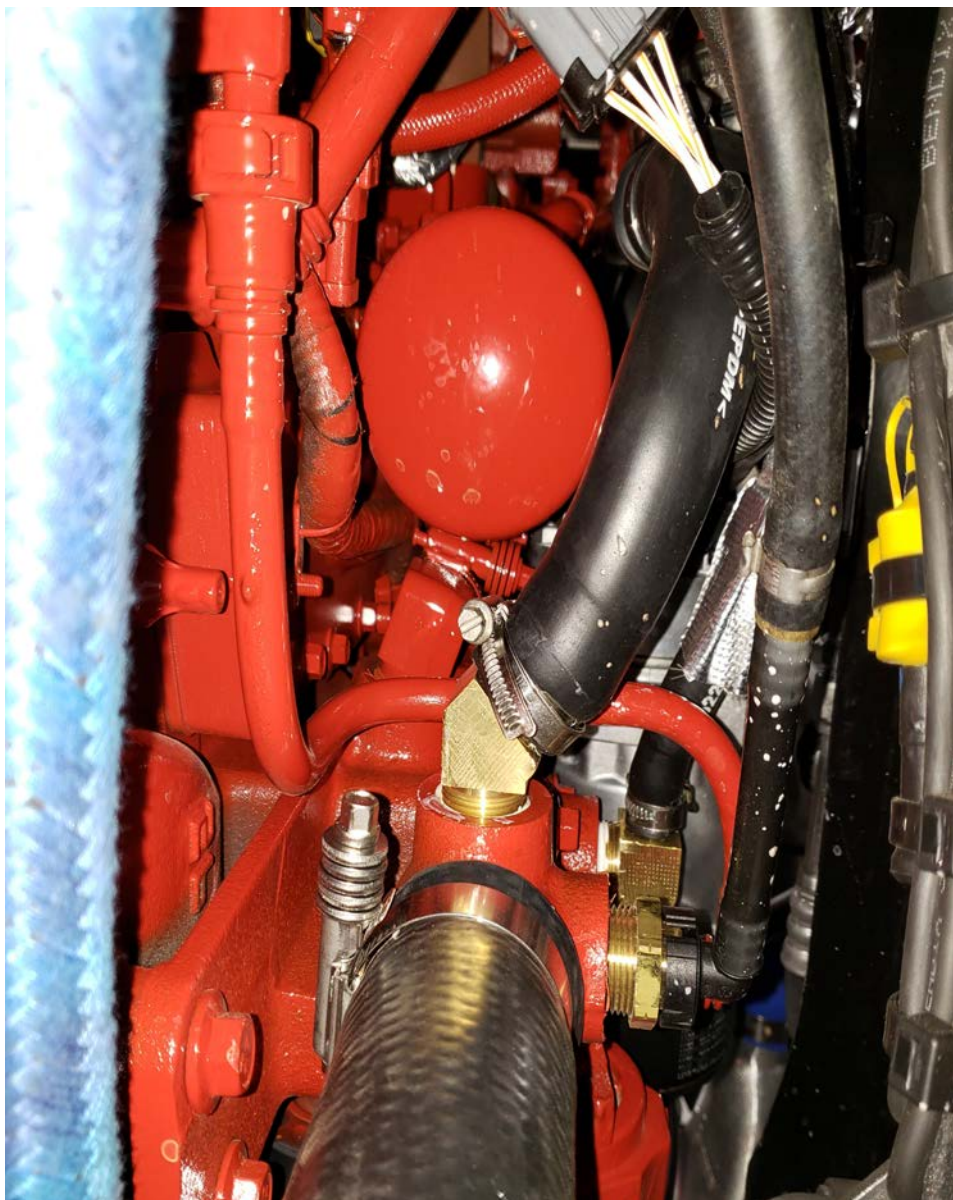
Affected vehicles will have a straight fitting for the expansion tank hose installed where the lower radiator hose connects to the engine.

- Ensure the fitting is oriented as shown in the image below.
- Refer to Impact for proper tools and procedures for draining coolant.

If the oil filter is found to be blocked by the hose, replace the straight fitting with a 45 degree fitting, part number 20907677.
