Mack Chassis -Technical Service Bulletin M-284 - 068, Exhaust Particulate Sensor, Repair (2016 Vehicles)

Exhaust Particulate Sensor, Repair

V-284-068

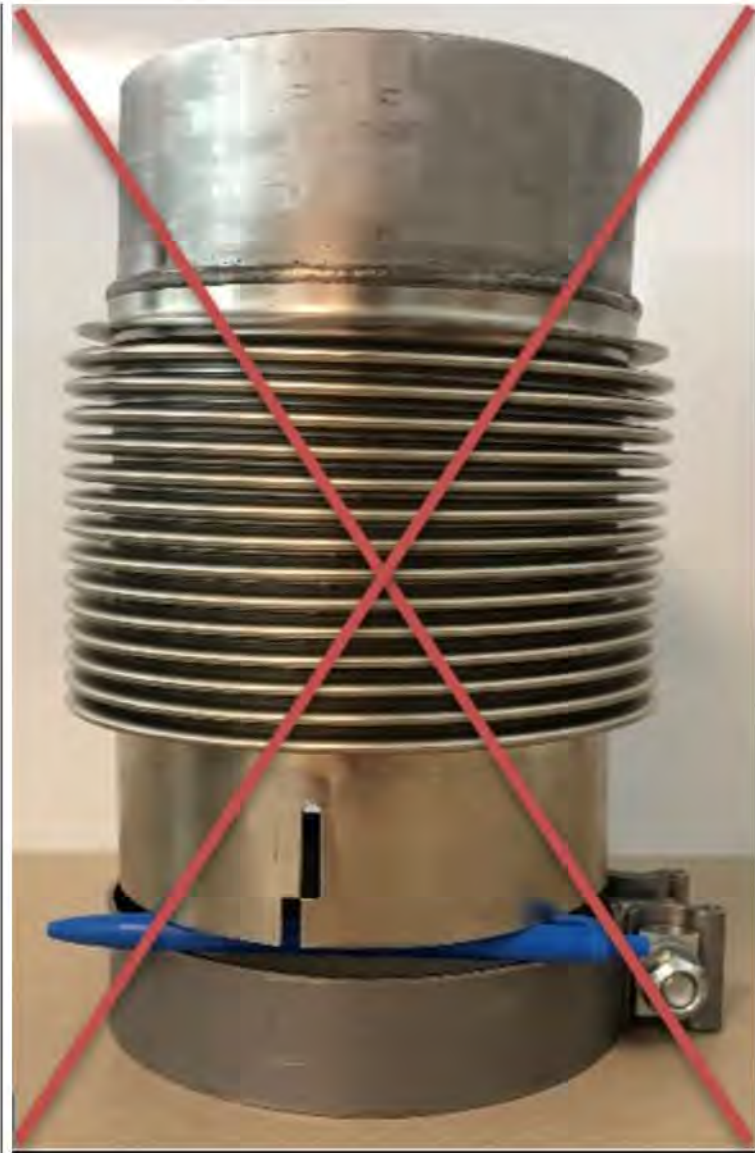
<p>Scenario 1</p> <p>This style Flex Pipe and Clamp will no longer work with the upper adjacent connecting pipe. The below parts in scenario 2 are required to perform this FSB.</p> <p>Follow the repair below that is applicable for your configuration.</p>
--	--

Determine which Flex Pipe and Clamp the truck currently has installed on it. If the truck you are repairing has the Flex Pipe and Clamp shown in scenario 1, you will need to order the improved Flex Pipe (P/N 21142254) and Clamp (P/N 25172497). If the truck you are repairing has the Flex Pipe and Clamp shown in scenario 2, this truck already has the improved parts and ordering a new Flex Pipe and Clamp is NOT required.

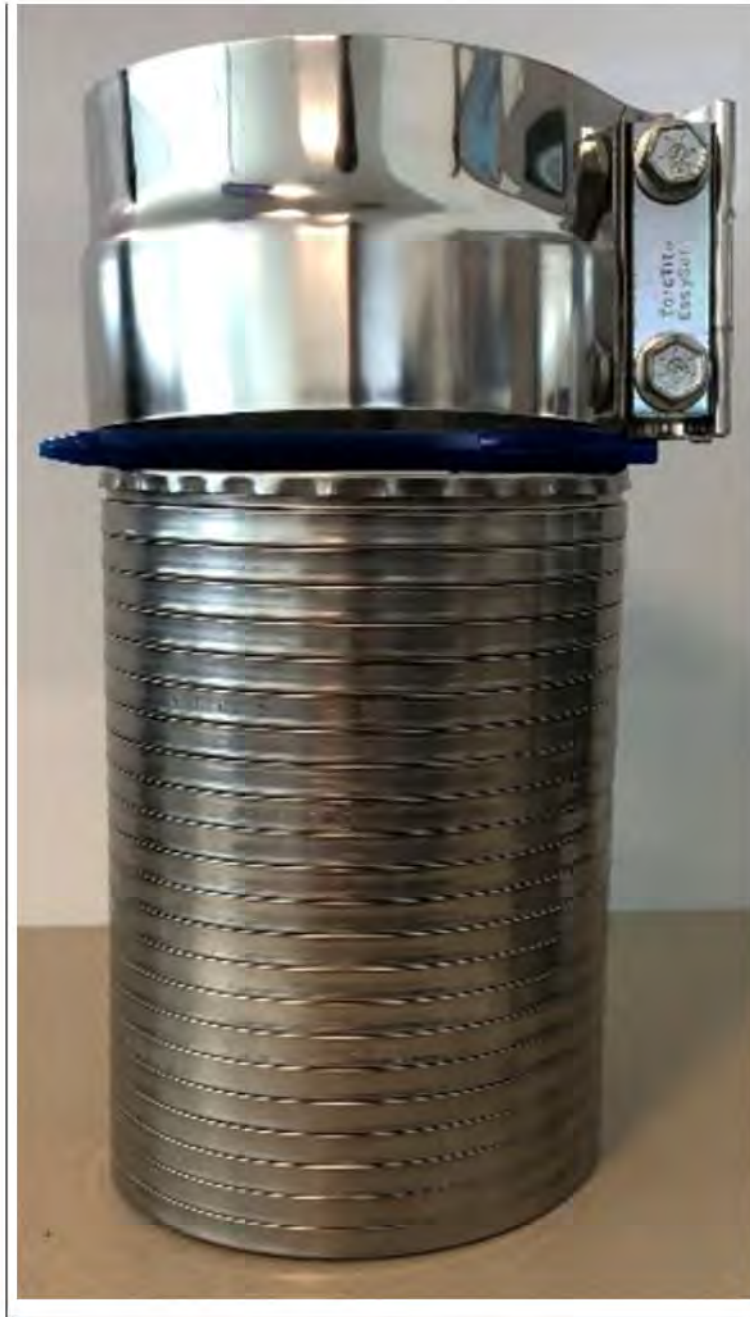
Scenario 2

This style Flex Pipe and Clamp only needs the upper adjacent pipe replaced. Reuse the existing Flex Pipe and Clamp, or order as needed.

Flex Pipe –
21142254

Clamp –
25172497

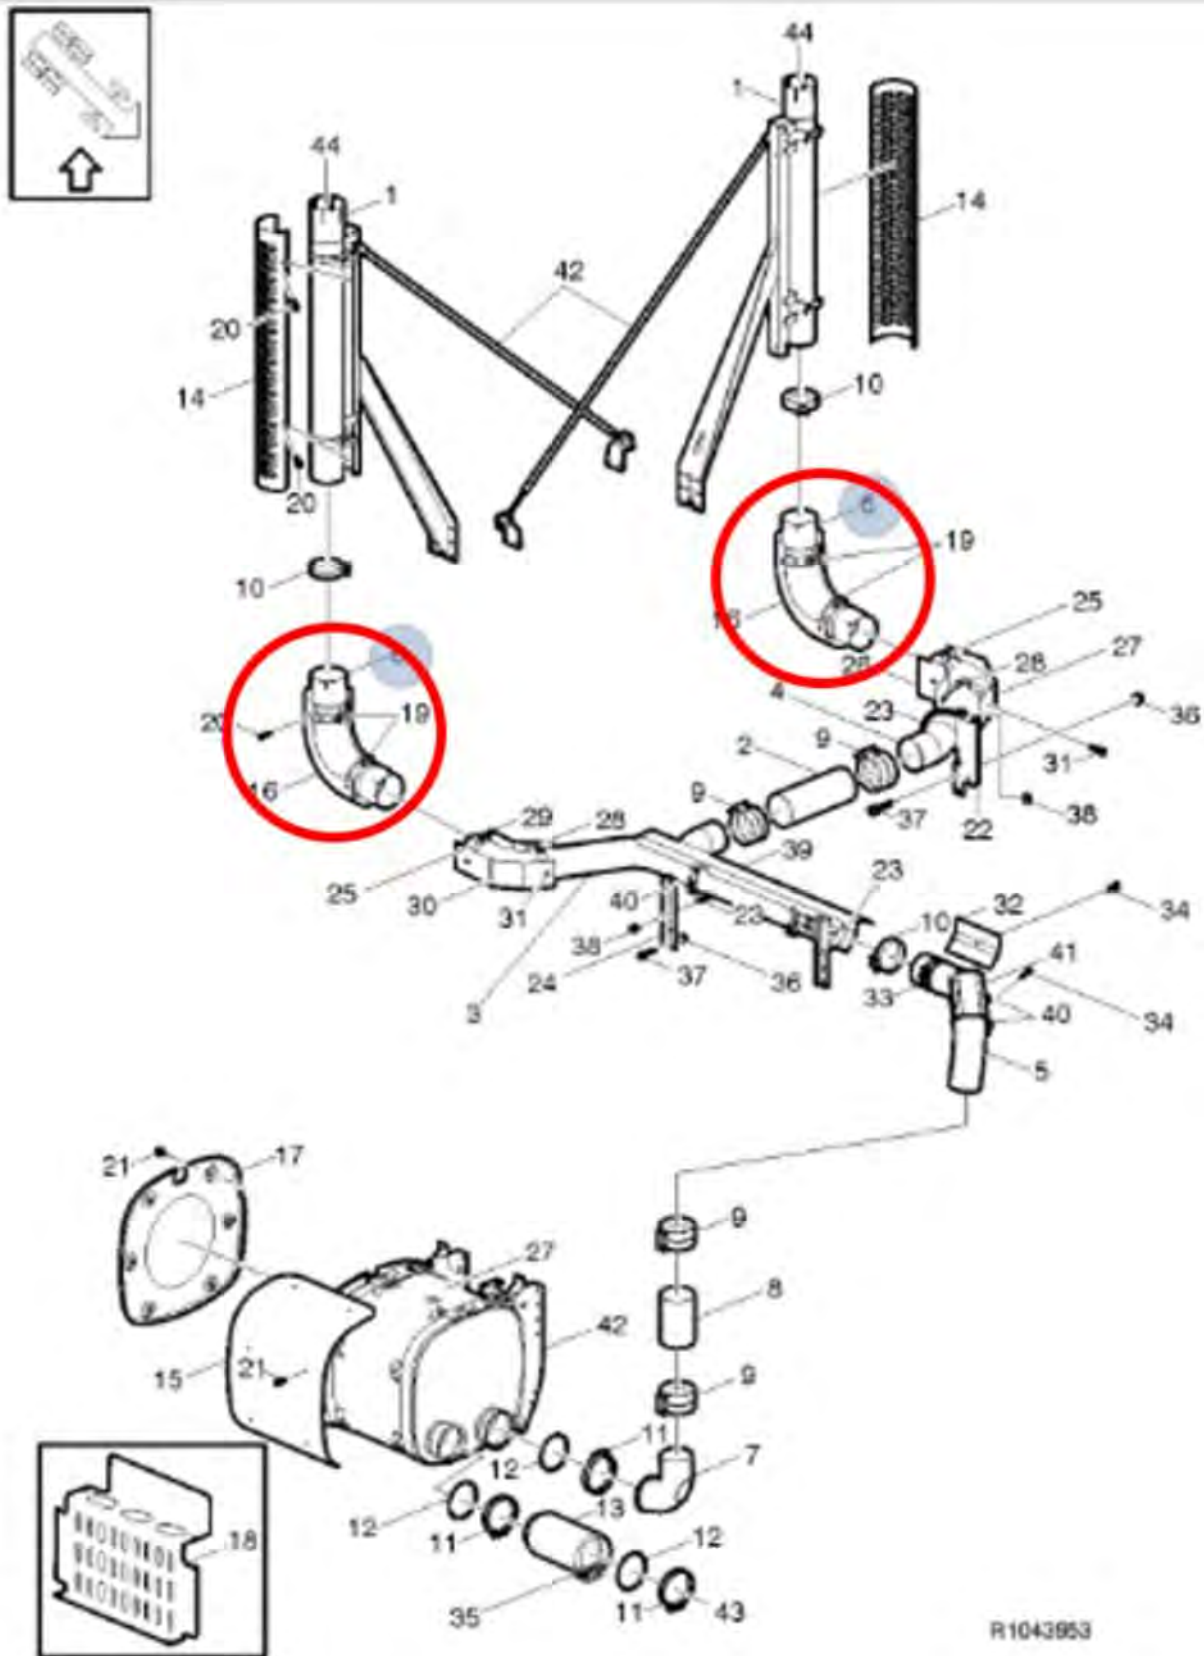
Repair 5

Model	Cab Type	Exhaust Configuration	Pipe 1
VNL	430/670/780 Sleeper	Single Outlet Right Side Inboard	(Not Bright) 23154798 (Bright) 23154799

Note: If the original flex pipe has previously been replaced, you will need a new elbow in addition to the new flex pipe

Model	Cab Type	Exhaust Configuration	Elbow
VNL	430 Sleeper	Single Outlet Right Side Inboard	21625282

Model	Cab Type	Exhaust Configuration	Elbow
VNL	670/780 Sleeper	Single Outlet Right Side Inboard	21625281

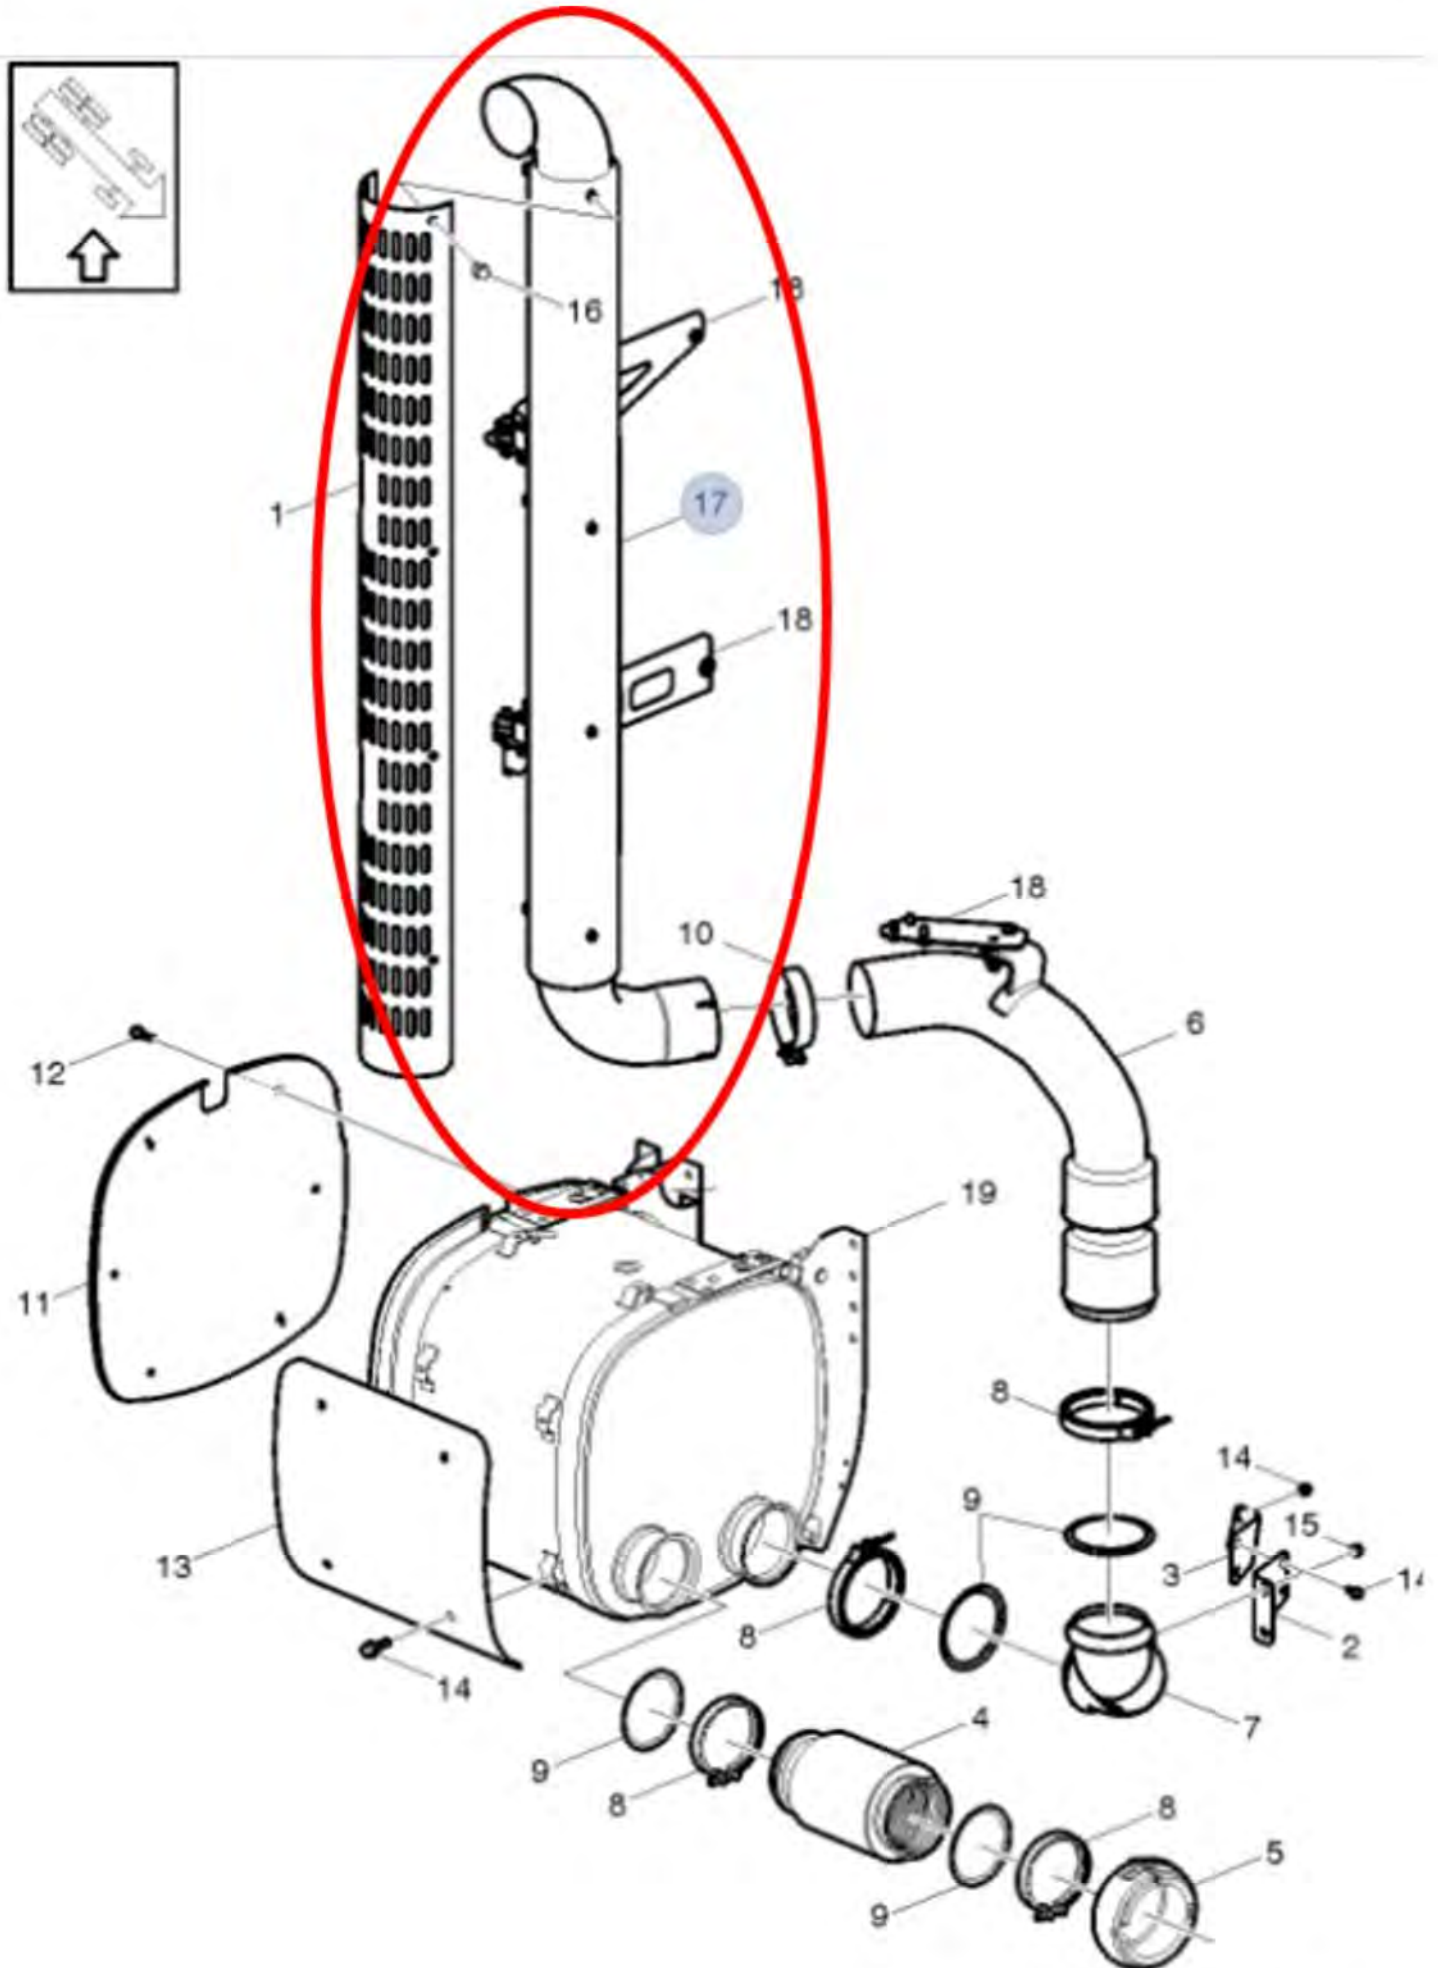
Repair 6

Model	Cab Type	Exhaust Configuration	Pipe 1	Clamp (Qty will vary)
VHD/VNM	Cab Mounted	SCR RH Horizontal Forward Mount	23154823	20961913
VHD/VNM	Cab Mounted	SCR Horizontal	23154825	20961913
VNL 11/13	Cab Mounted	SCR Horizontal	23154827	20961913

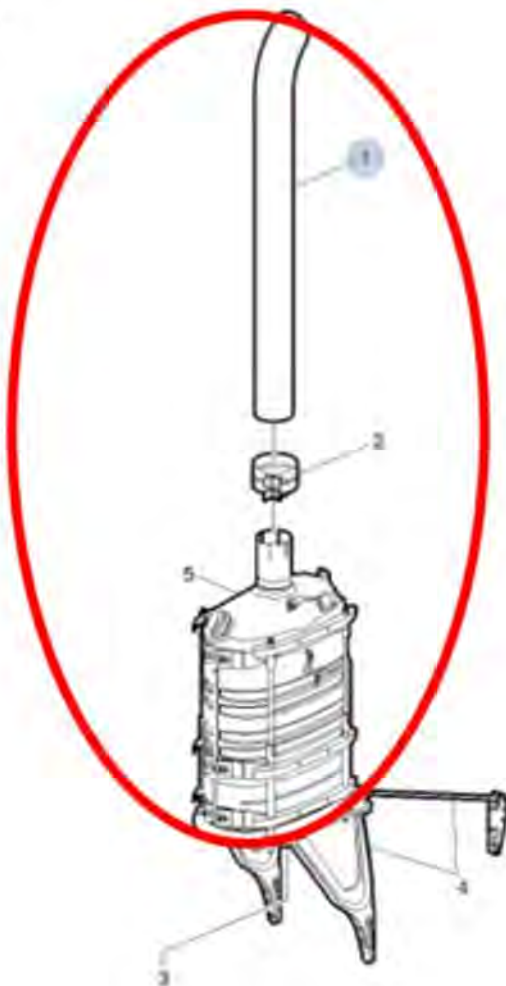
Repair 7

Model	Cab Type	Exhaust Configuration	Pipe 1	Pipe Insert	Clamp (Qty will vary)
-------	----------	-----------------------	--------	-------------	-----------------------

vary)
All	16L	12.5 ft Exhaust Stack Right Side	23208705	23296273	23189982
All	11L / 13L	11 ft 8 in Exhaust Stack Right Side	(Not Bright) 23208698 (Bright) 23208699	23176623	23189982
All	11L / 13L	12 ft 6 in Exhaust Stack Right Side	(Not Bright) 23208700 (Bright) 23208701	23176623	23189982
All	11L / 13L	13 ft 5 in Exhaust Stack Right Side	(Not Bright) 23208702 (Bright) 23208703	23176623	23189982
