Technical product information

Topic	Air bag warning - resistance related fault codes
Market area	United States E05 Bentley USA and rest America (6E05)
Brand	Bentley
Transaction No.	2033170/5
Level	EH
Status	Approval
Release date

Continental GTC derivatives 11MY,12MY,13MY USA. not GT

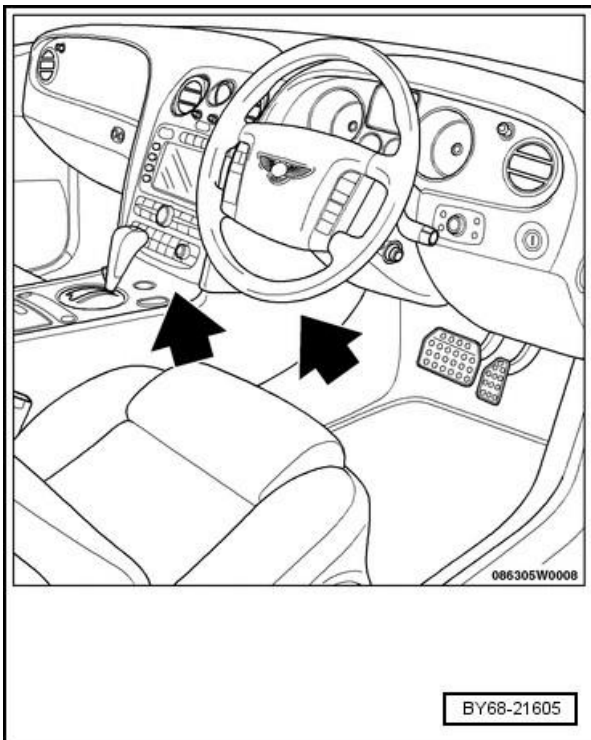
Figure 1

3. Note the front centre console is secured to the dashboard by two side buttons and two screws located under the fascia panel, arrows figure 1

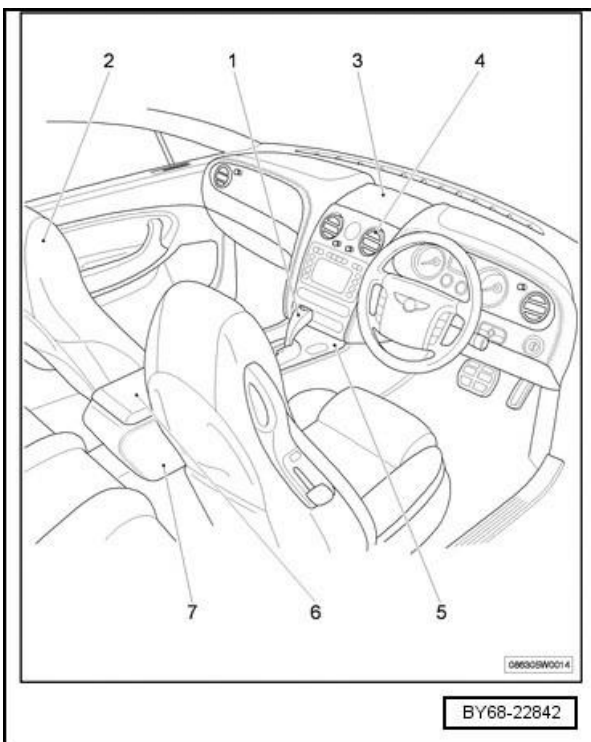
Figure 2

4. Move the gear selector (1) into the 'D' (drive) position
5. Remove the front console fascia panel (5) Rep. Gr 68.
6. Remove the centre console armrest (6) Rep. Gr 68
7. Remove the rear centre console (7) Rep. Gr 68

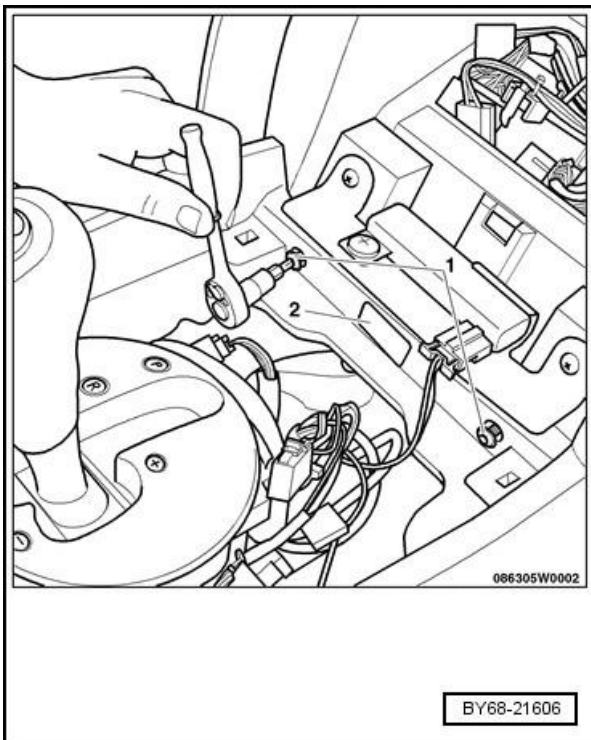
Figure 3

8. Remove the two retaining screws (1) from the front of the console frame (see Figure 3)
9. Pull the console rearwards to disengage the two side buttons and the centre pin (2) then lift upwards over the gear selector and remove from the car (see Figure 3)

- Ensure that the seat belt webbing runs correctly through the webbing guides
 - Tighten all relevant fixings to the specific torque values
 - When refitting the centre console, locate the centre pin (2) first followed by the two side buttons before pushing forward into position

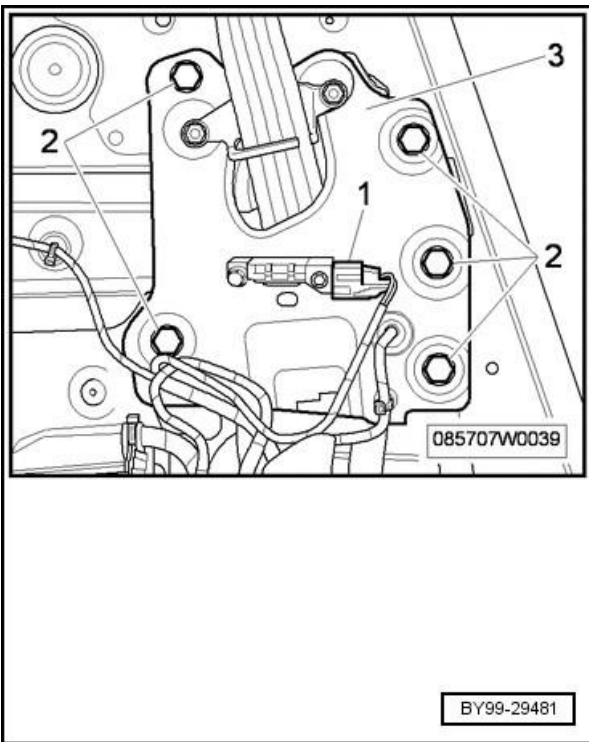
Figure 4

13. Disconnect the main harness from the crash sensor (1). Remove the five screws and washers (2) that secure the retractor mounting plate (3) (see Figure 4)

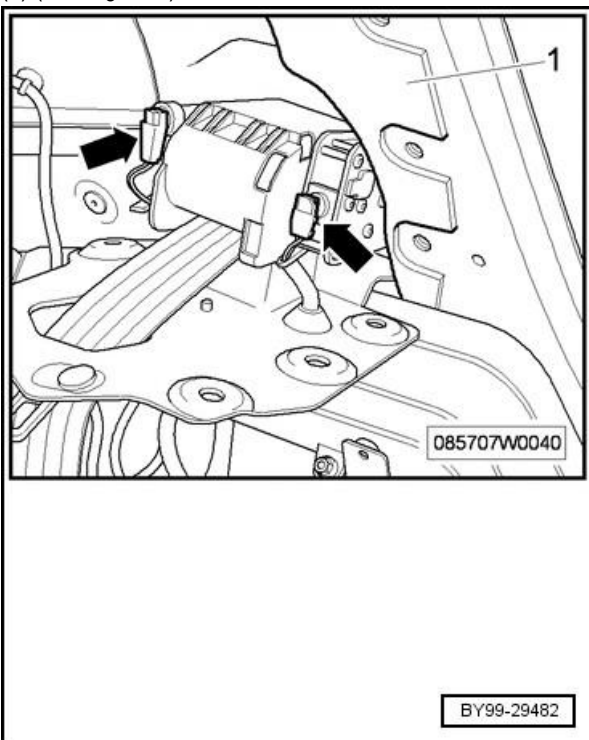
Figure 5

14. Move the retractor plate away from the body taking care not to damage the water shedder (1). If the water shedder is damaged, it must be replaced. (see Figure 5)

35. Re install all removed parts. Note the following during installation.
 - Care must be taken to prevent damage to the water shedder located behind the seat belt retractor plate. If damaged it must be replaced

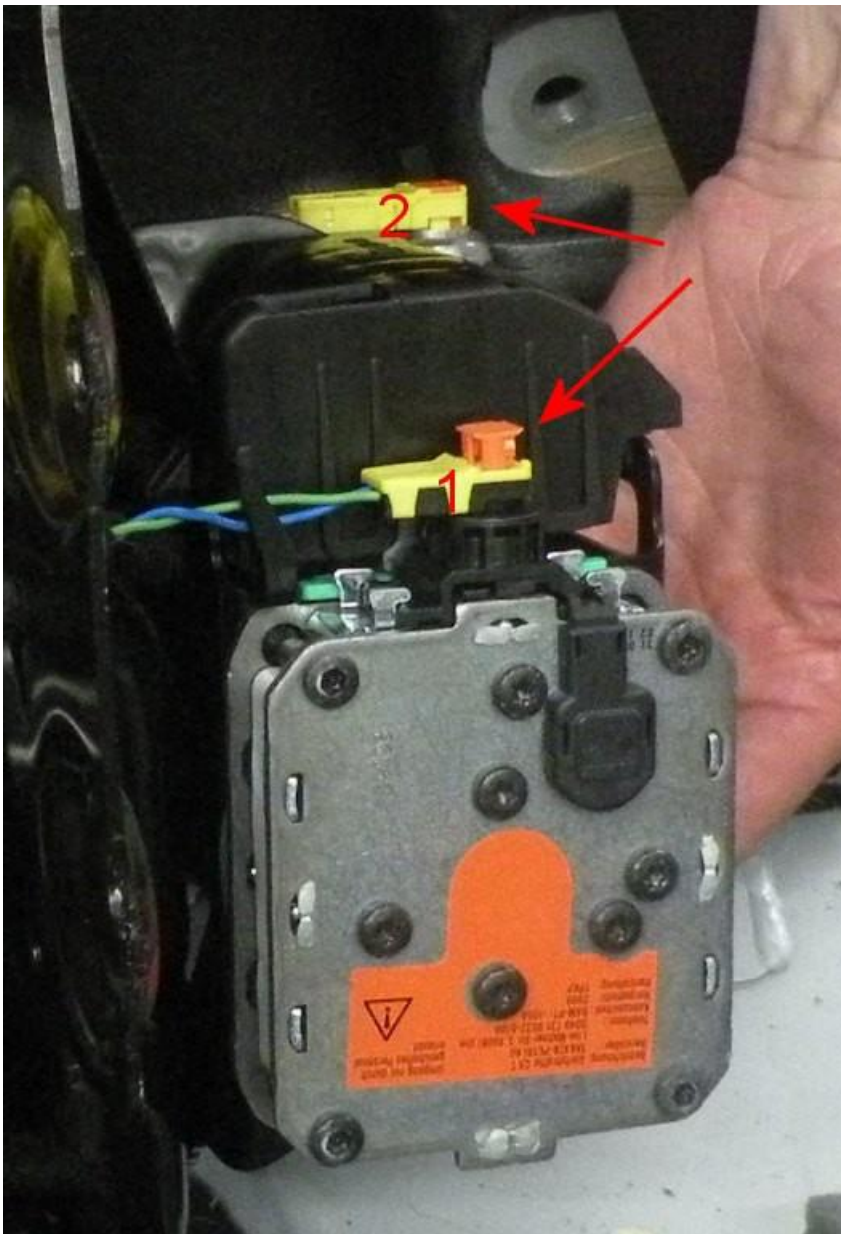
Figure 6

15. Disconnect the two electrical connectors (arrows) from the load limiter and pre-tensioner. The pre-tensioner plug housing is yellow and black (1), the load tensioner plug housing is all yellow (2). Note: Lift the orange keeper up before attempting to release the connectors from the seat belt assembly (see Figure 6)

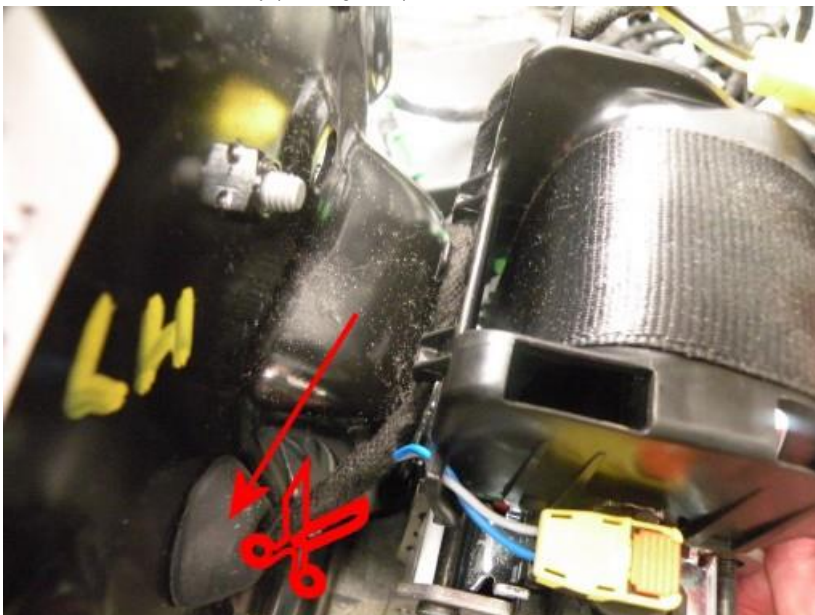
Figure 7

16. Referencing figure 7 cut the plugs off the harness, push out the grommet (arrow) and discard. Tape back the now redundant end of the

harness

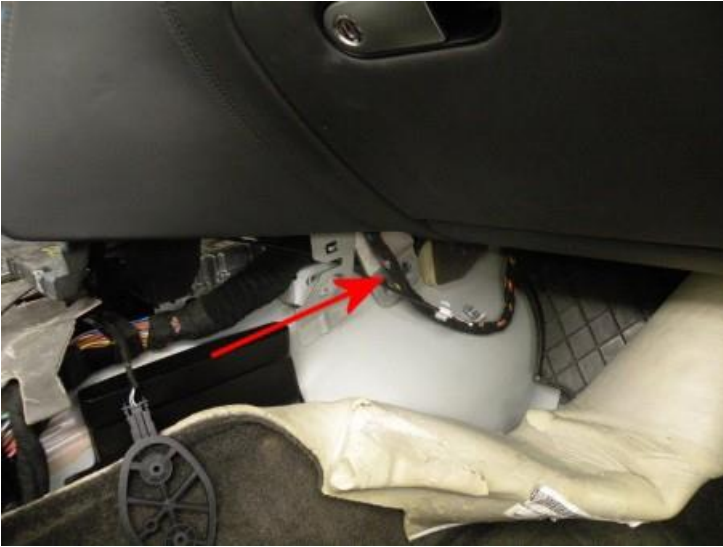
Figure 8

17. To improve access at the air bag control module remove the upper and lower retaining bolts secure the right hand support bracket for the instrument panel (see Figure 8)

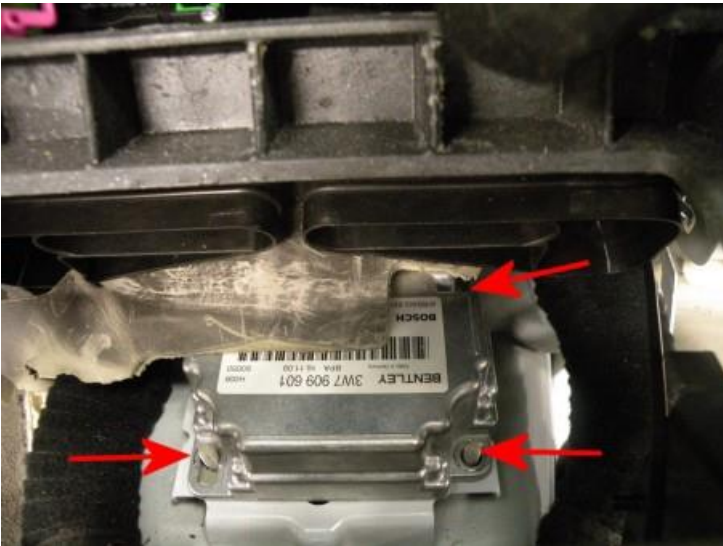
Figure 9

18. Ensure both batteries have been disconnected for a least on minute and are still disconnected before removing three fasteners securing the air bag control module (see Figure 9)

29. Position the control module onto the three studs and secure the three fasteners

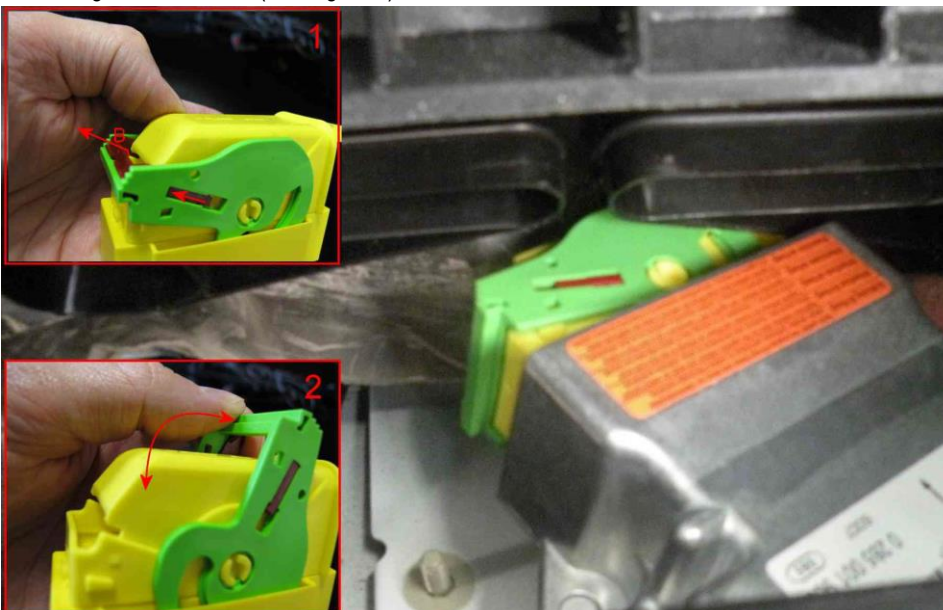
Figure 10

19. Lift the module off the three studs and position through the aperture in the instrument panel enabling access to the electrical connection. To release the connector housing from the control module. 1/ Pull the red locking bar (B) out to unlock. 2/ Rotate the securing cam until

the housing is released (see Figure 10). Remove the control module. Note: Do not drop or expose the unit to shock loads

28. Re connect the harness to the air bag control module pushing the securing cam down to lock before pushing the red locking bar in, reverse operation 19

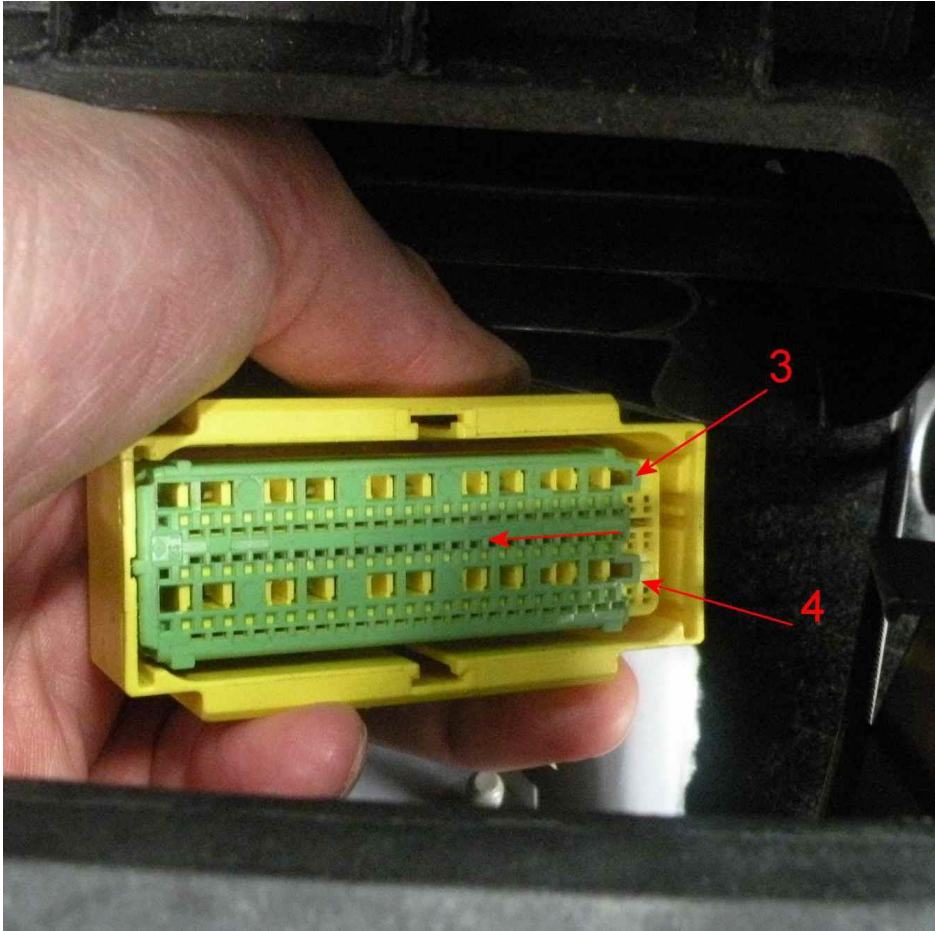
Figure 11

20. Lift and slide the secondary keeper over the two barbs at points 3 and 4 to reveal the terminal lance access ports (see Figure 11)

25. Re check that you have correctly populated the air bag control module terminal housing (see Figure 13 and 15)
26. Re engage the secondary keeper, reverse operation 20

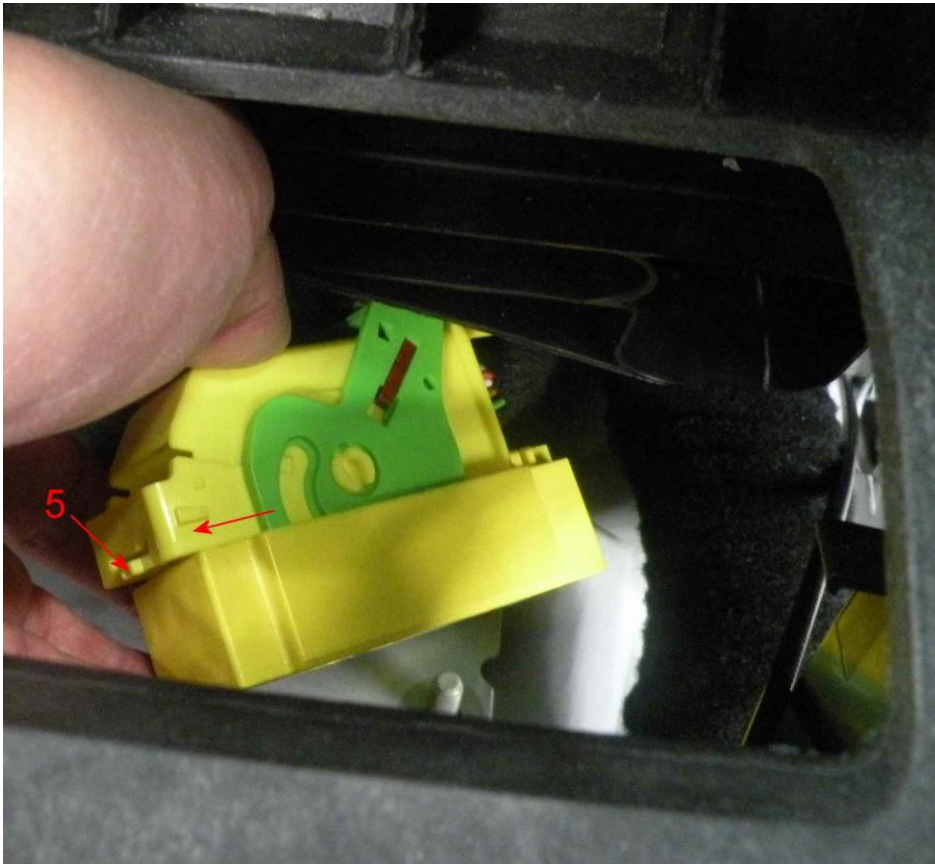
Figure 12

21. Lift and slide the cable cover at the rear of the housing over the two barbs at points 5 then lift the cover off the housing (see Figure 12)

27. Remove a section of harness tape to allow the cut point to be staggered then cut off the redundant terminals. Over tape the cut cables before refitting the cable cover onto the rear of the housing, reverse operation 21

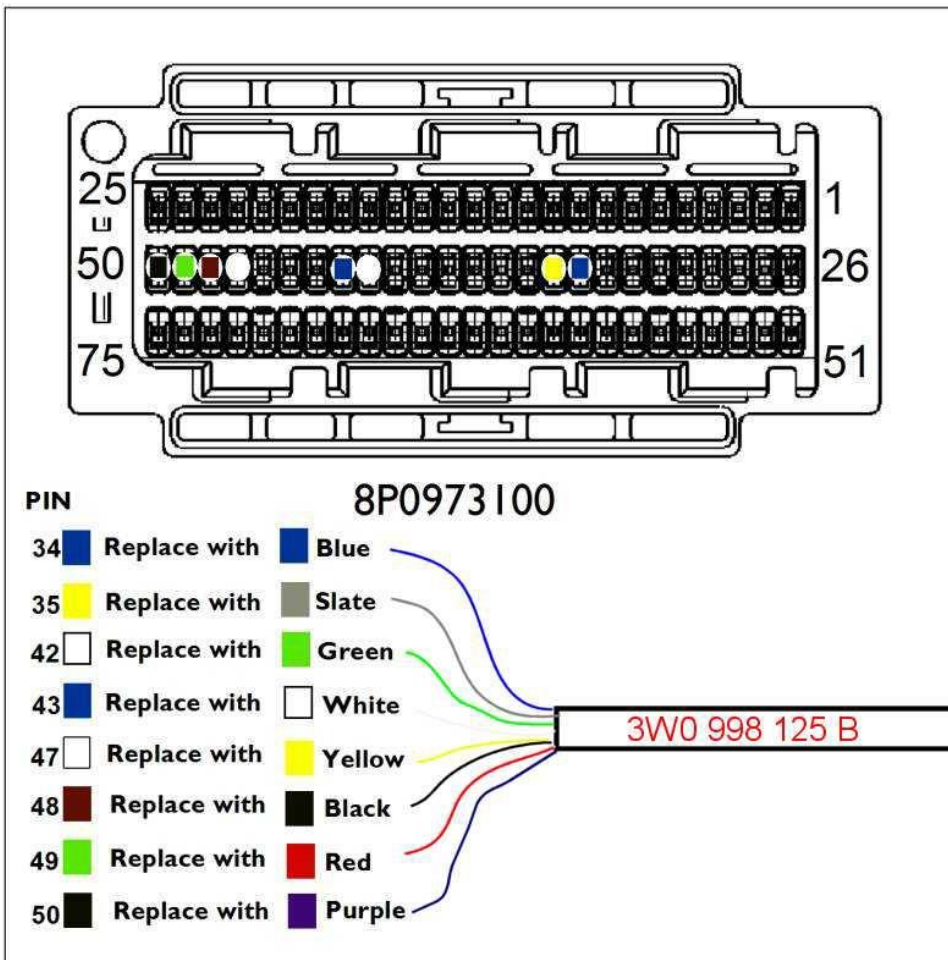
Figure 13

22. Identify the eight wires that have to be removed from the housing (see Figure 13). Note: figure 13 shows the connector face (not cable entry). The left hand list and the plug detail depicts the cable colours originally in the harness. The new cable colours are shown associated with the new harness (part number 3W0 998 125B)

23. Using VAS 1978/35-2 releasing tool from kit ASE 401 578 000 00 extract each of the eight wires in turn.
 Note: A sample of vehicles may have the white and brown cables in cavity 47 and 48 transposed this is expected and despite this the new harness cables should be inserted into the cavities as shown in figure 13. This is the yellow in cavity 47 and the black in cavity 48
 Note: Each of the eight terminals in the new harness will have a seal incorporated into the crimp this seal may not be present on the original wires in the air bag harness. The absence of this seal in the rest of the housing is not detrimental

24. With the new harness in position fit each of the eight new wires in turn into the correct cavities as detailed in figure 13. Note: the correct orientation of the locking lance when fitting the new terminals into the centre row of cavities in the housing (see Figure 14)

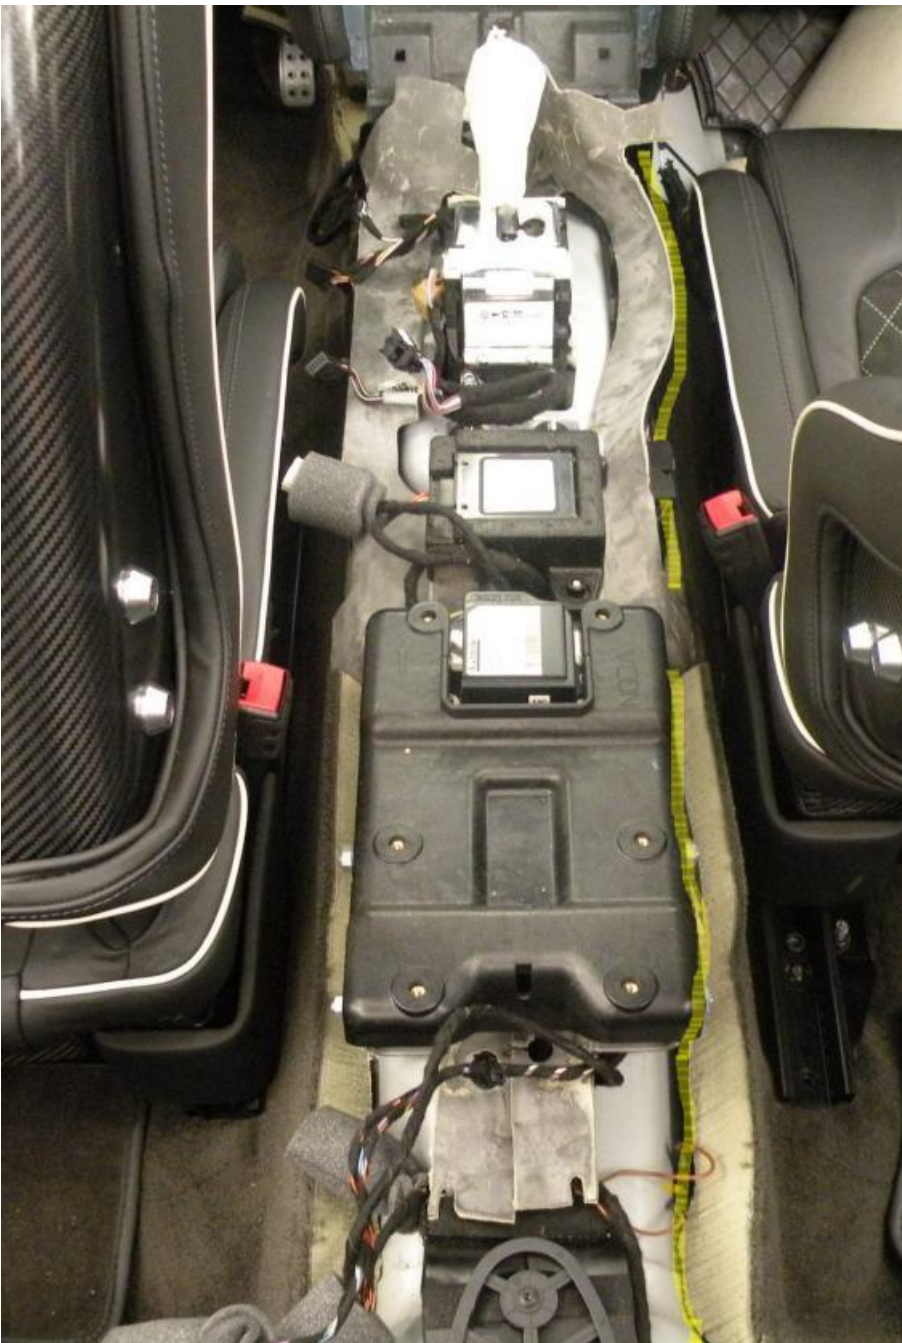
Figure 16

30. Route the new harness down the right hand side following the centre console main harness (see Figure 16)

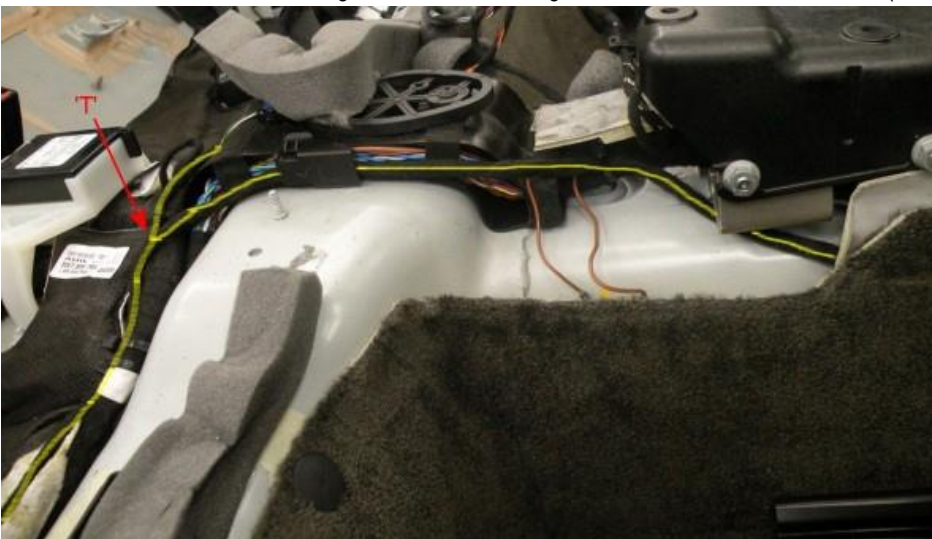
Figure 17

31. Route each branch from the 'T' point to both seat belt reel assembly's follow the original harness route. (see Figure 17)

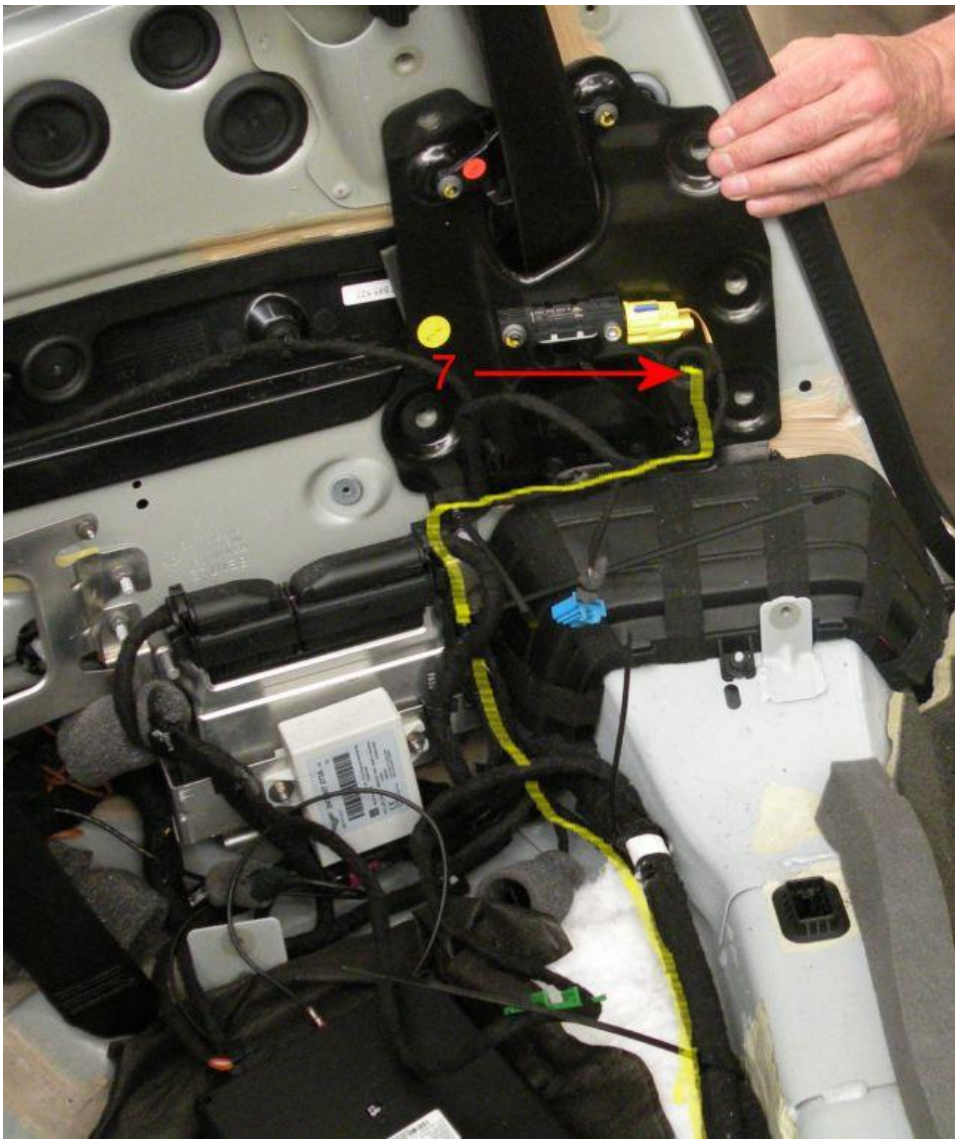
Figure 18

32. Locate the grommet (7) incorporated in the new harness into each retractor plate. To enable correct harness routing on the right hand side remove the fasteners and lift the cable carrier (6), route the new harness under the carrier then refit the carrier. Ensure the harness is not trapped when refitting the carrier. On the left hand side the harness runs over the top of the cable carrier (see Figure 18)
33. Ensure the harness is secure along its entire length, use cable ties where required

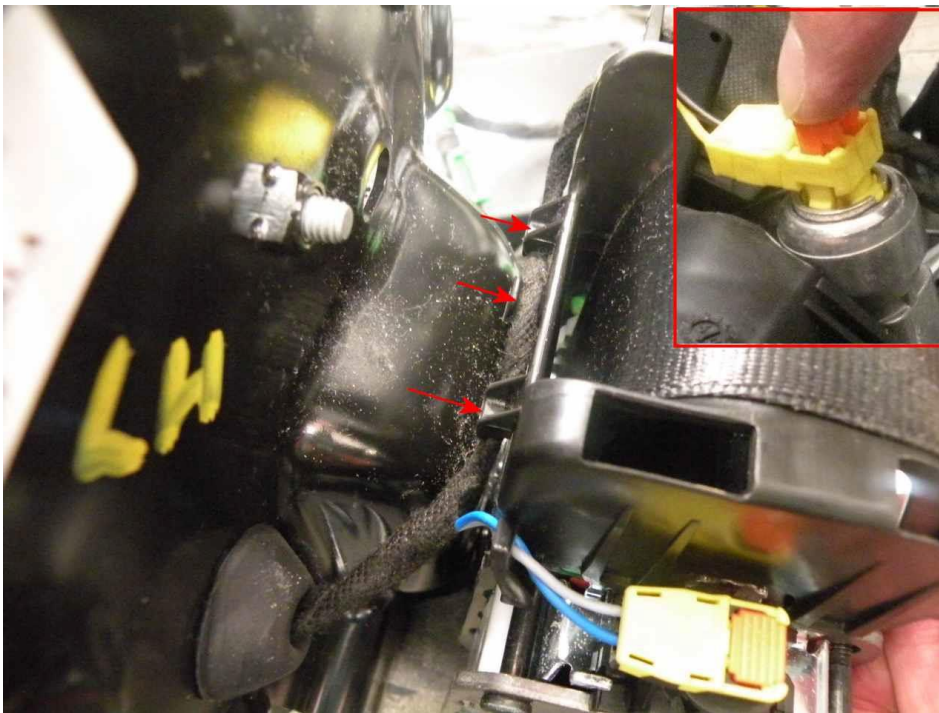
Figure 20

34. With the new harness in position and the grommet (7) engaged in the retractor plate position the harness under, over and finally under the three guides (arrows) before making the connections at each seat belt pre-tensioner and load limiter. To make each connection the respective connector should be positioned over the component before pressing down on the orange keeper this will first engage the main yellow housing into the component before the inhibit is released allowing the orange keeper to engage (see inset Figure 20). Carry out the same operation on the right hand belt assembly

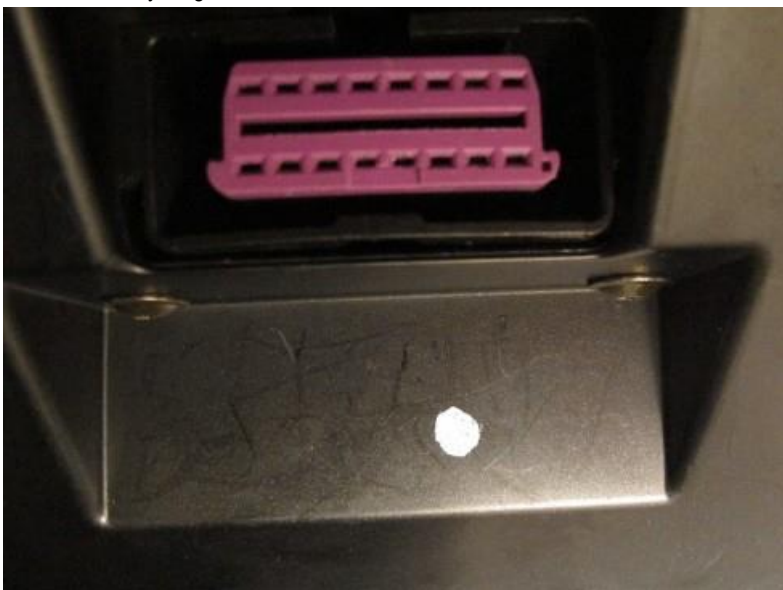
Figure 21

On completion apply a white paint identification mark adjacent to the OBD connector
