# Technical product information

<b>Topic</b>	Continental GT Convertible – Front seat belt webbing twisted
<b>Market area</b>	Bentley: worldwide (2WBE)
<b>Brand</b>	Bentley
<b>Transaction No.</b>	2038562/4
<b>Level</b>	EH
<b>Status</b>	Approval
<b>Release date</b>

Front seat belt webbing twisted

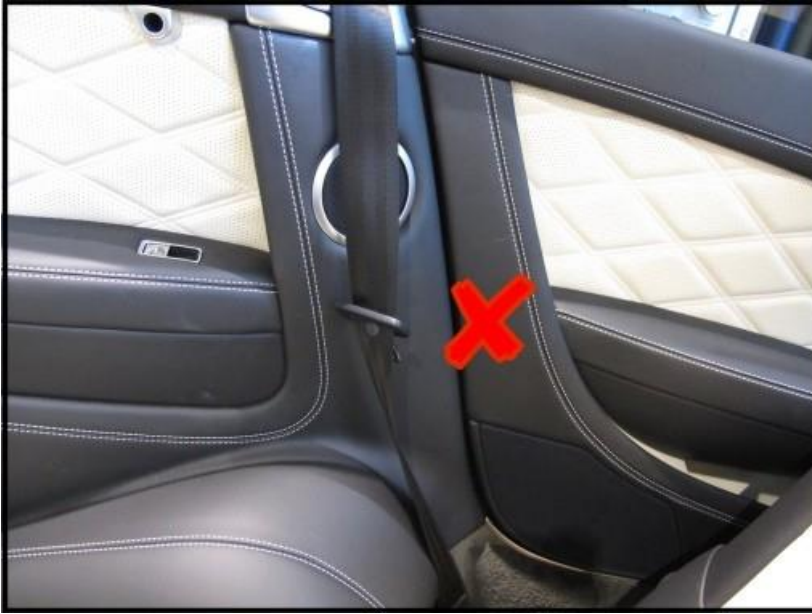
The front seat belt webbing is twisted this is evident in both the stowed position and also when the seat belt is worn see Figure 1

The plastic seat belt webbing guide, a plastic moulding incorporated in the seat belt upper 'D' loop assembly, may not have been fully clipped onto the metal 'D' loop. When this is the case a twist in the seat belt webbing is possible

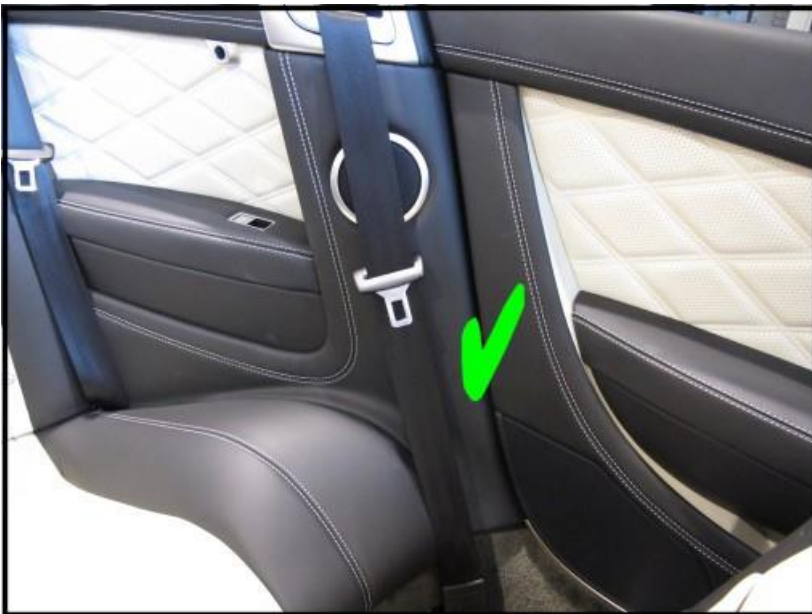
Figure 2

The front seat belt in the stowed position should be as shown in figure 2

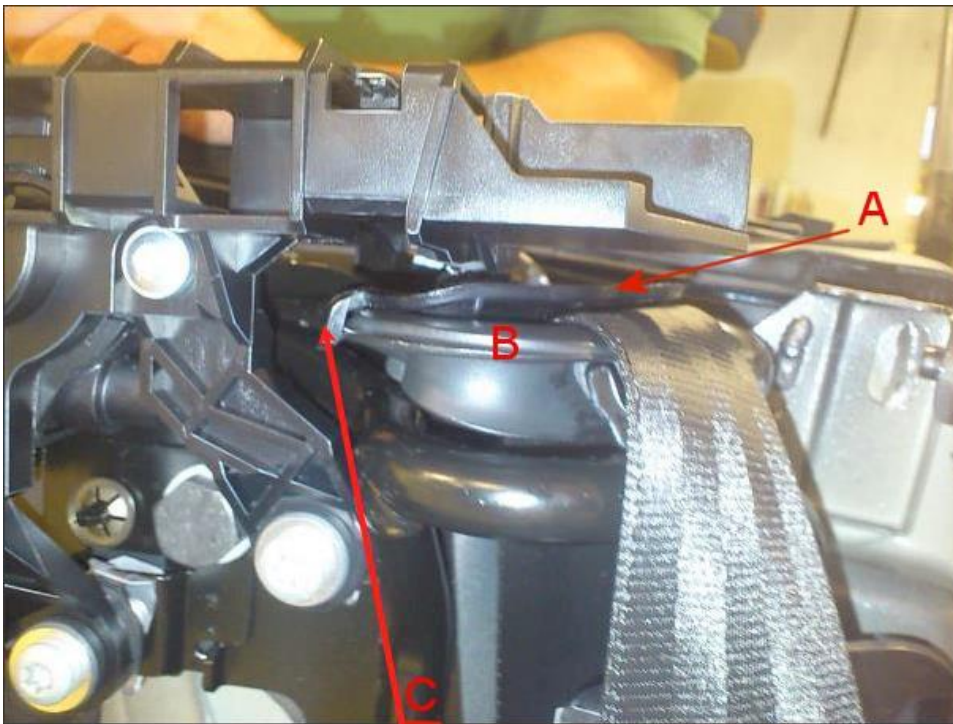
Figure 3

2. Referencing figure 3 and 4 inspect the seat belt webbing plastic guide (A). Ensure the three clipping points (C) are securely clipped to the 'D' ring (B).
3. If the guide is not securely clipped then remove and discard the guide and fit a new replacement guide.
4. On completion the guide must be correctly secured to the 'D' ring paying close attention to both outer clipping features (C)
