HYUNDAI Technical Service Bulletin	GROUP CAMPAIGN	NUMBER 22-01-023H
	DATE MARCH 2022	MODEL(S) APPLICABLE VEHICLES BELOW
SUBJECT: DTC P1326 - ENGINE BEARING INSPECTION / ENGINE REPLACEMENT (SERVICE CAMPAIGN T6G)

Description: Certain vehicles listed below may experience the Check Engine warning lamp illuminated with DTC P1326 and/or an engine concern/noise related to connecting rod bearing wear or damage. Follow the procedure to inspect the vehicle and replace the engine and/or update the engine ECU software (if new ROM is available) based on the inspection results.

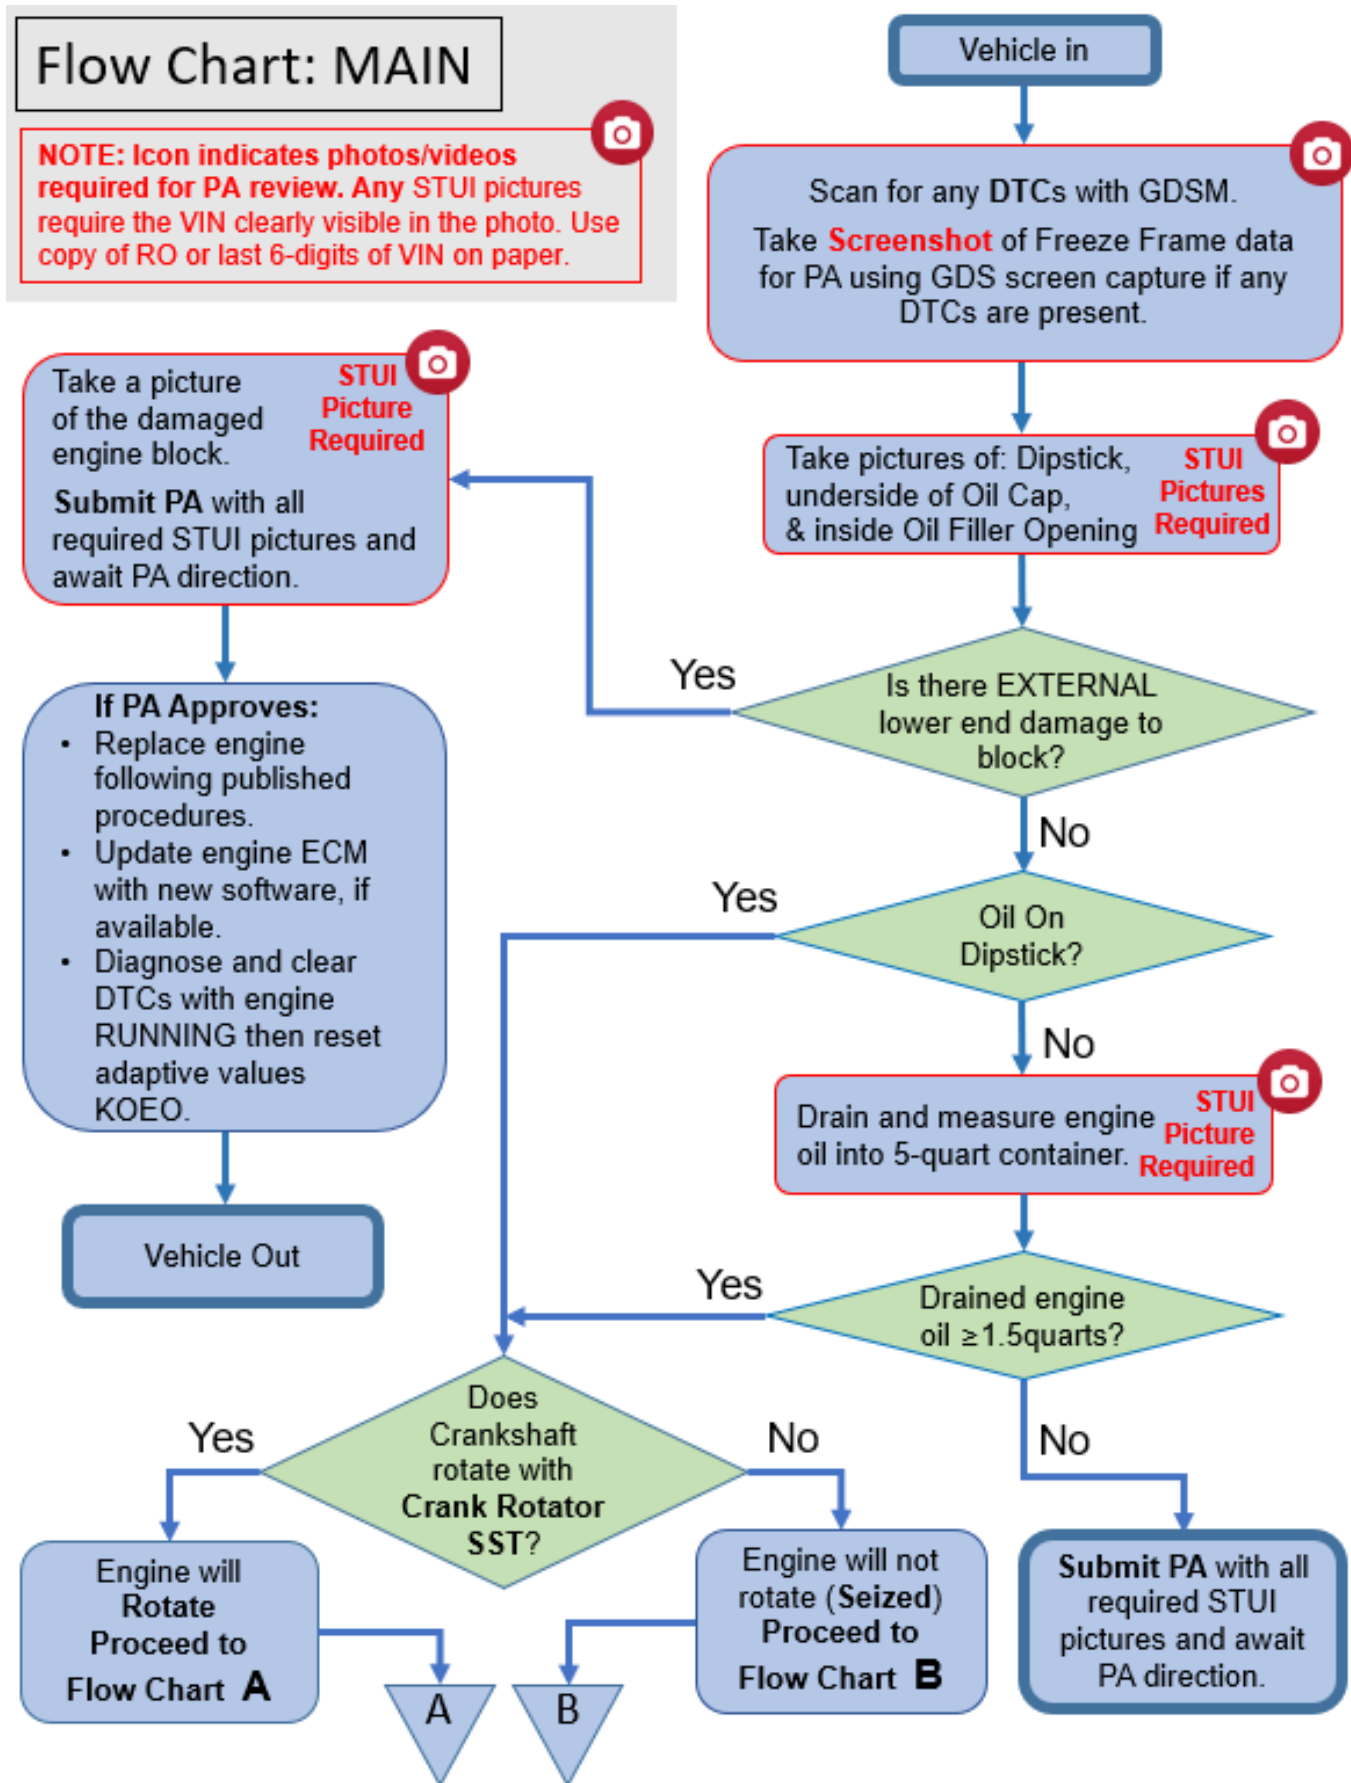
Flow Chart: MAIN

NOTE: Icon indicates photos/videos required for PA review. Any STUI pictures require the VIN clearly visible in the photo. Use copy of RO or last 6-digits of VIN on paper.

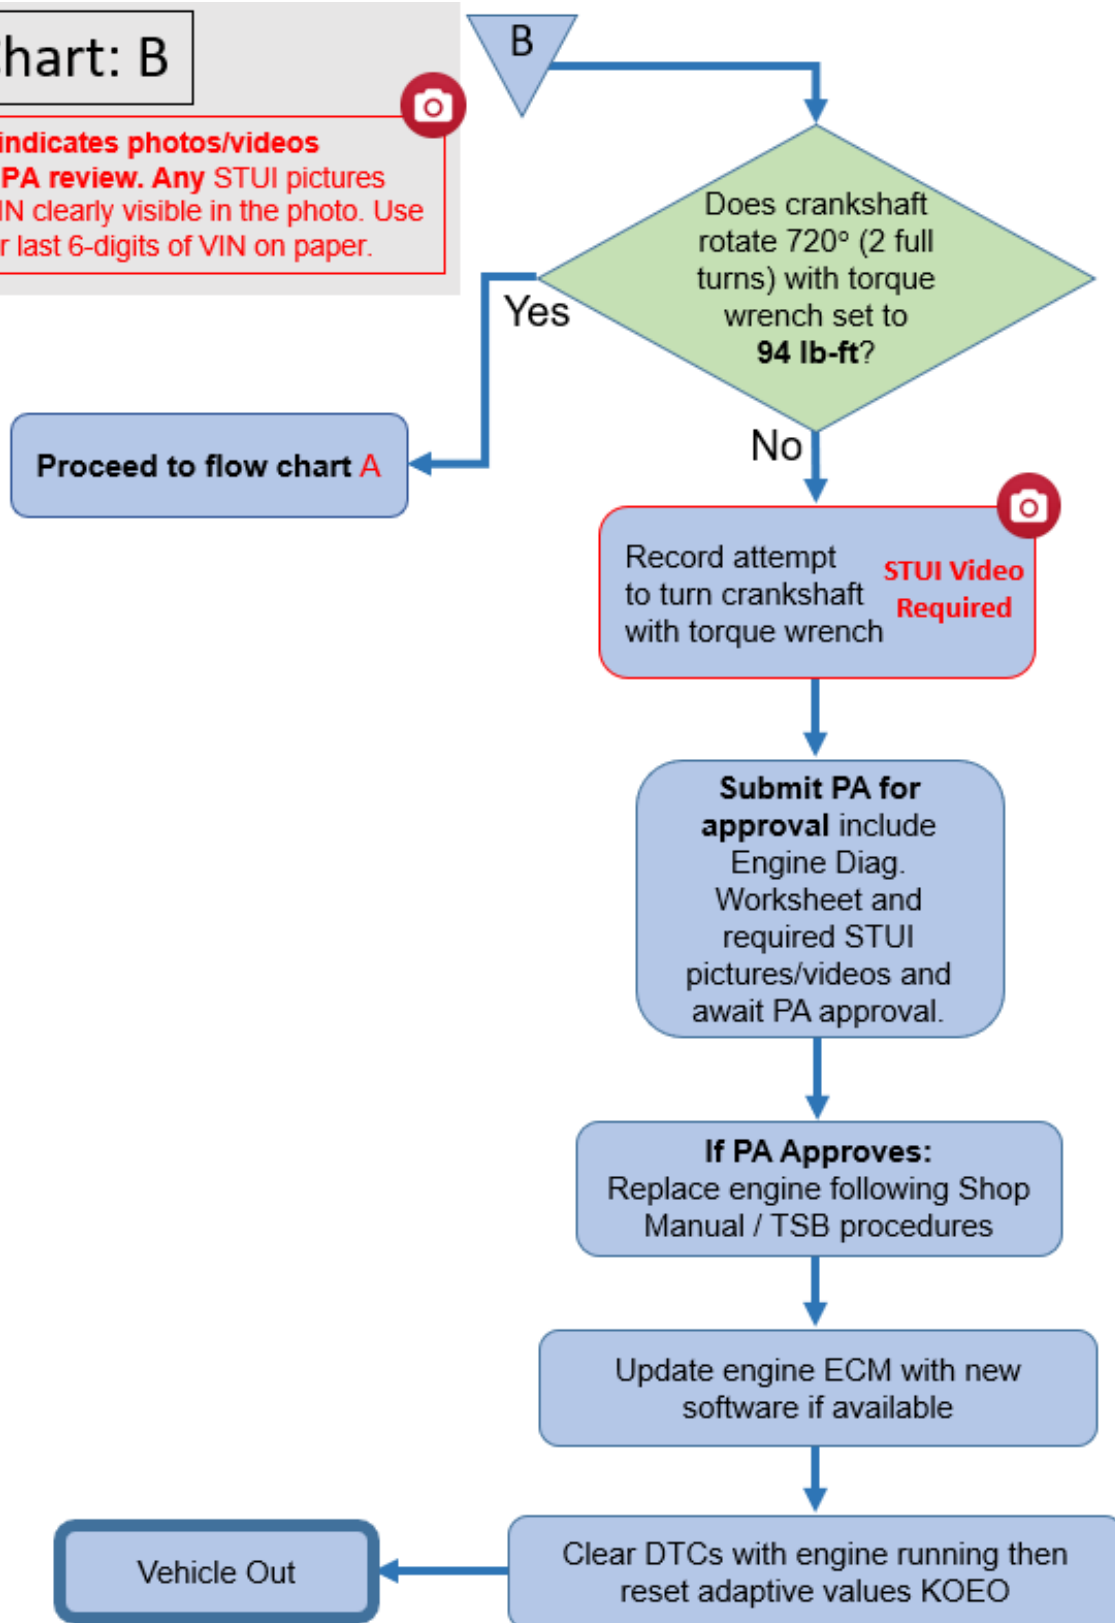
Flow Chart: B

NOTE: Icon indicates photos/videos required for PA review. Any STUI pictures require the VIN clearly visible in the photo. Use copy of RO or last 6-digits of VIN on paper.

- Follow the procedure sequence in **Flow Chart B** to complete the crank rotation inspection.

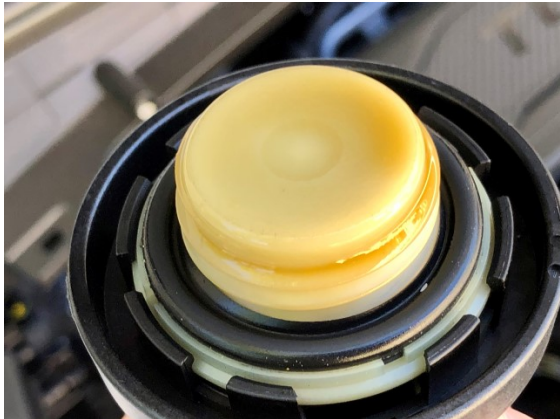
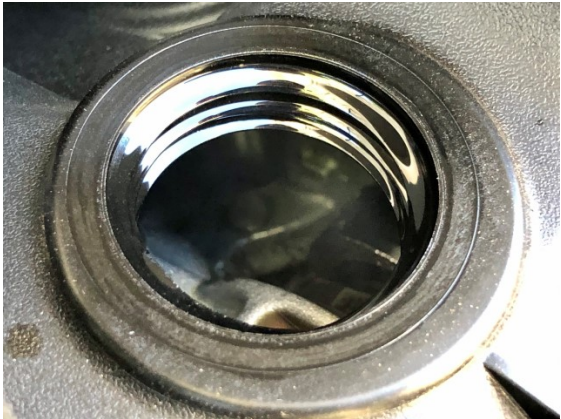
1. Scan for DTC P1326 using the GDS.
 - ❖ If DTC P1326 (or any other code) is present, take screenshot of Freeze Frame data for PA using GDS screen capture if any DTCs are present and proceed to Step 2.
2. Take pictures of the dipstick, engine oil filler cap, and inside the valve cover oil filler opening.
 - Using STUI on the GDS, take and submit pictures of the following with the VIN in the background of the photo (RO or last 6 digits written on paper). **VIN must be legible.**

Oil filler cap: Clear view of cap underside	Oil filler opening: Clear view inside opening.

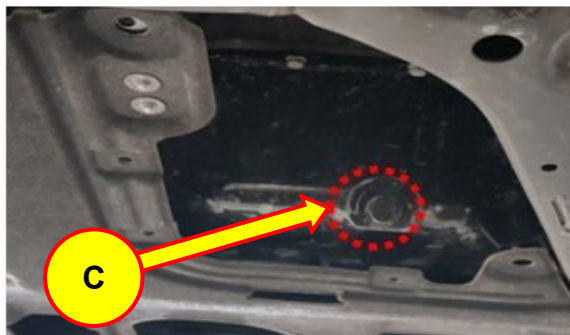
2. Lift up the vehicle and remove the oil drain plug (C).

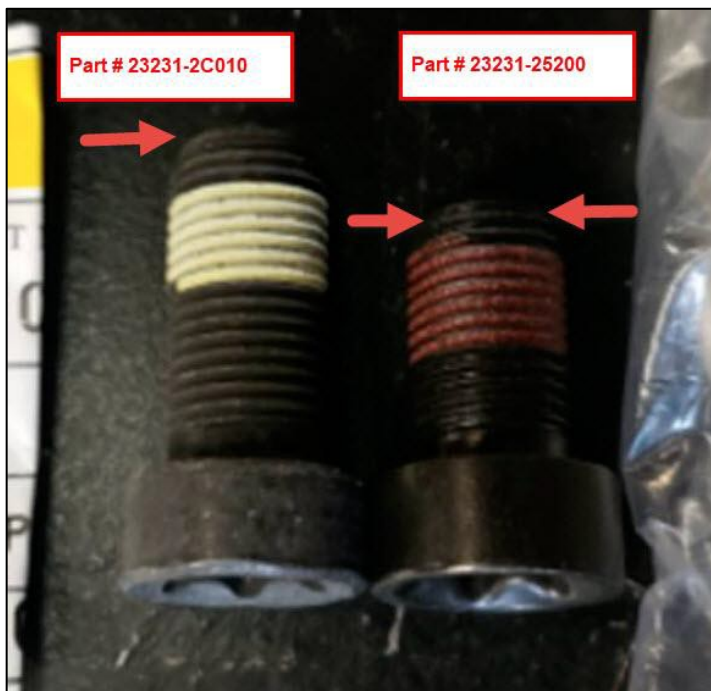
For 11-12MY Sonata Hybrid (YF HEV):

When installing a new engine, the drive plate bolts must be replaced with P/N 23231-25200.

- ❖ Due to changes to the crankshaft design, the existing bolts are ~2mm too long and will result in improperly fastened drive plate if reused.
- ❖ The 13-15MY version drive plate bolts (P/N 23231-25200) are correct length for the new engine and will provide proper fastening during engine installation.

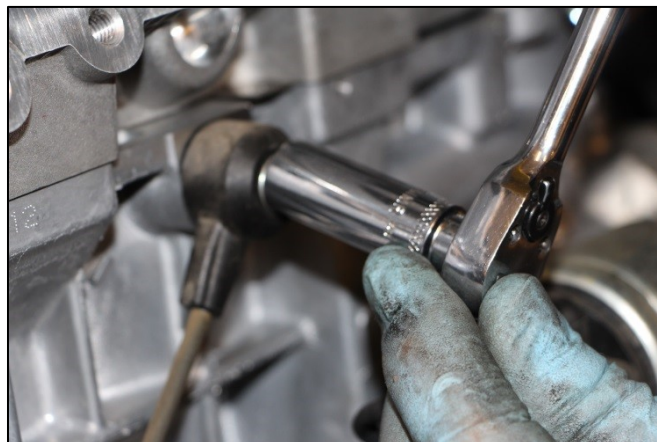
3. Remove and reinstall the engine knock sensor (if not newly supplied) from the old engine to the new engine.

Knock Sensor Fastener Tightening torque:
21Nm (15.5lb-ft)

Ensure the knock sensor is torqued to specification using a torque wrench.

- ❖ Improper installation can result in DTC codes.

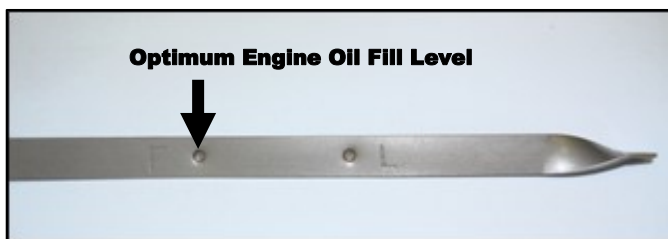
- Check for any leaks during this time.
 - After the engine has warmed up to normal operating temperature, turn the engine off, wait a few minutes, and then **adjust the engine oil level to near the “F” mark as shown.**
