# HYUNDAI Technical Service Bulletin

GROUP <b>CAMPAIGN</b>	NUMBER <b>22-01-016H-1</b>
DATE <b>MARCH, 2022</b>	MODEL(S) <b>PALISADE (LX2)</b>

**SUBJECT:** FRONT DOOR LOWER GARNISH REPAIR PROCEDURES  
(SERVICE CAMPAIGN 975)

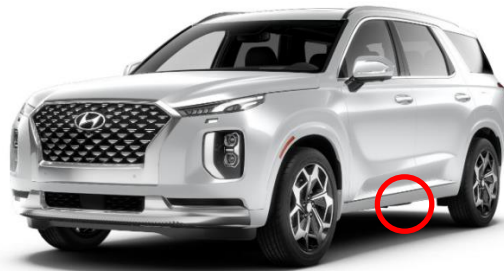
**Description:** Certain 2020 – 2022MY Palisade (LX2) vehicles may have been produced with a rough edge on the front door lower garnishes during manufacturing. This bulletin describes the procedure to repair the condition.

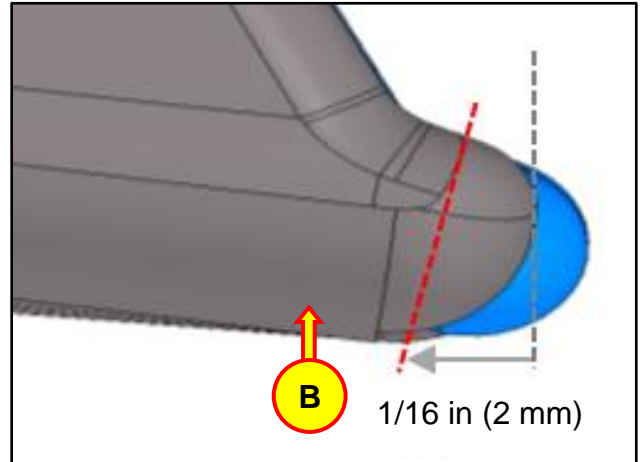
Do not cut too deep on the door garnish. Damage to the door garnish bracket may occur.

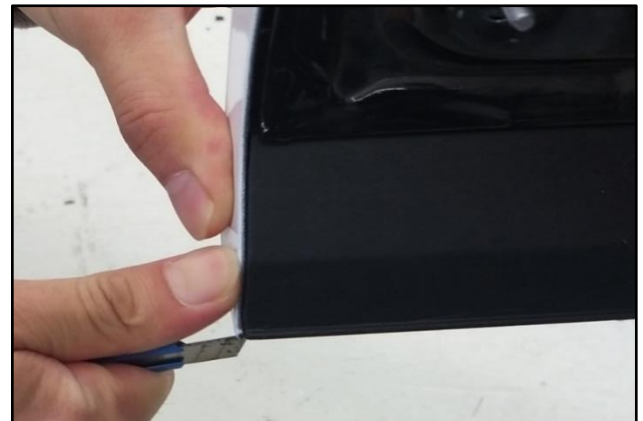
Inspect the area with your fingertips after cutting to be sure there are no sharp edges.

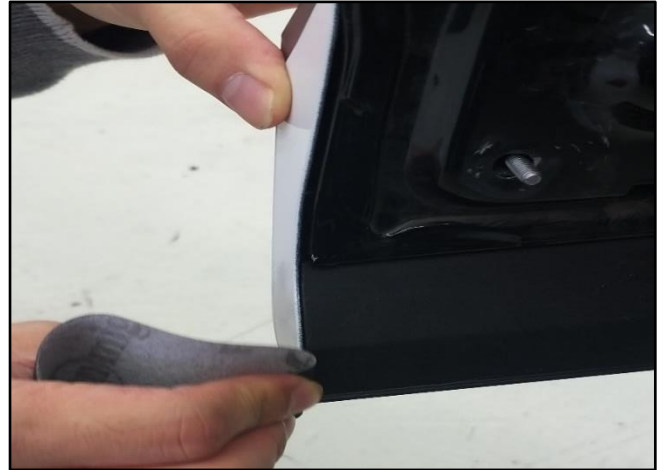
5. Inspect the area with your fingertips to ensure there are no sharp edges after sanding.

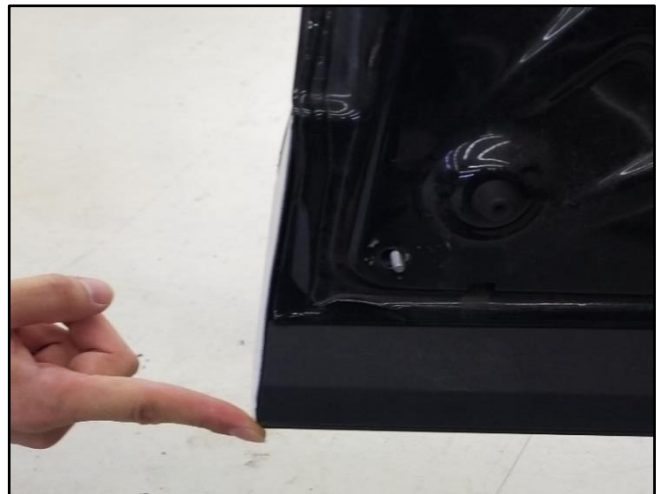
6. If necessary, apply touch up paint to the lower garnish with a touch up paint pen.

Paint touch up is not necessary for non-painted garnishes. Painted garnishes are applied only on Limited and Calligraphy trims and are body colored.

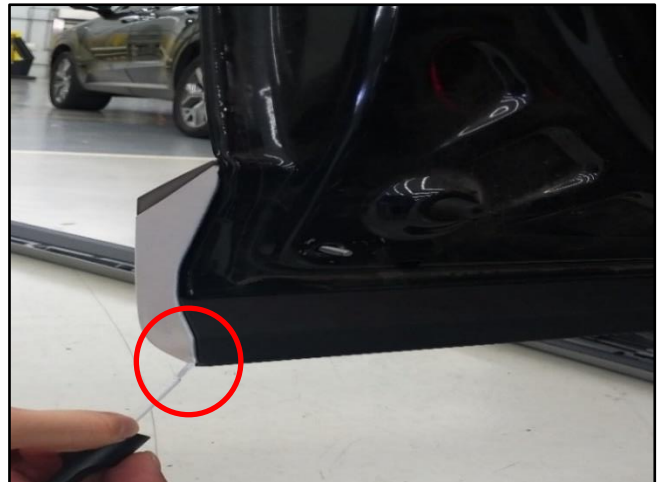
7. Use a heat gun to apply heat in a sweeping motion for approximately 1-2 minutes to assist with drying the touch up paint.

**Do not apply heat too close to the garnish as it may cause damage.**

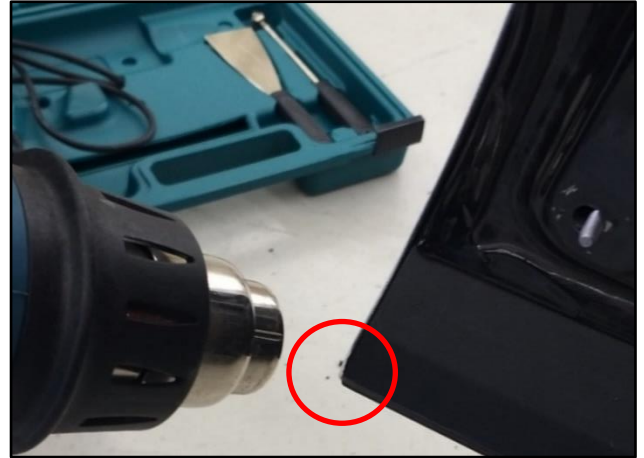
8. The service procedure is complete.
