Subject: N212351811 - Customer Satisfaction Program
Poor Hem Flange and Shy Sealer in Rear Wheelhouses

Models: 2021 Buick Enclave

N212351811 Poor Hem Flange and Shy Sealer in Rear Wheelhouses

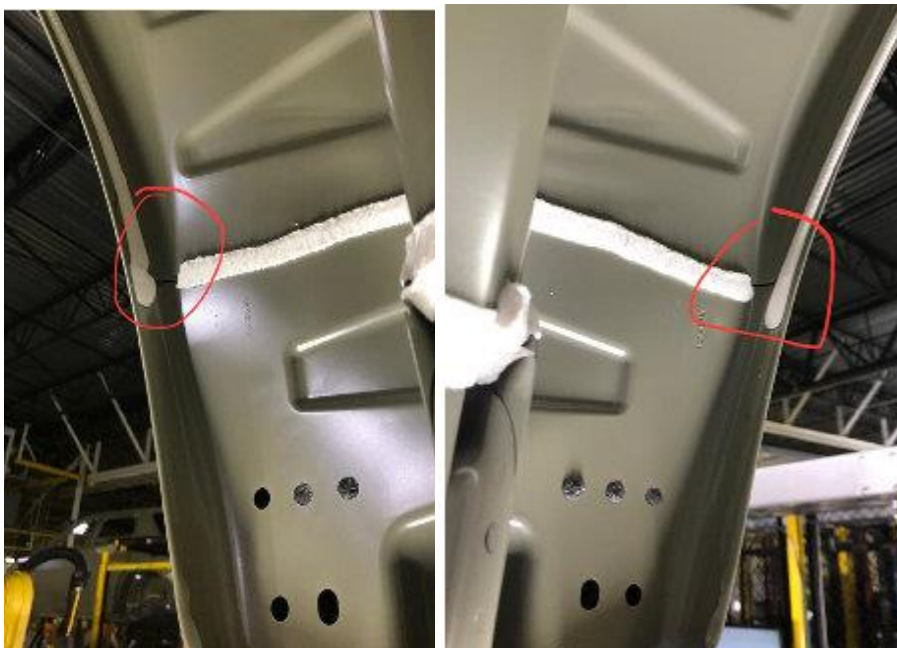
6043068

1. Raise the vehicle on a hoist. Refer to *Lifting and Jacking* in SI.
2. Partially remove the left and right rear wheelhouse liners, it is only necessary to remove the 4 front fasteners and the air deflector. Carefully fold the wheelhouse liners allowing access to the work area. Refer to *Rear Wheelhouse Liner Replacement* in SI.

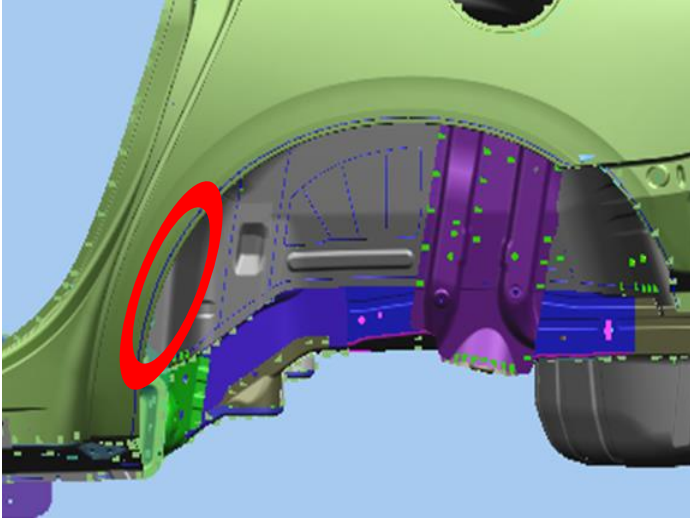
6041878

3. Locate the skip in the sealer on the left and right-side inner wheelhouse. See the graphic for the area to be sealed.

6. Using Kent Automotive High-Tech Seam Sealer-Clear, seal the left and right wheelhouse joints and left side hem flange area identified in the graphics above. Ensure the complete area is sealed. Smooth the sealer with a small brush to ensure coverage. Note that **only the left side hem flange requires sealing**.
7. To avoid contaminating the wheelhouse liner material, allow the seam sealer to cure per the manufacturer's instructions.
8. Reinstall the wheelhouse liners and fasteners as required. Refer to *Rear Wheelhouse Liner Replacement* in SI.

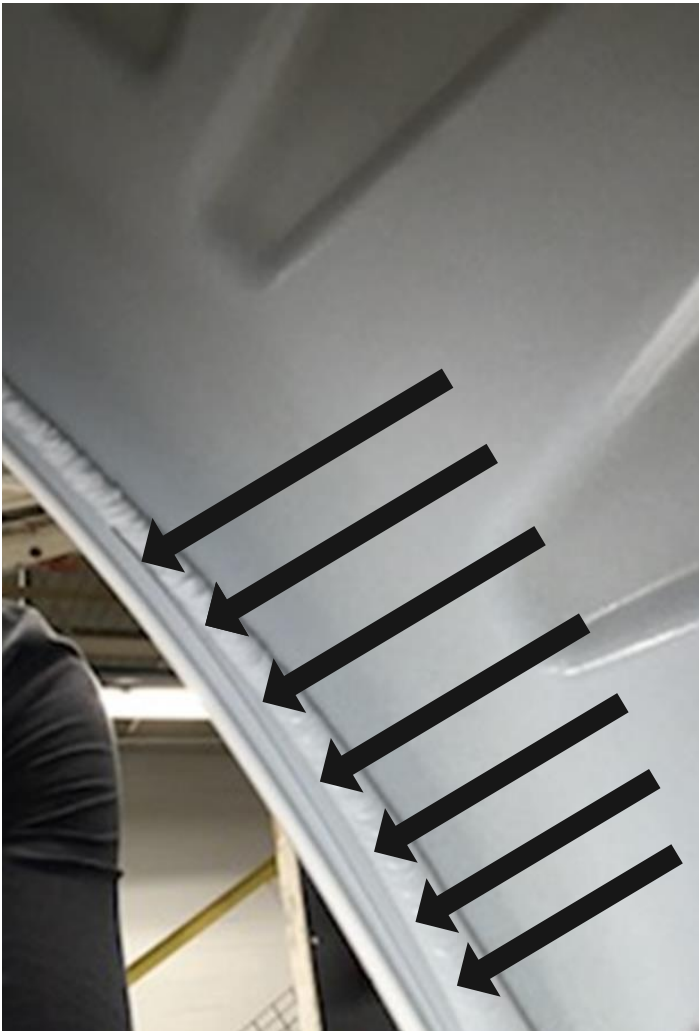
6041800

4. Locate the out of position seam sealer between the outer wheel well and the outer panel hem flange. See the above graphics for the sealing location. The actual sealing area is on the inside of this area.
5. Clean the sealing areas with a general-purpose adhesive remover.
