2017-18MY
Forte (YD, YDm)
w/Nu 2.0L GDI

PI2106Y/Z

ENGINE REPLACEMENT INSTRUCTIONS
FOR DTC P1326 (PI2106Y/Z)

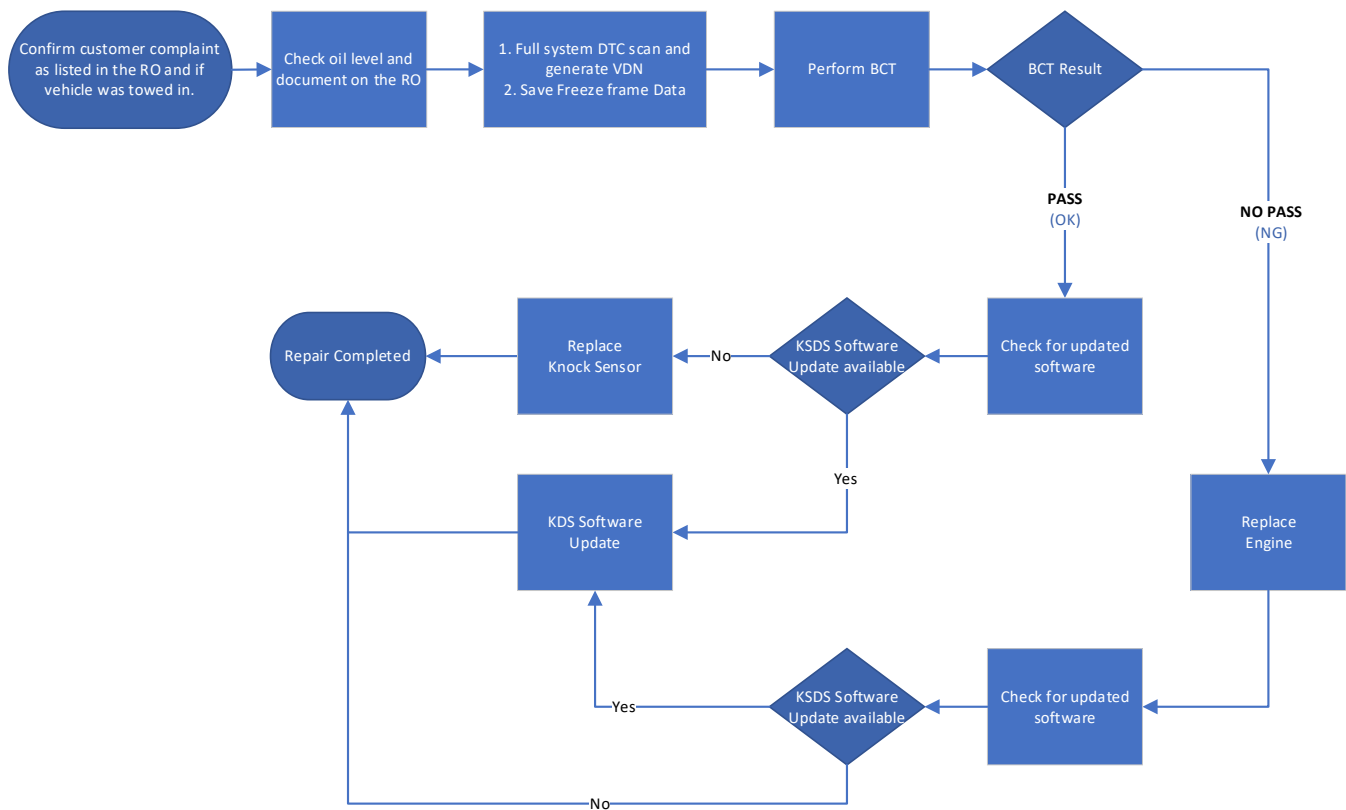
A. DTC P1326 STORED

Create PI2106Y Claim – No Techline PWA Required

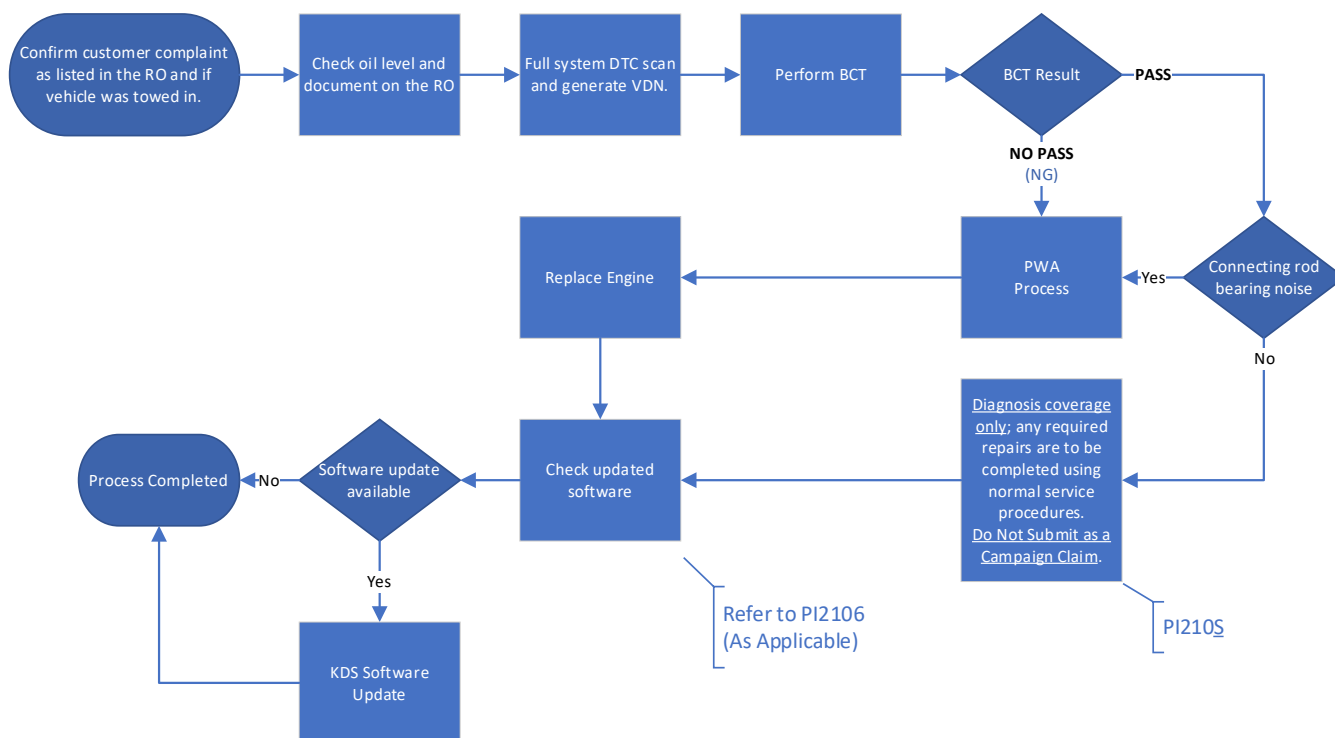
ENGINE REPLACEMENT INSTRUCTIONS FOR DTC P1326 (PI2106Y/Z)**B. ENGINE NOISE**

Techline PWA Required; Diagnosis only Campaign Possible

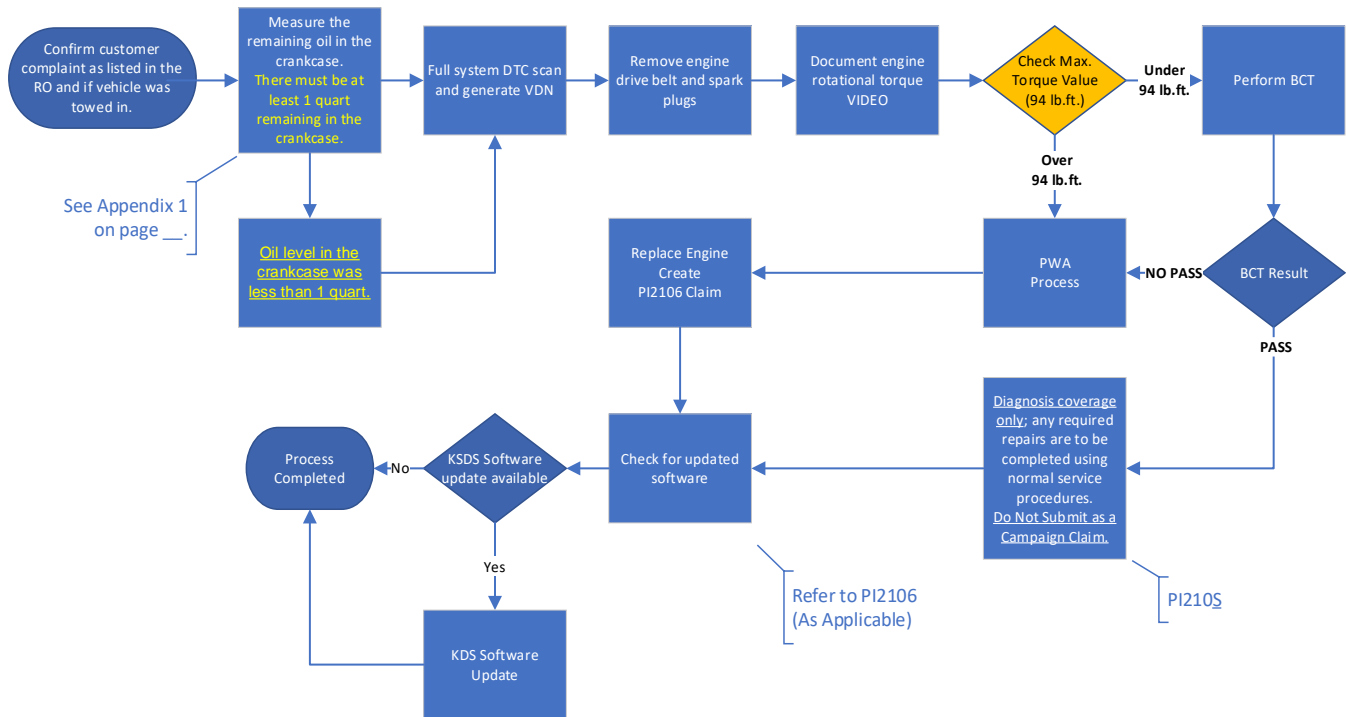
C. ENGINE NO CRANK

Techline PWA Required; Diagnosis only Campaign Possible

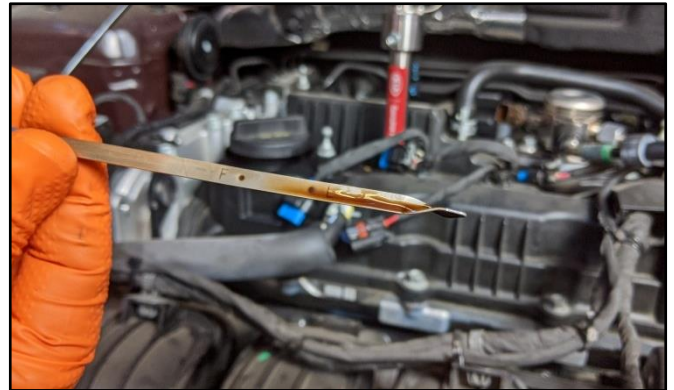
Oil Level Check: (Applies to all Flowcharts B and C)

1. Measure and record oil dip stick level.
2. Note oil dip stick reading on the RO.
3. If no oil is showing on dipstick, proceed to Oil Level Measurement.

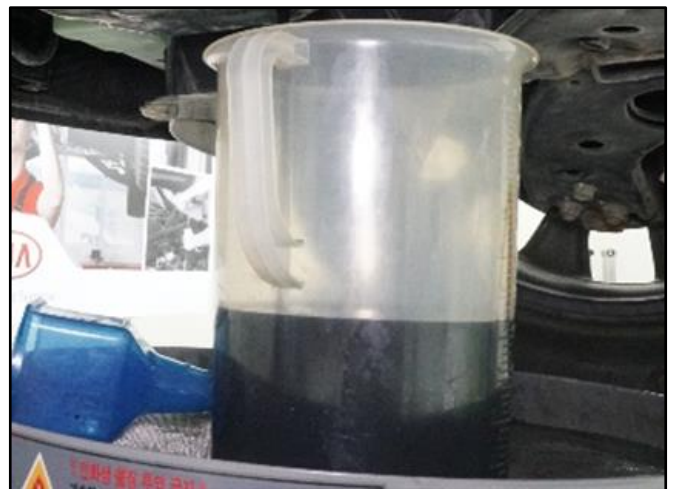
Oil Level Measurement: (Flowchart C)

1. Remove oil filler cap, remove oil drain plug and drain oil into the supplied measuring container SST067BUCK and check oil level.
2. Record oil level reading.
3. Take photo of the oil level using KDS. Attach to Warranty Claim.

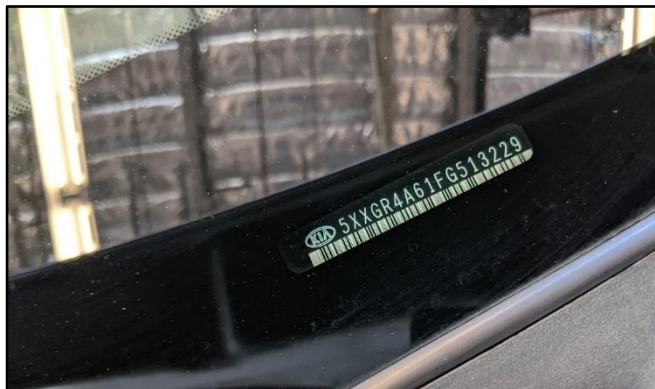
1. Start video showing the dash VIN tag.

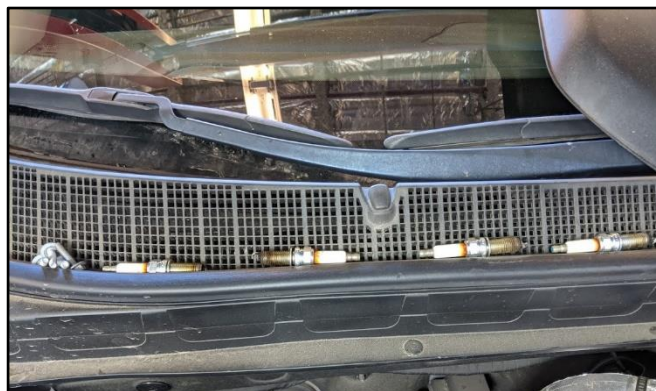
2. Show the removed spark plugs.

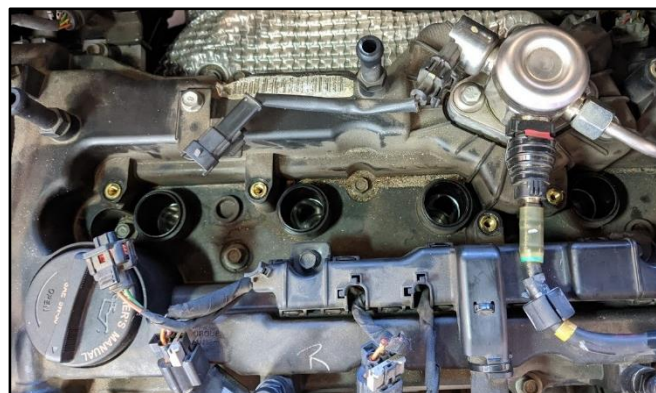
3. Show the empty spark plug holes from the engine.

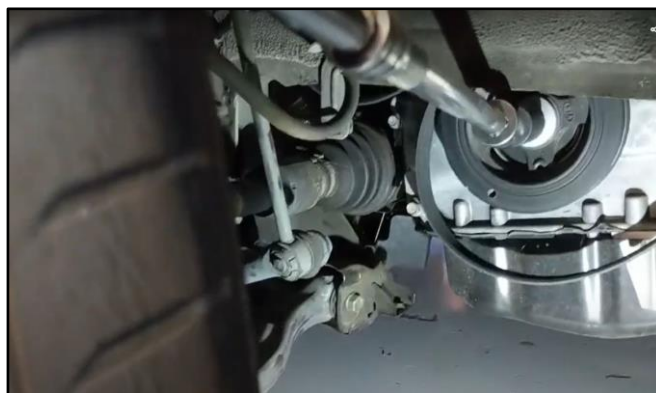
4. Show the removed drive belt and attached torque wrench to crank bolt.

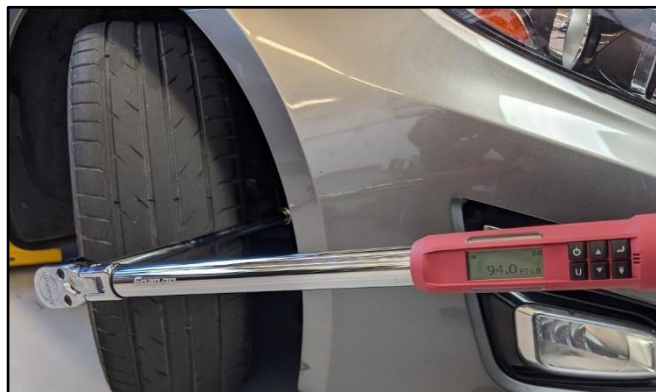
5. Show the engine being cranked and torque specification exceeding 94 lb.ft. torque.
