Title: DEF Tank Coolant Hose Routing on 73" Sleeper Cabs

Applies To: LT with Feature code 16AUN (Hi-Rise) and 16AUP (Sky-Rise)

This document will guide the user through re-routing the DEF tank coolant line on 73" sleeper to prevent rubbing on near the under cab fuse box.

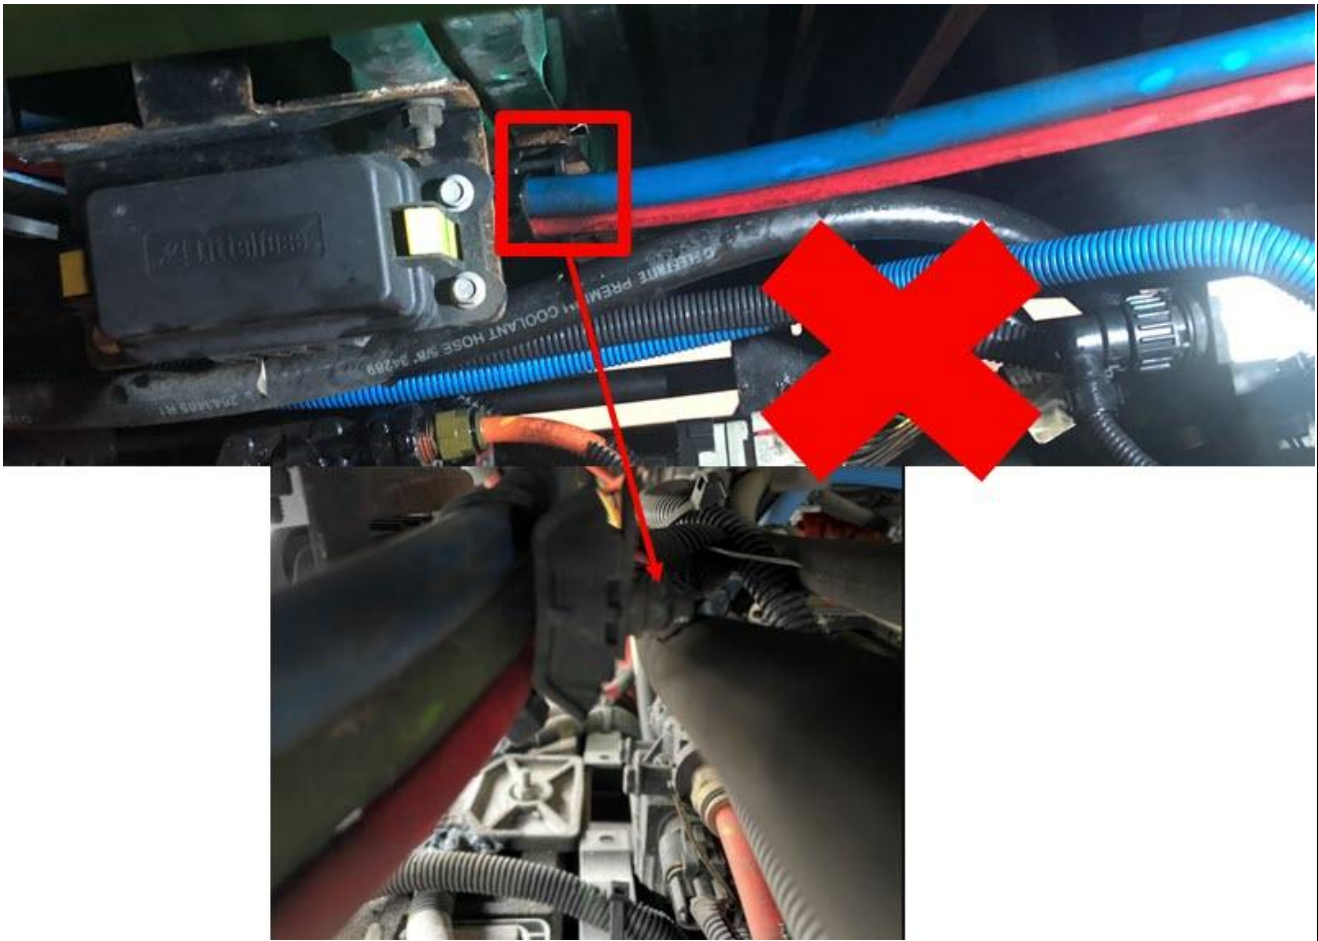
**Figure 1: Leak Location**

Coolant leak from under the cab on the drivers side.

| Step | Action | Decision |
|---|---|---|
| 1 | DIAGNOSTIC:<br><br>Refer to figure 1 below.<br><br>Do you have a leak in this location? | Yes. Go to Repair instructions |

Repair the hose as needed.

To prevent future rub conditions it's recommended to rotate the L-bracket supporting the trailer hoses 180deg and attach it to the hole in the cab structure near the fuse box. See Figure 2 and 3.
