<b>Subject:</b>  THE CLIP OF THE REAR END OF THE REAR BELTLINE	<b>Bulletin No.:</b> 09-013/22
	<b>Last Issued :</b> 04/12/2022

2019-2021 Mazda3 (5-door HB) with VINS lower than JM1BP\*\*\*\*\*401257 (produced before July 23, 2021)

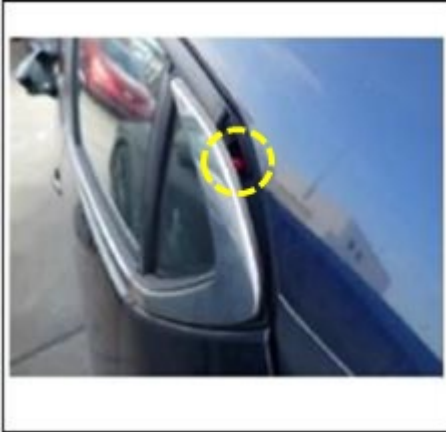
Some customers may complain that the clip on the rear end of the rear beltline molding is loose and the molding is slightly lifted up.

Due to the poor shape of the clip claws, the fitting force to the door body may decrease while in use. To eliminate this concern, the clip has been enlarged in the horizontal direction to improve the fitting force against the door body. Customers having this concern should have their vehicle repaired using the following repair procedure.

1. Verify the customer concern.
2. Replace both the left and right side clips with the modified ones according to the following repair procedure.
