Service Bulletin

Bulletin No.: 12-06-01-003D

Subject: Information for Repairing Engine Front Cover Oil Leak, Sealing Surface Preparation and Applying RTV Sealant

Models: 2006-2022 GM Passenger Cars and Trucks (Including Export Vehicles) Equipped with V6 Engine – RPO LAU, LF1, LFW, LFX, LFY, LLT, LP1, LY7, LF3 or LF4

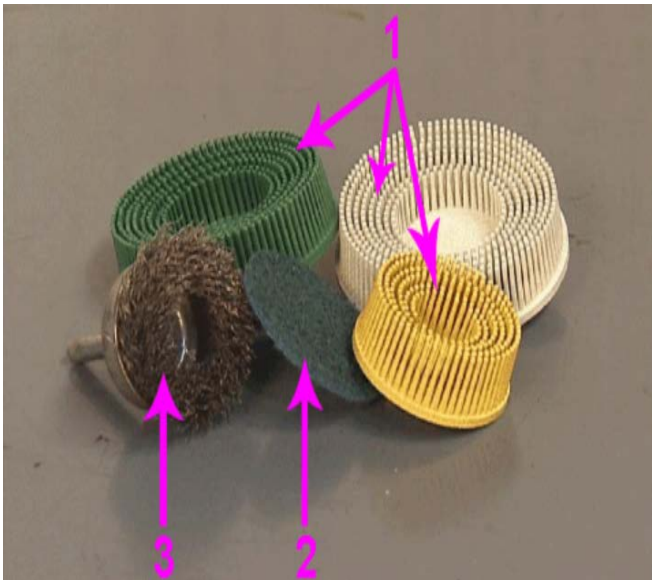
2833722

Notice: DO NOT use bristle discs (1), abrasive pads (2), wire wheels (3) or surface conditioning discs to clean the sealing surfaces of engine components.

Abrasive pads and bristle discs are embedded with abrasive material. The bristle discs wear down as they clean, continually exposing fresh abrasive to the surface of the component. These types of devices should not be used because they produce a very fine grit that the oil filter is unable to remove from the oil. THIS GRIT IS ABRASIVE AND IS KNOWN TO CAUSE INTERNAL ENGINE DAMAGE.

- Abrasive pads, wire wheels and bristle discs can remove enough metal to affect the engine front cover, cylinder head, engine block, oil pan rail, and intake manifold runner surface flatness, which can then result in engine coolant leaks, engine oil leaks and air leaks. It takes about 15 seconds to remove 0.203mm (0.008in) of metal with an abrasive pad.

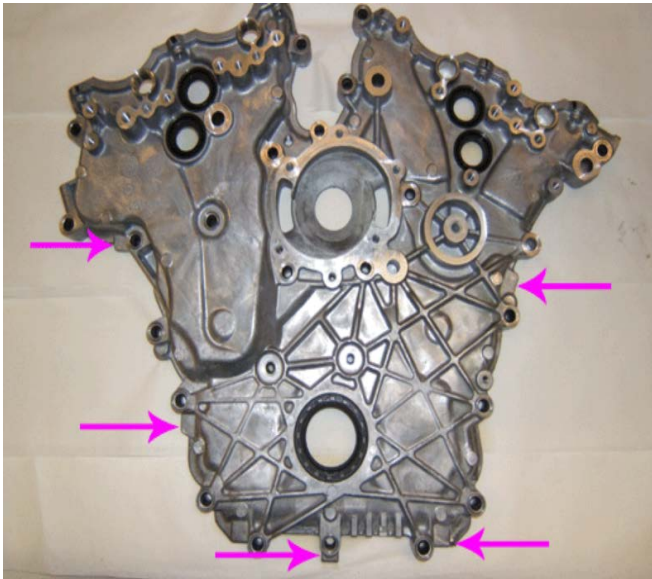
2834479

- Use the incorporated pry points to separate the engine front cover from the engine block.
- The pry points are positioned so that other vital engine components are not damaged when the pry points are used.
- Do not try to separate RTV sealed components by prying against other engine components.

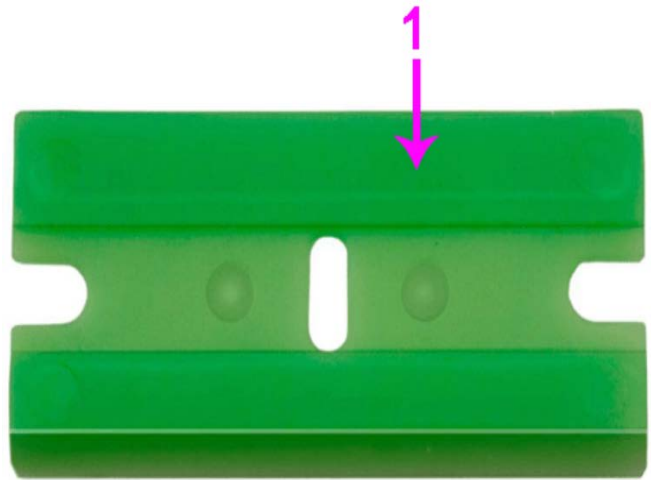
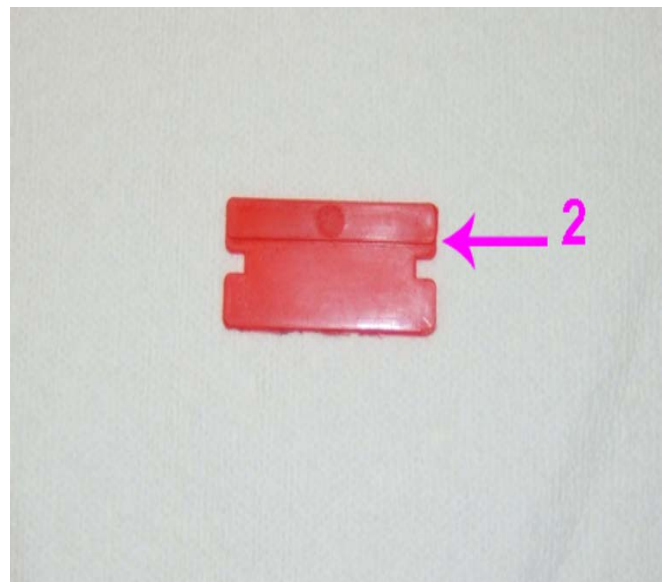
2833177

- Use a plastic razor blade (1), that mounts in a scraper device or a hand held plastic razor blade (2), to remove old RTV sealant from a sealing surface. Use a new blade for each corresponding engine component surface. Hold the blade as parallel to the flat surface as possible.

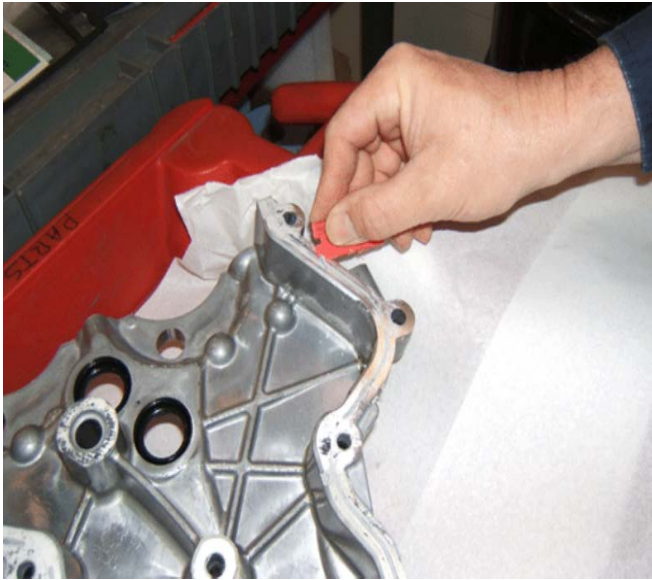
2834507

- Position and work the blade back and forth in the grooved areas of the component to loosen and remove the old RTV.

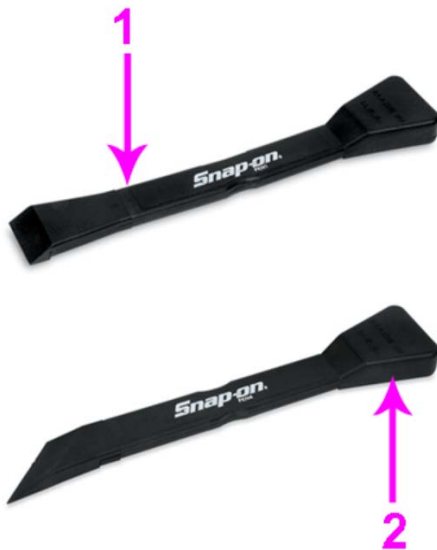
2832527

- When using a plastic gasket scraper with a straight blade (1) to remove old RTV sealant from a sealing surface, hold the scraper as parallel to the flat surface as possible.
- Use a plastic gasket scraper with an angle blade (2) and work the blade back and forth in the grooved areas of the component to loosen and remove the old RTV.
- Clean the engine front cover in solvent.
- Dry the engine front cover with compressed air.

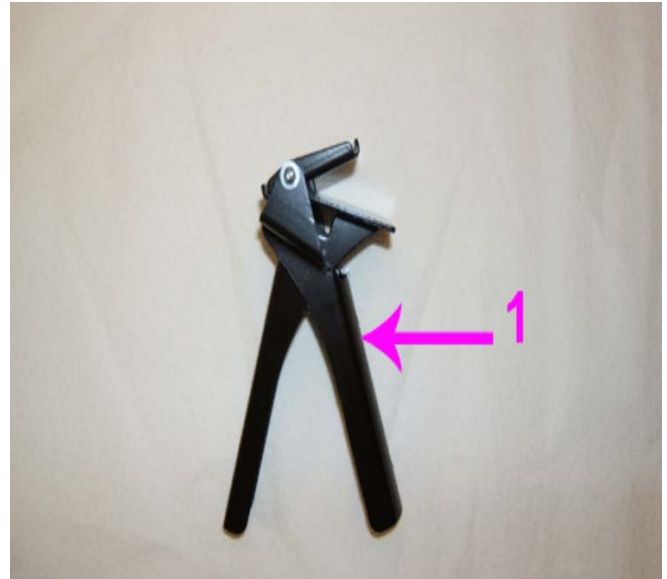
2833110

- Use a Tube Grip® dispensing device (1) or an equivalent to apply the new RTV sealant for the following reasons:
 - A precise application of the RTV sealant bead to the component, in the specified amount.
 - The dispensing device will squeeze 35 % more material out of the tube, reducing waste.
 - Using the device will eliminate most cleanup.

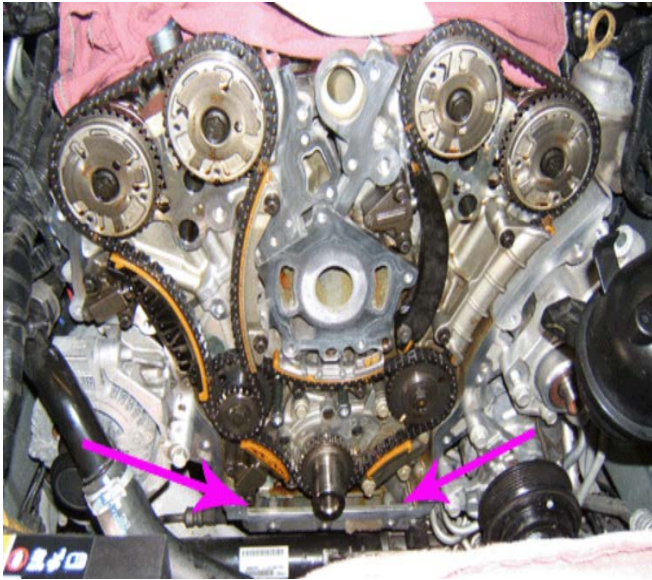
2833996

4. Insert a piece of cardboard at the front of the oil pan in the area shown to prevent any contaminants and debris from falling into the oil pan.

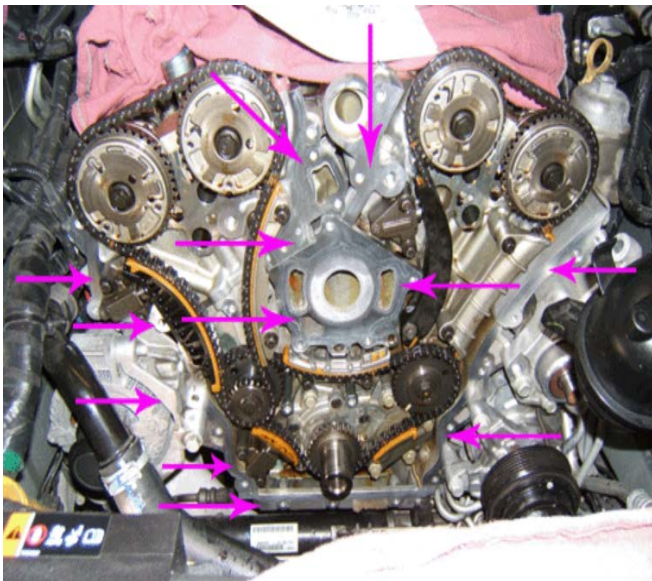
2834020

5. Using the tool or tools as outlined in this bulletin, carefully clean the front cover sealing surfaces on the **engine**.
6. Clean out any debris from the bolt holes for the front cover fasteners in the **engine**.

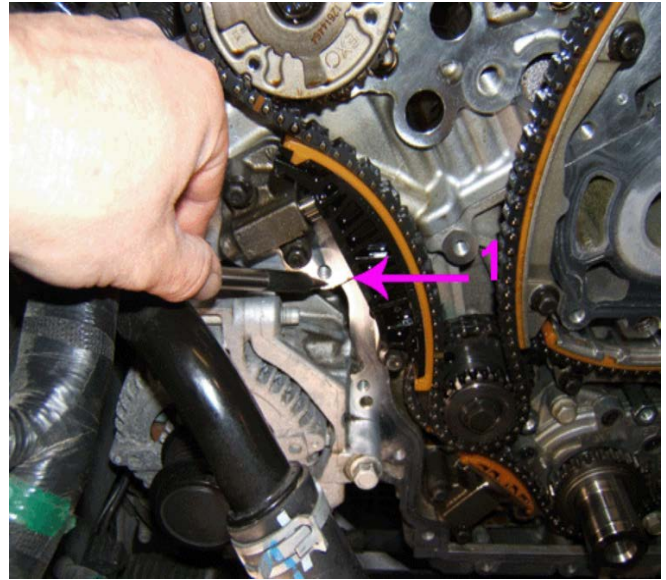
2834570

7. Clean out any debris from the T-joint (1) where the left side of the cylinder head meets the engine block.

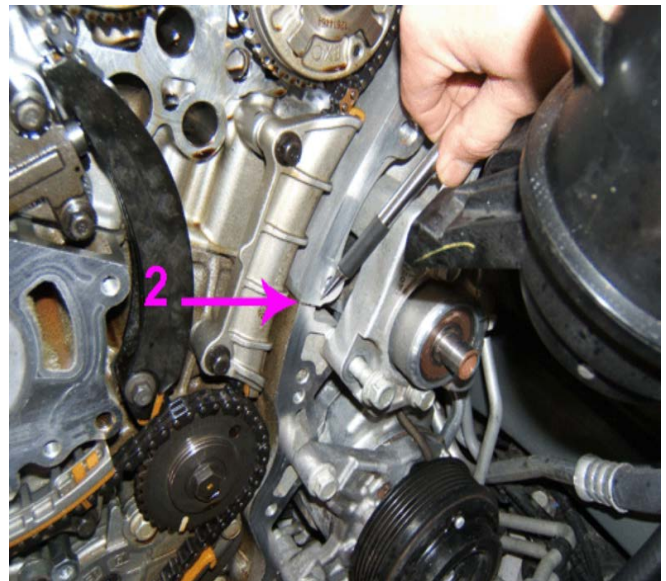
2834612

8. Clean out any debris from the T-joint (2) where the right side of the cylinder head meets the engine block.

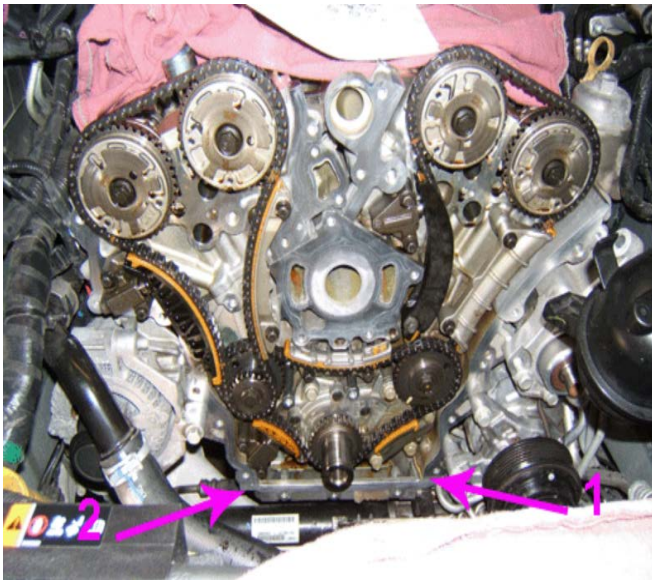
2834622

9. Clean out any debris from the T-joint (2) where the left side of the oil pan meets the engine block.

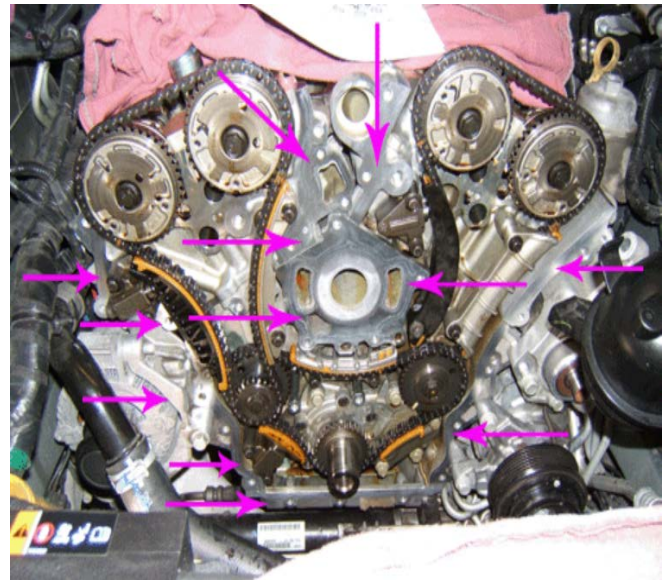
2834020

12. Wipe the front cover mating surfaces on the **engine** with a folded lint free shop cloth. Rotate the shop cloth until there are no more visible signs of contamination on the cloth.
13. Spray GM Low VOC Cleaner, or an equivalent, on the mating surfaces of the front cover and allow it to soak in for 5 minutes.

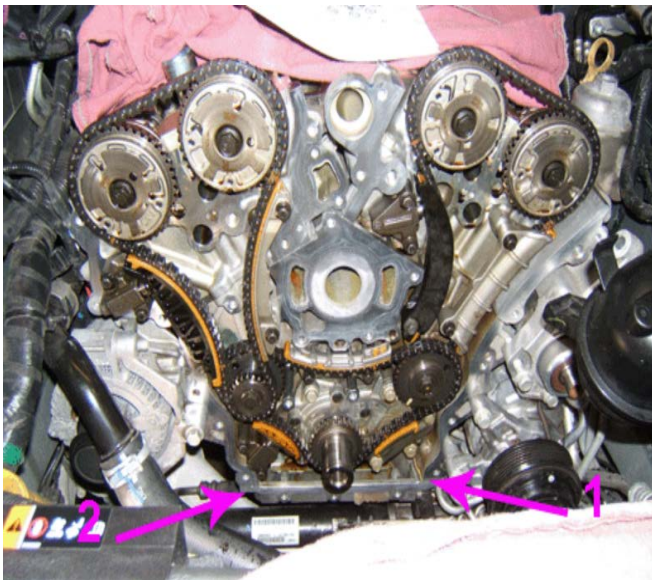
2834622

10. Clean out any debris from the T-joint (1) where the right side of the oil pan meets the engine block.
11. Spray GM Low VOC Cleaner, P/N◆19287401 (in Canada, P/N 88901247) or an equivalent, on the mating surfaces of the **engine** side for the front cover and allow it to soak in for 5 minutes.

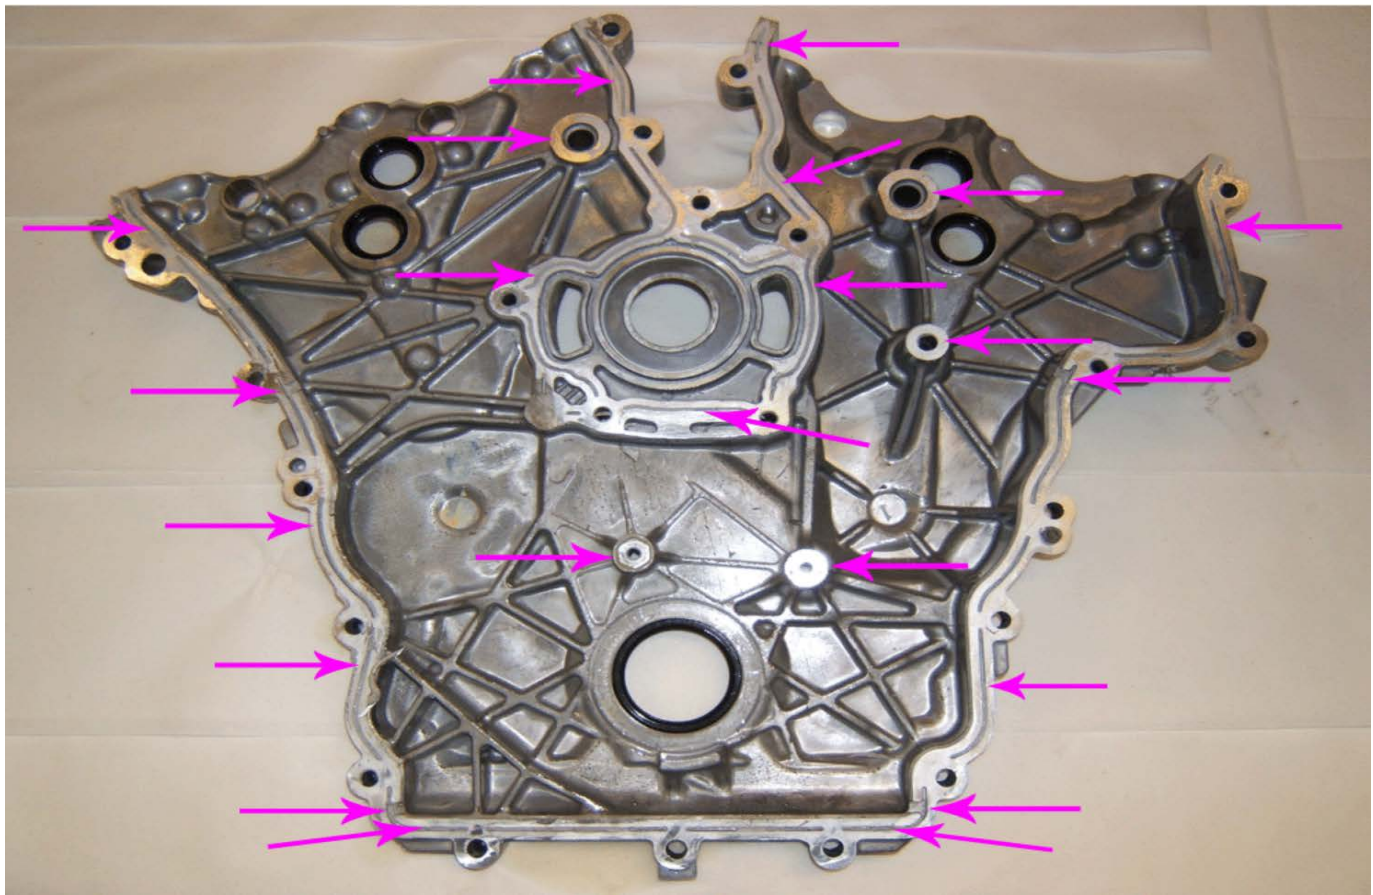
2834958

14. Carefully clean the front cover sealing surfaces and grooves.
15. Clean out any debris from the bolt holes for the front cover fasteners.
16. Drain and wipe the remaining oil from the front cover.
17. Dry the front cover with compressed air.

18. Inspect the exterior of the front cover for the following conditions:
 - Damage to the camshaft position actuator valve oil seal bores (1).
 - Damage to any bolt holes (2).
 - Damage and/or corrosion to the engine coolant passage (3).
 - Dents or damage to the exterior (4).
 - Damage to the crankshaft front oil seal bore (5).
 - Gouges or damage to the water pump sealing surfaces (6).
 - Damage to the water pump bolt hole threads (7).

⇒ If any of the above conditions are found, repair or replace the front cover as necessary.

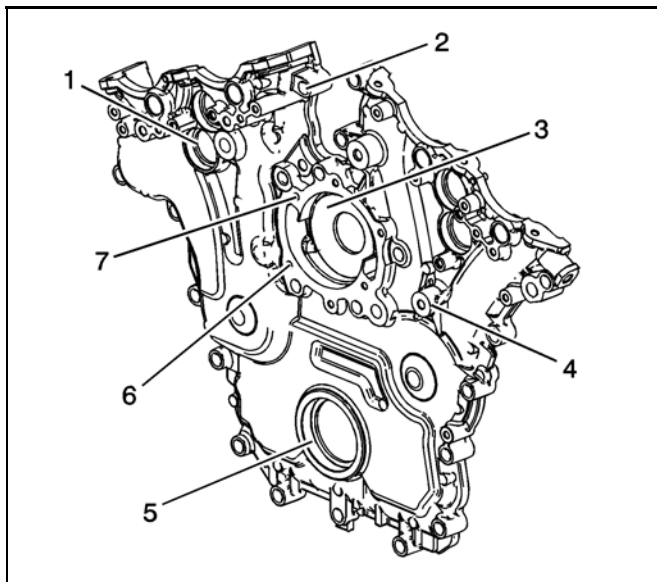
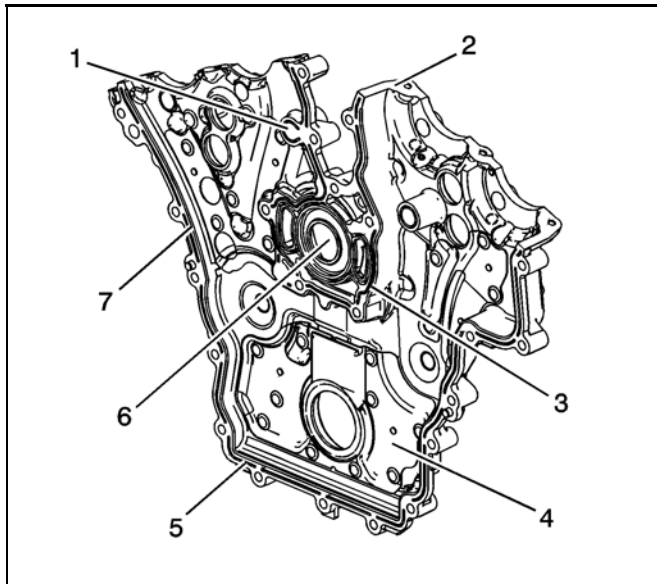
1408427

19. Inspect the interior of the front cover for the following conditions:
- Damage to any bolt holes (1).
 - Gouges or damage to the cover sealing surfaces to the engine block (7), oil pan (5) and camshaft covers (2).
 - Gouges or damage to the water pump seal area (3).
 - Loose or damaged deadener plates (4).
 - Damage and/or corrosion to the engine coolant passage (6).
 - Damage to the crankshaft front oil seal bore.
 - Gouges or damage to the O-ring sealing areas.
- ⇒ If any of the above conditions are found, repair or replace the front cover as necessary.

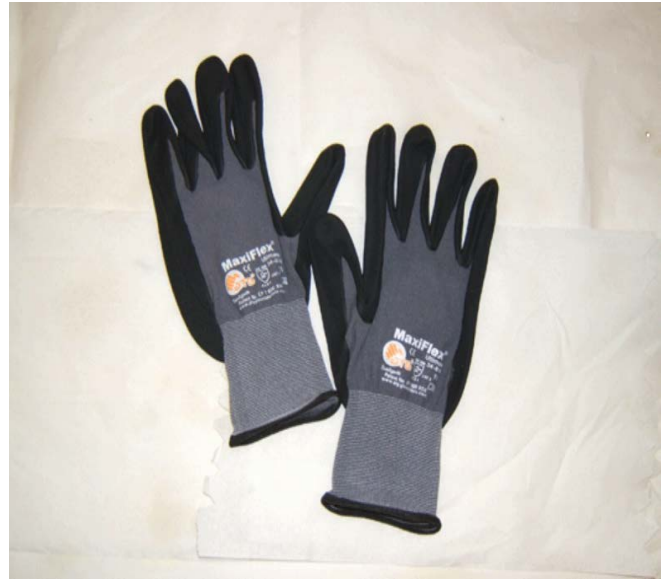
2835832

- Notice: Wear Gloves. After the final cleaning with GM Low VOC Cleaner and before reassembly, DO NOT touch the cleaned surfaces with your bare hand. The oils from your skin WILL CONTAMINATE the surfaces and prevent proper bonding of the new RTV sealant.**
20. Clean the sealing surface prior to reassembly by spraying GM Low VOC Cleaner, on a folded lint free shop cloth. Wipe the mating surfaces and rotate the shop cloth until there are no more visible signs of contamination on the cloth.
 21. After the final cleaning of the parts, allow 5 minutes for the components to dry before applying new RTV sealant.
 22. Remove the cardboard from the front of the oil pan.

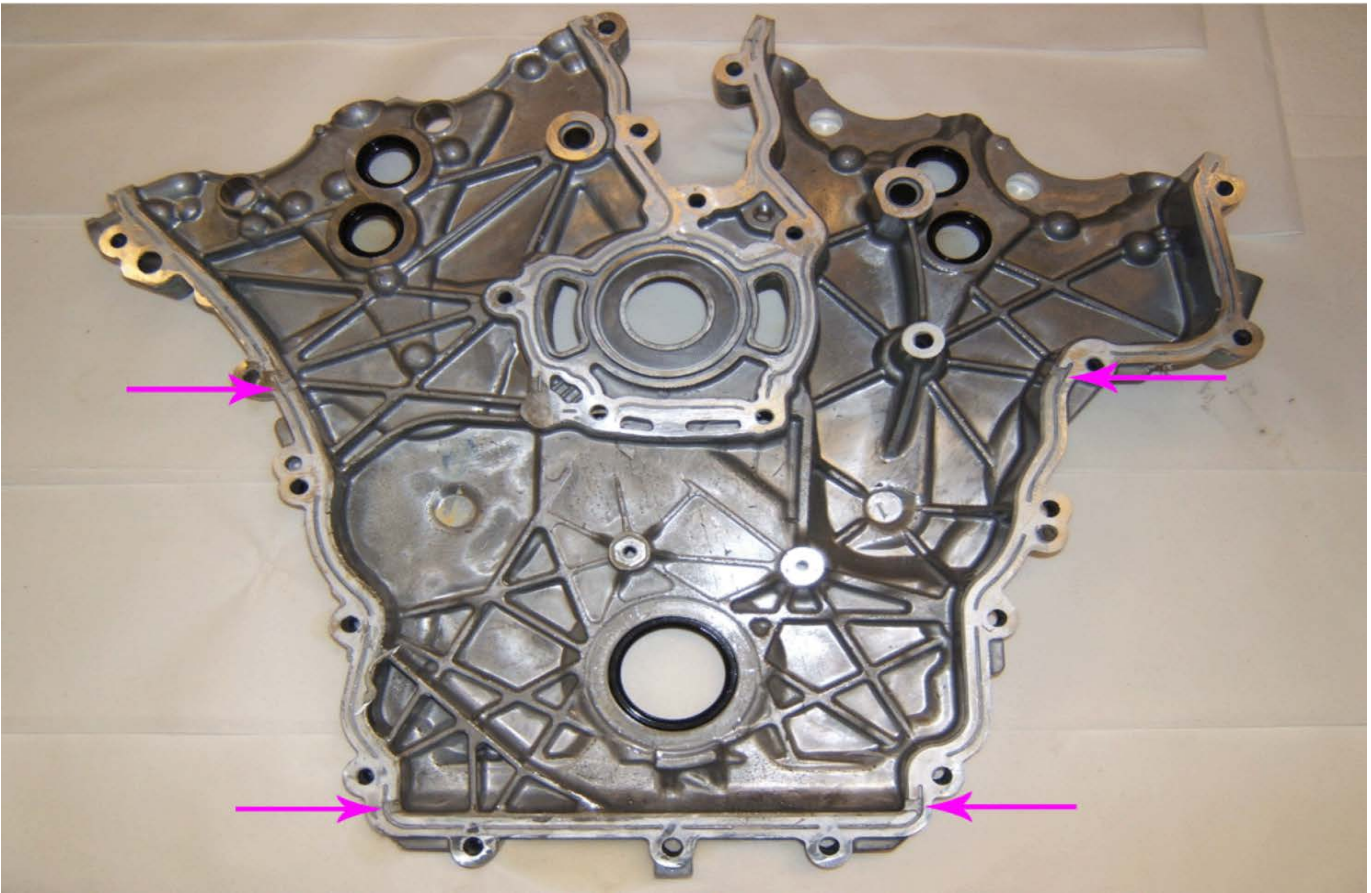
2834933

Oil leaks at the T-joints are one of the most common conditions encountered.

23. Apply a 5 mm bead of RTV sealant to the T-joints on the front cover in order to ensure that there is enough sealant to extend into the joint.

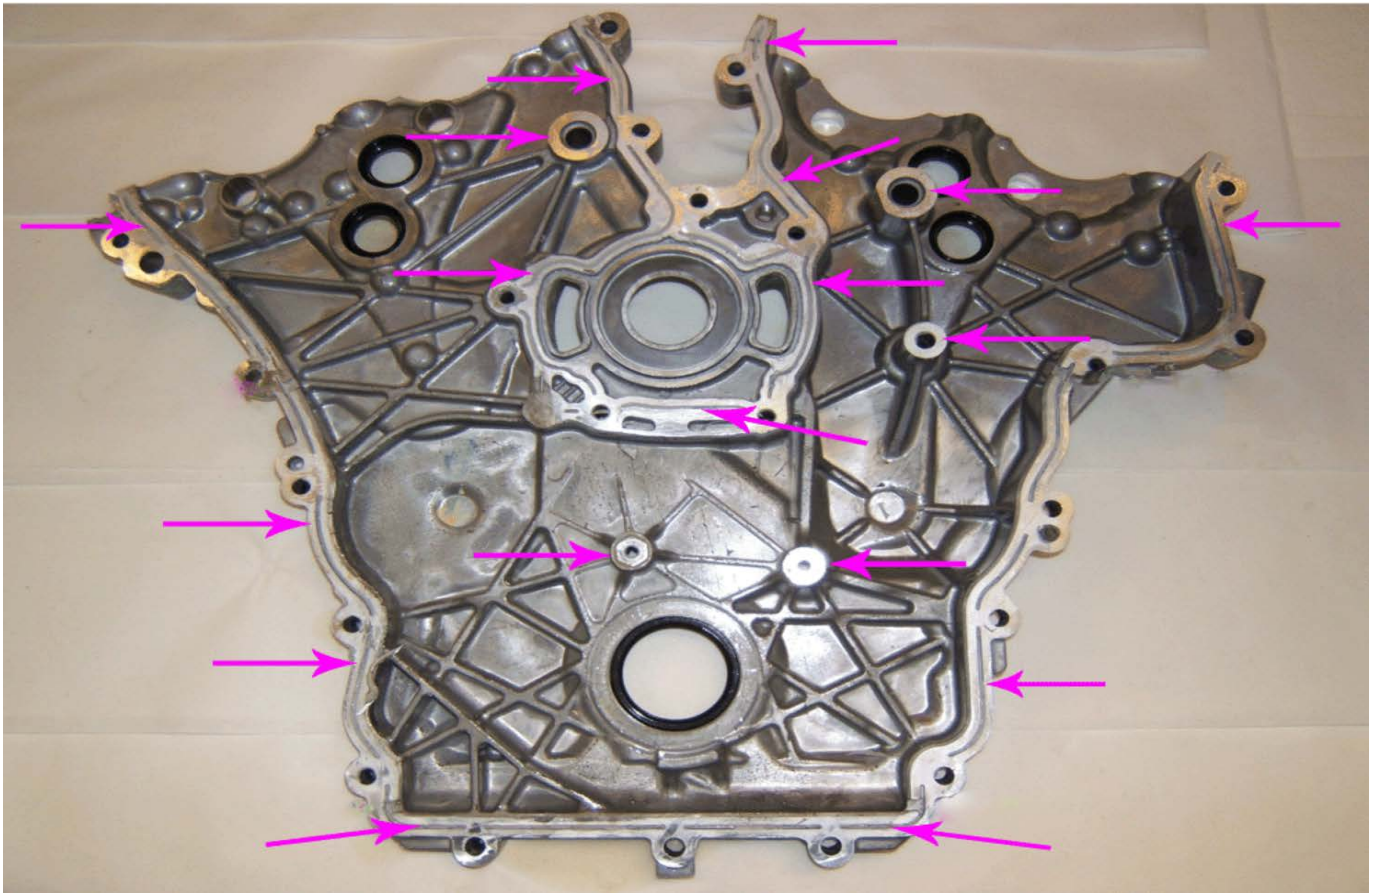
2835399

24. Apply a 3 mm bead of RTV sealant to the remaining front cover sealing surfaces.

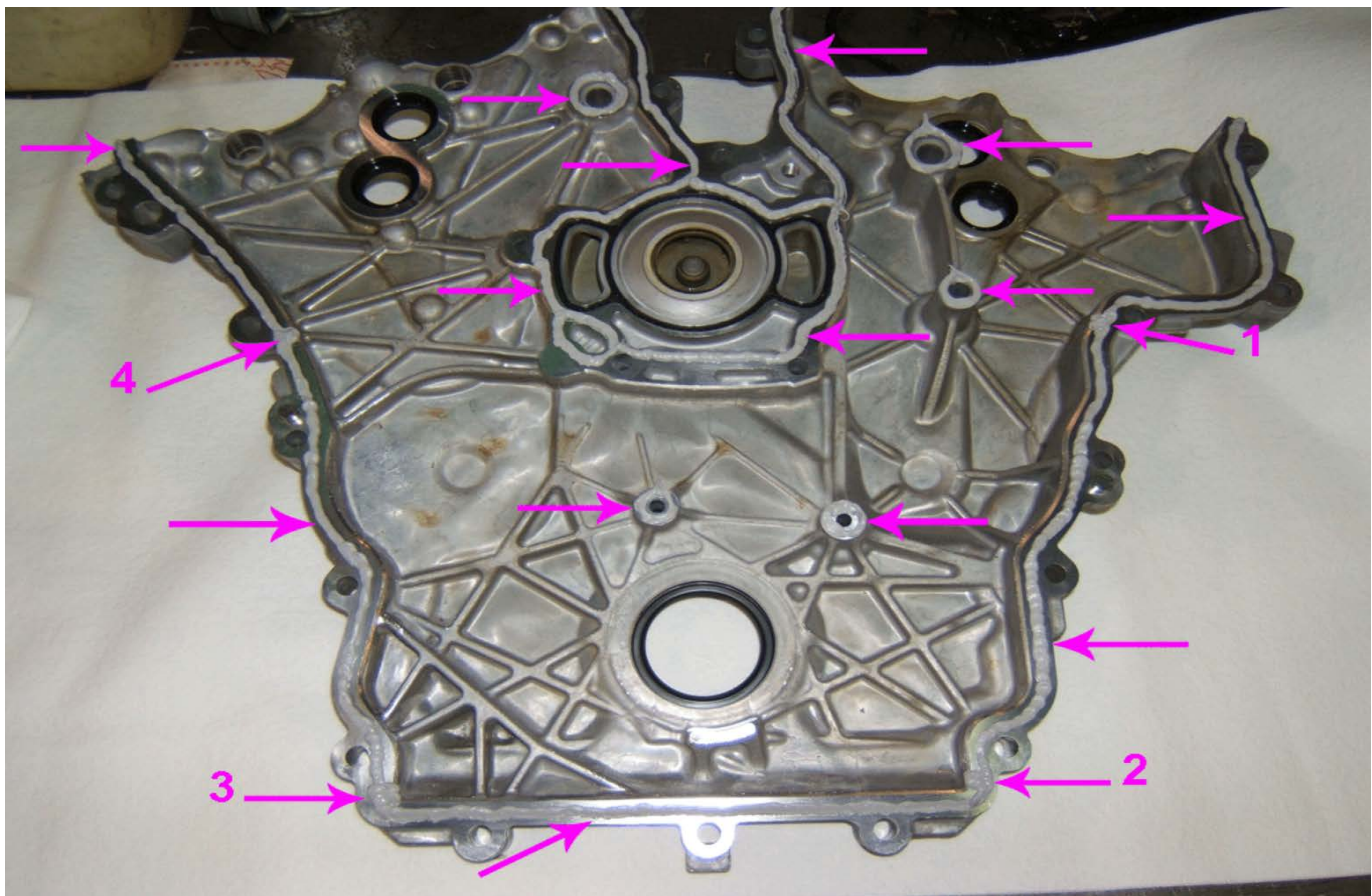
2835122

25. This is a typical view of the proper application of the RTV sealant to the front cover, with a 5 mm bead of RTV sealant to the T-joints (1, 2, 3, 4) and a 3 mm bead of RTV sealant to the rest of the sealing surfaces.

Notice: The front cover must be installed BEFORE the RTV sealant is allowed to “skin over” or the sealant will not adhere.
