Service Campaign T3G & Warranty Extensions TXXC/TXXI - ENGINE BEARING INSPECTION / ENGINE REPLACEMENT- Dealer Best Practice

Revised publication April 15, 2022

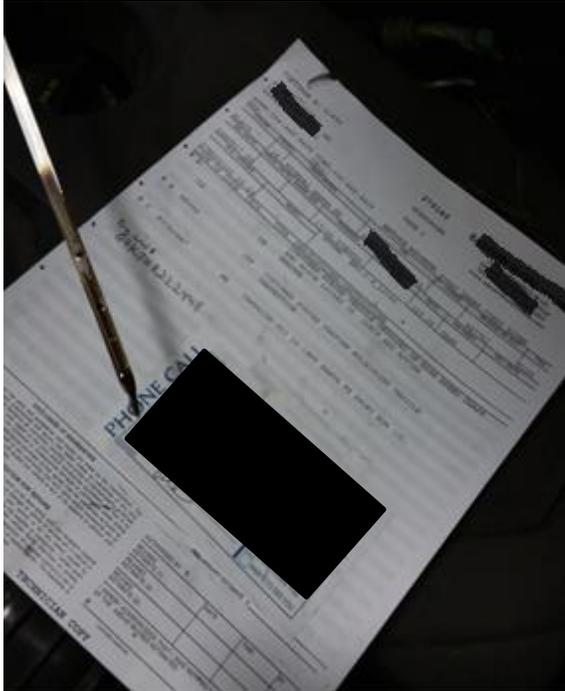
Example 1

Good Dipstick Photo (see below)

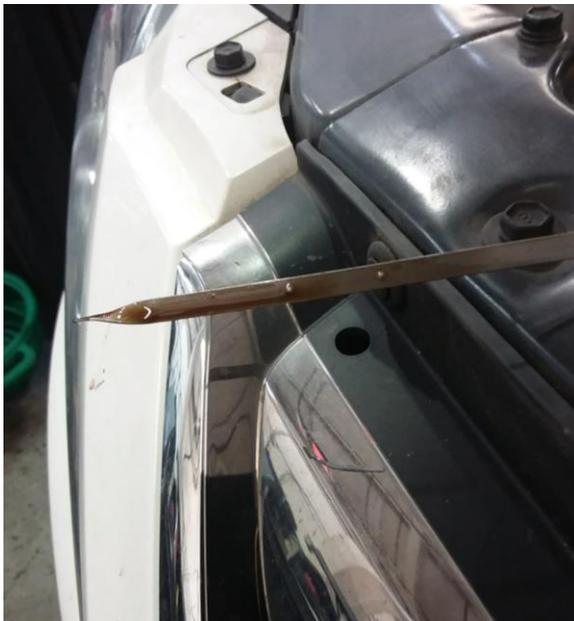
Bad Dipstick Photo (see below)

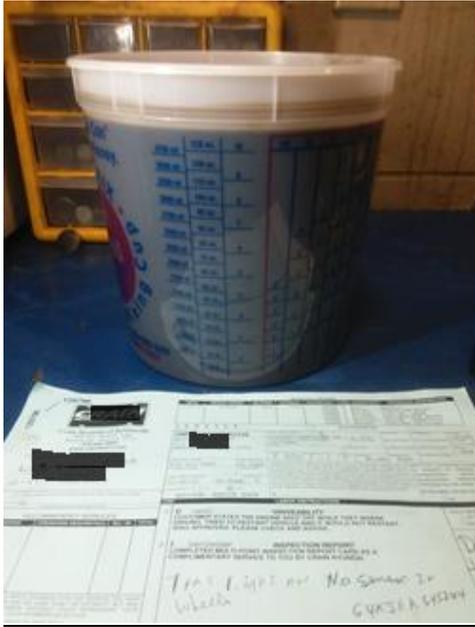
Good Oil Drain Photo (see below)

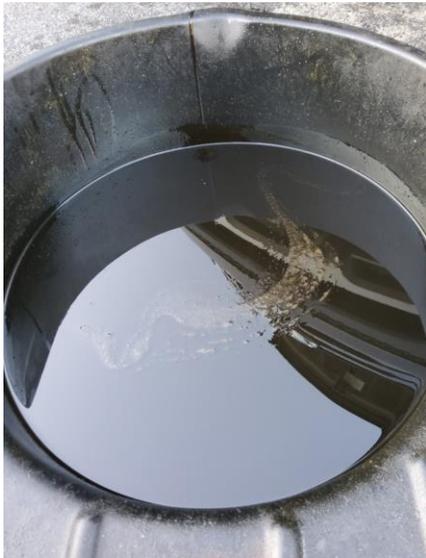
Example 1

Bad Oil Drain Photo (see below)

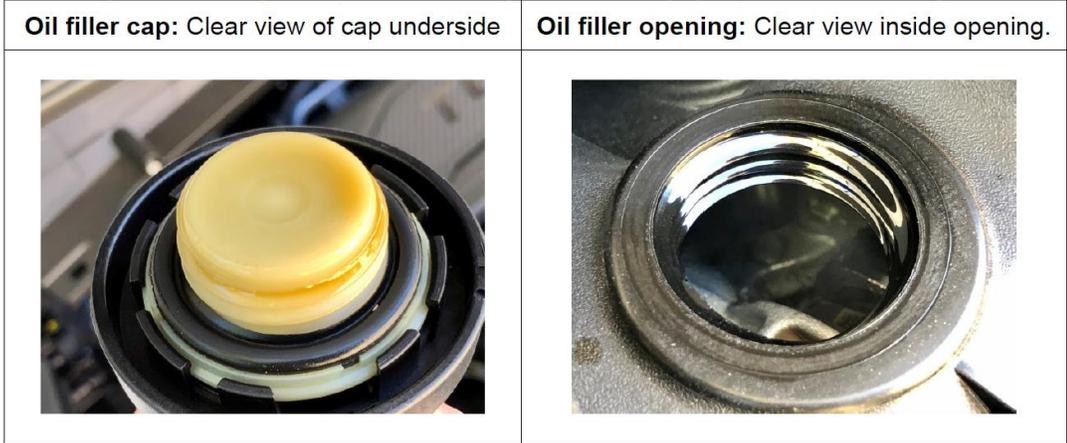
Good Oil Cap and Valvetrain Photos (see below)

When submitting a picture of the oil cap, please include it with a picture of the repair order showing the last 6 digits of the VIN as seen below

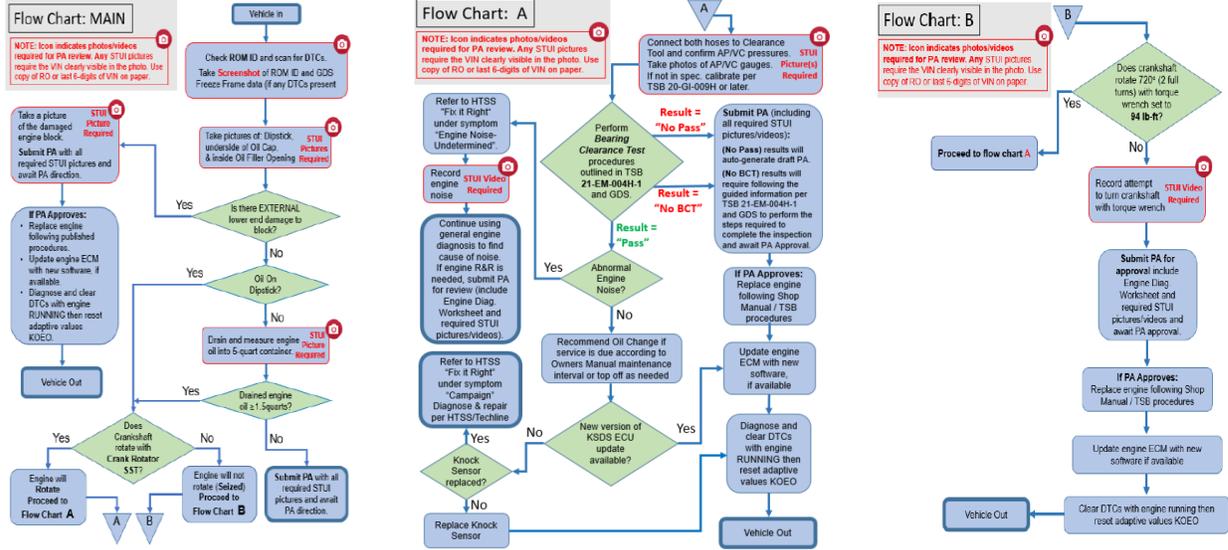
Service Procedure Flowchart:

- Follow the **Service Procedure Flowchart** found in the latest TSB and update the Engine ECM if new version is available (Campaign T3G).

- Important: If a vehicle passes the bearing inspection test, but DTC P1326 comes back on after the code is cleared, contact Techline for further assistance on diagnosing the vehicle.**
- Use the **Service Process Results Worksheet** (reference latest repair TSB) as a guide to help diagnose the vehicle. This should be used as a tool to assist.

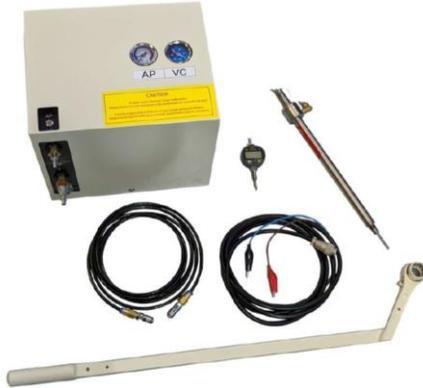
- Engine Bearing Clearance Tester set (bearing tool)

- **Note:** the bearing tool must be accurately calibrated prior to performing the engine inspection procedure outlined in the T3G TSB. Refer to TSB 21-GI-009H (or latest revision) for the calibration procedure as needed.
