NOISE FROM SEAT RAILS DURING SEAT OPERATION

This Service Information Bulletin (Revision 2) replaces SI B52 09 21 **dated October 2021**.

Service greasing of first row seat structure (1SR)

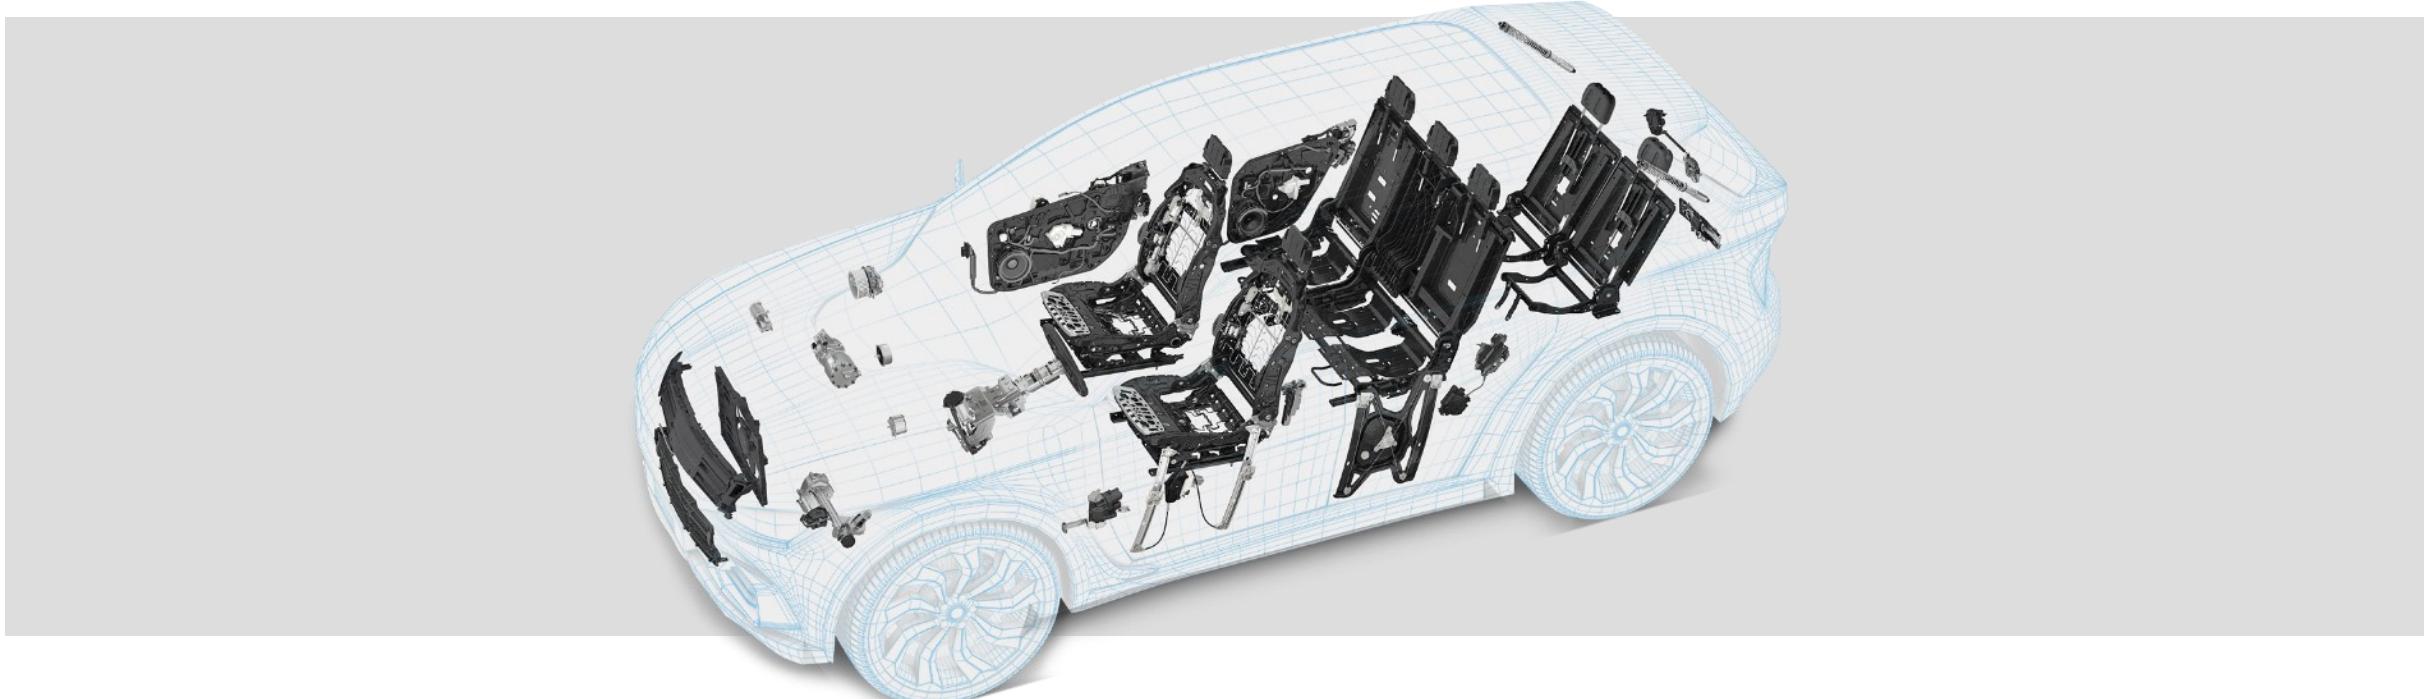
1SR greasing overview

All spindles can be greased on motors and LV spindles to help with noises

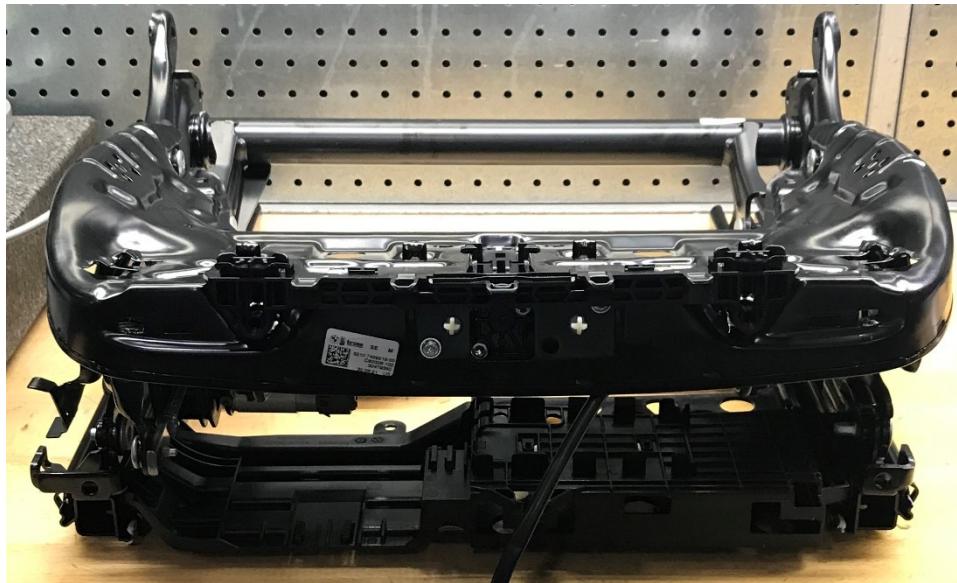
Brush needed to apply grease

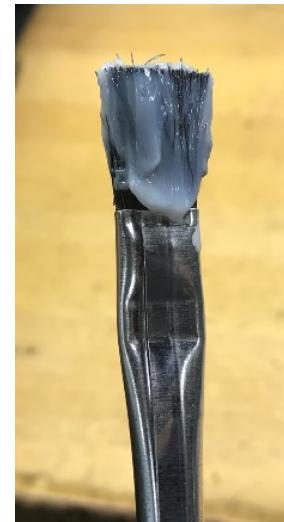
Preferred grease for all spindles on 1SR structure is P/N 83 23 **0396713** Klubersynth LF 44-22

One tube is sufficient to service 10 seat rails or 5 vehicles total.

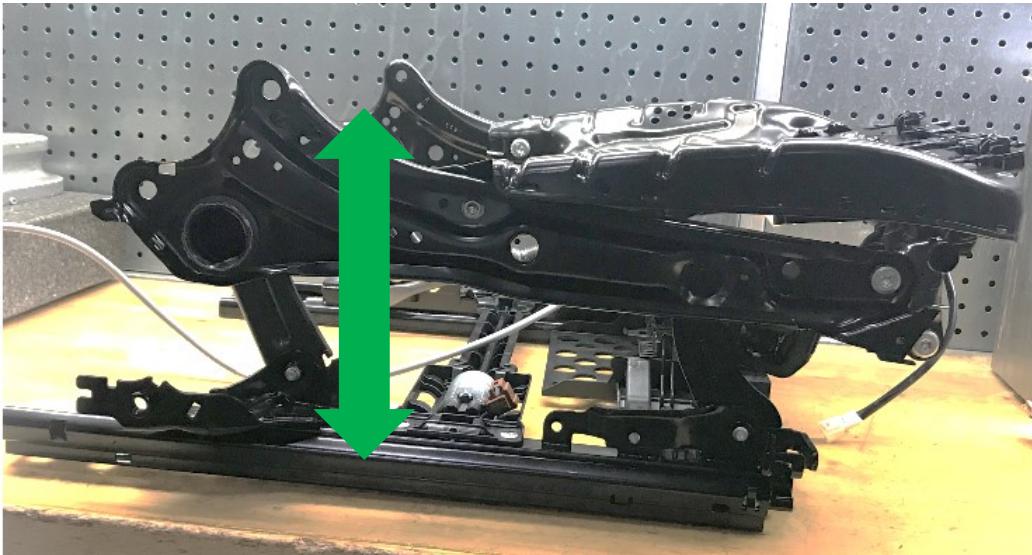
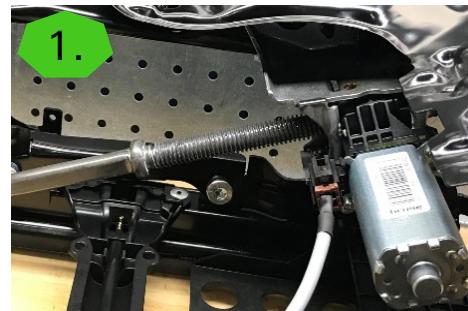
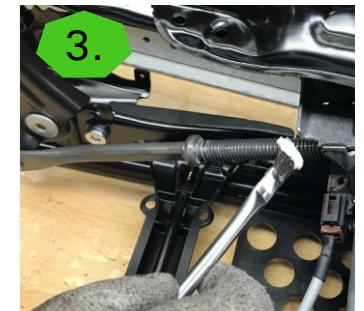
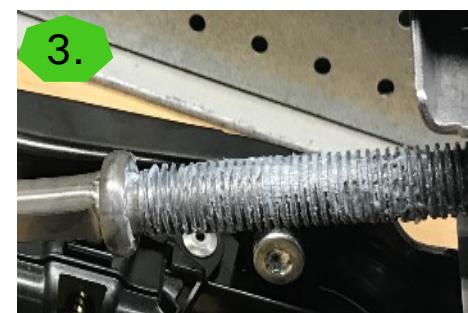
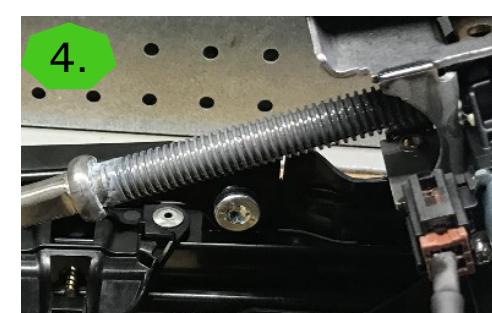
SHV motor spindle greasing

Function seat adjuster full up and leave seat adjuster up for all greasing

1. Locate HV spindle once seat is all the way up.
2. Apply even amount of grease to brush.
3. Spread grease along the entire HV motor spindle.
4. Once grease is spread function seat full down and up 3x to distribute grease evenly along the spindle.

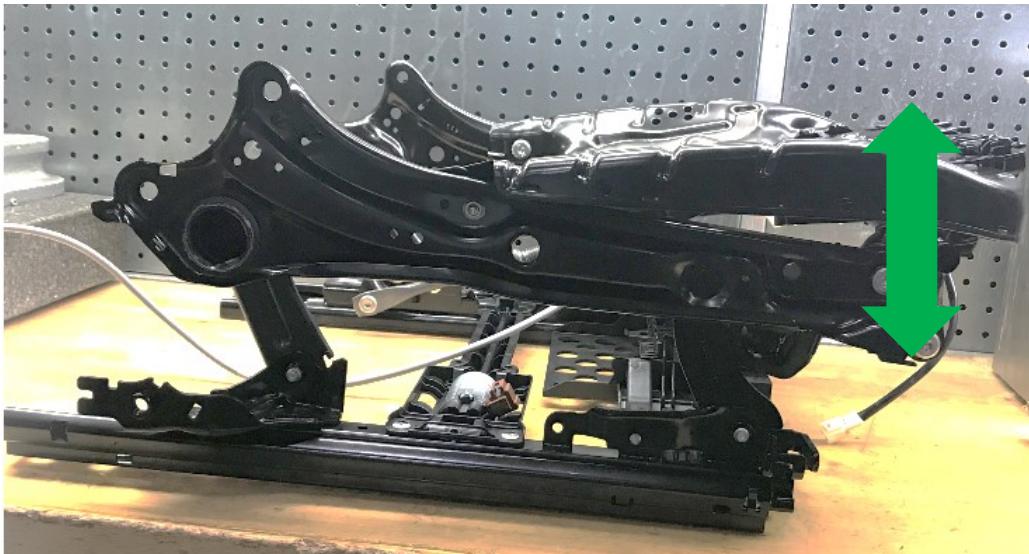
SNV motor spindle greasing

Function Cushion (NV) motor full up and leave seat adjuster up for all greasing

1. Locate NV spindle once NV is driven all the way up.
2. Apply even amount of grease to brush.
3. Spread grease along the entire HV motor spindle.
4. Once grease is spread over spindle function Cushion motor full down and up 3x to distribute grease evenly along the spindle.

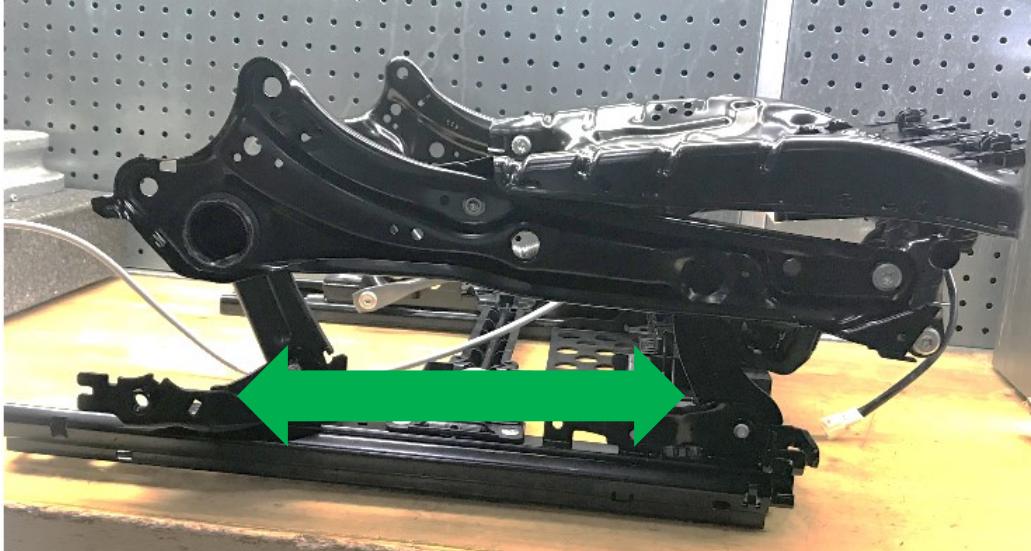
IB and OB LV spindle greasing

Function Length adjuster full forward to grease front of spindles and full rear to grease rear of spindles

1. Locate SLV motor and run seat full rearward to show IB and OB spindles.
2. Apply even amount of grease to brush.
3. Spread grease along the entire LV spindle.
4. Once grease is spread over IB and OB spindle function length adjuster back and forth 3x to distribute grease evenly along the spindle.
5. Run seat full forward to show rear IB and OB of spindles and repeat above process.

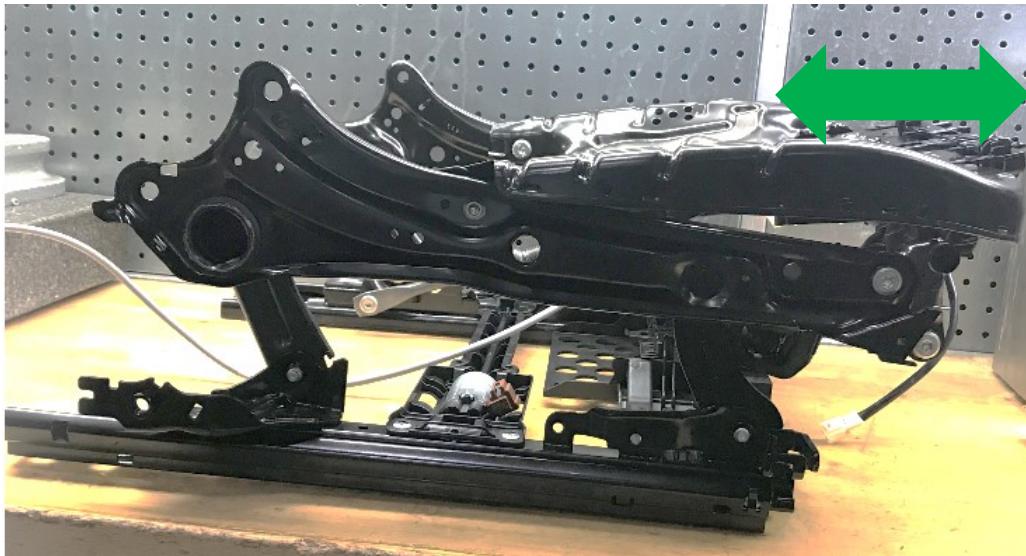
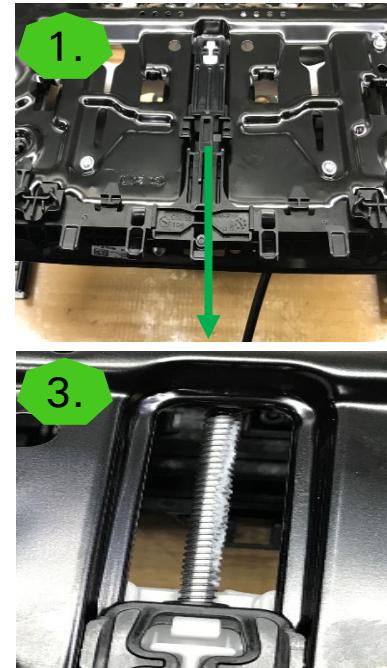
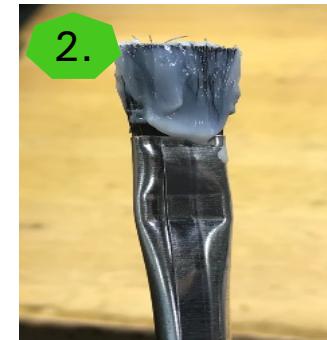
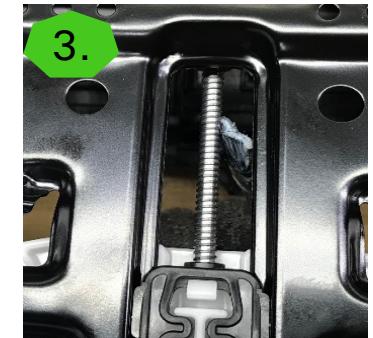
STV spindle greasing

1. Run STV cushion extender all the out and locate the spindle under the cushion pan.
2. Apply even amount of grease to brush.
3. Spread grease along the entire STV motor spindle.
4. Once grease is spread over spindle function STV motor full forward And rearward up 3x to distribute grease evenly along the spindle.
