AN21-012

ITB22-012

## HEADREST DVD DISPLAY ISSUES

**APPLIED VEHICLES:** 2016-2020 QX60 (L50)  
**APPLIED SYSTEMS:** Rear Seat Entertainment

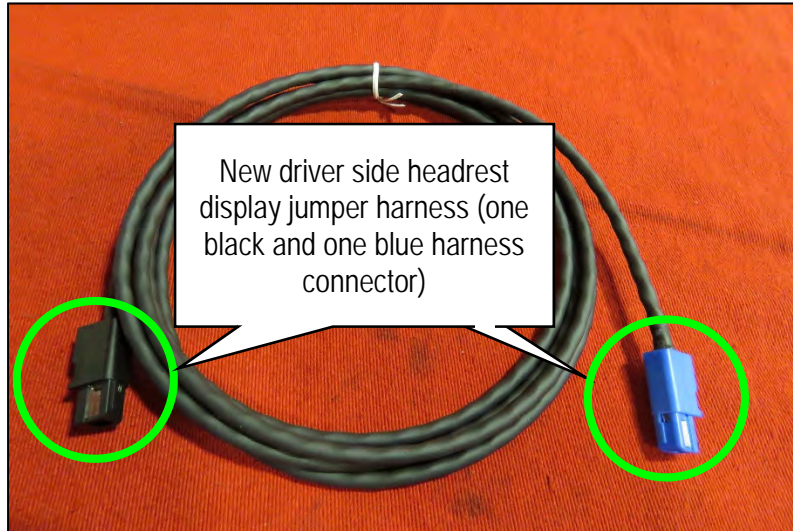
Figure 7

10. Obtain the new driver side headrest display jumper harness which has one blue and one black harness connector (Figure 7).

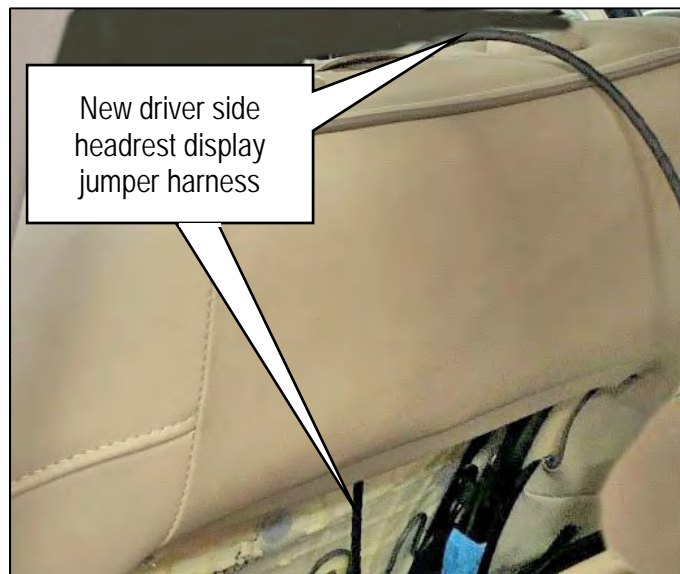
Figure 9

- Starting with the blue harness connector, route the new driver side headrest display jumper harness down through the opening in the top of the driver side seat, and allow it to run down the center of the driver side seatback (Figure 9).

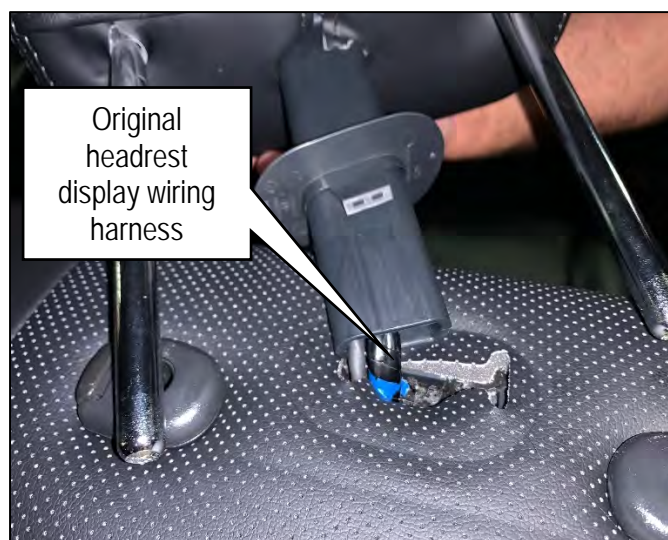
Figure 15

19. Guide the original headrest display wiring down through the center opening of the driver seat (Figure 15).

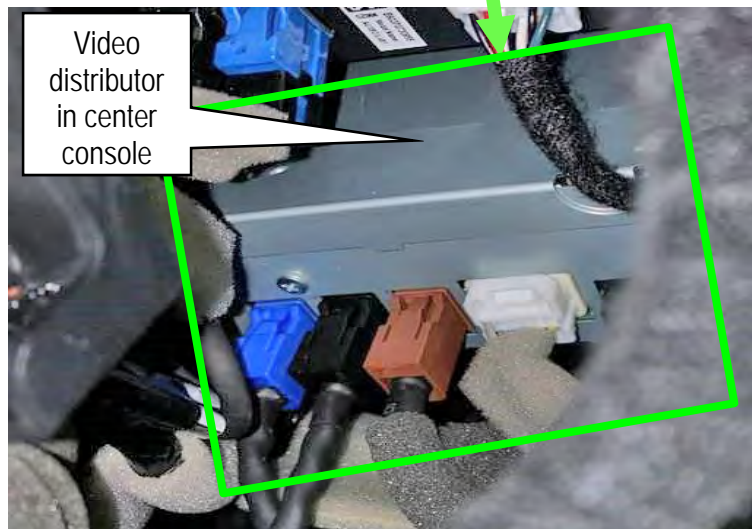
Figure 21

29. Locate the video distributor toward the middle of the center console (Figure 21 and Figure 22).

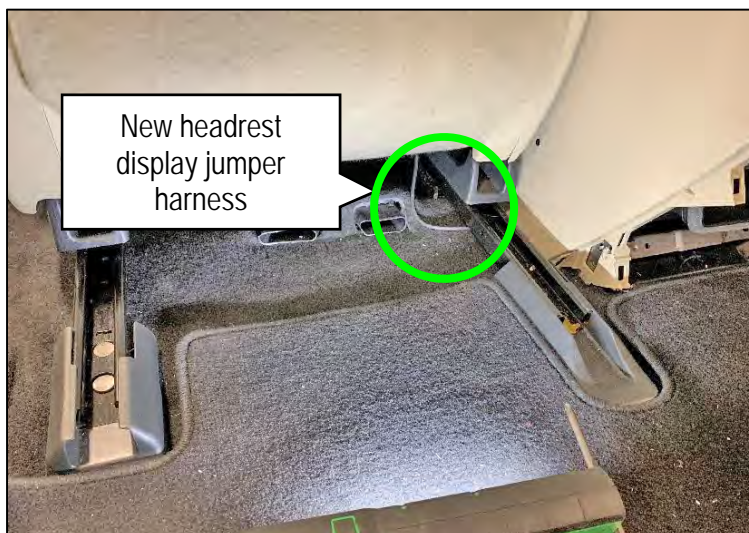
Figure 28

37. Ensure there is enough slack in the 2 new headrest display jumper harnesses under both front seats to allow for full travel of the seats (Figure 28).
- Do not leave excessive slack in the harness.
  - Place any excessive slack in the harness inside the center console area.
