# SERVICE BULLETIN

Classification: BT21-007	Reference: NTB22-018	Date: March 14, 2022
-----------------------------	-------------------------	-------------------------

## MANUAL FRONT SEAT DOES NOT MOVE FORWARD/REARWARD

**APPLIED VEHICLES:** 2018-2020 Kicks (P15)  
2020 Versa (N18)  
**APPLIED DATES** Built before October 19, 2020  
**APPLIED GRADES:** S, SV, SR

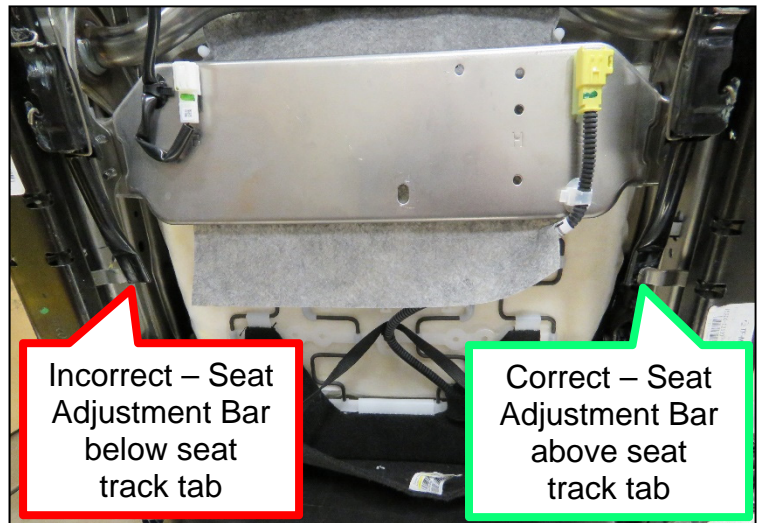
Figure 1

One or both ends of the Seat Adjustment Bar are below the seat track tabs (Figure 1) displays one end of the Seat Adjustment Bar below the seat track tab and the other end above the seat track tab (with the seat removed from the vehicle).

1. Replace the Seat Adjustment Bar on the affected seat(s).
  - Refer to the **SERVICE PROCEDURE** of this bulletin for the repair procedure.

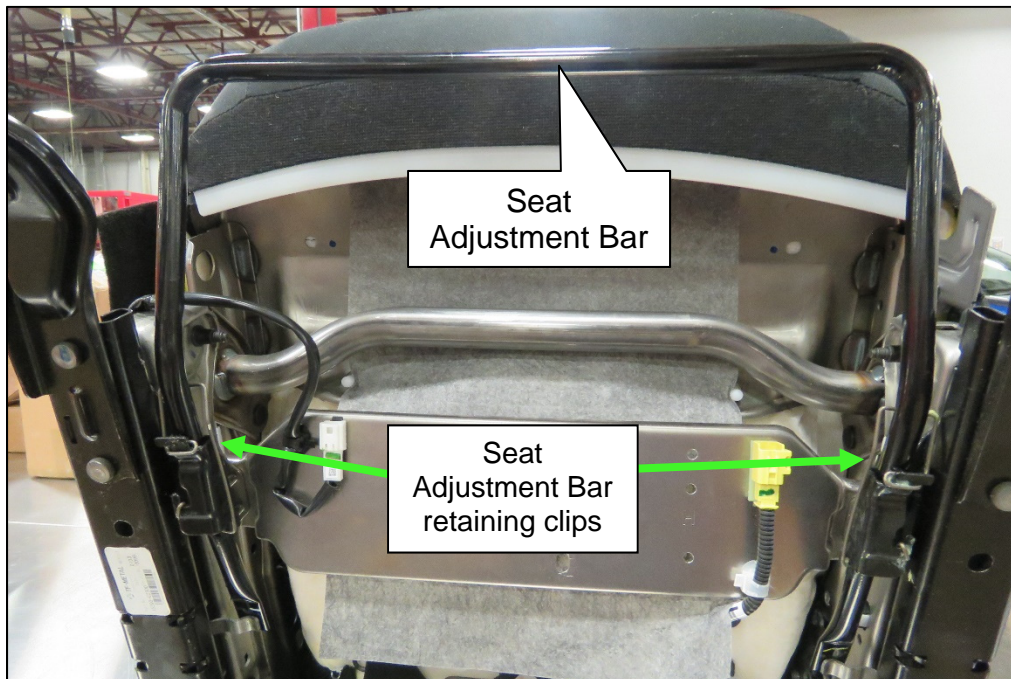
Figure 2

1. Remove the seat from the vehicle.
  - Refer to the ESM: **BODY INTERIOR > SEAT > REMOVAL AND INSTALLATION > FRONT SEAT > DRIVER SIDE or PASSENGER SIDE**
    - Before seat removal, turn off the ignition switch, disconnect both battery cables (negative cable first). Wait a minimum of 3 minutes before proceeding, so that the ACC power supply may fully discharge any remaining electricity.
    - When removing and installing, use suitable covering to protect the vehicle from damage.
    - Perform seat repairs in a clean work area, such as a work bench with suitable covering.
2. Place the seat on a clean work surface with the backside facing downward.
3. Locate the Seat Adjustment Bar retaining clips.

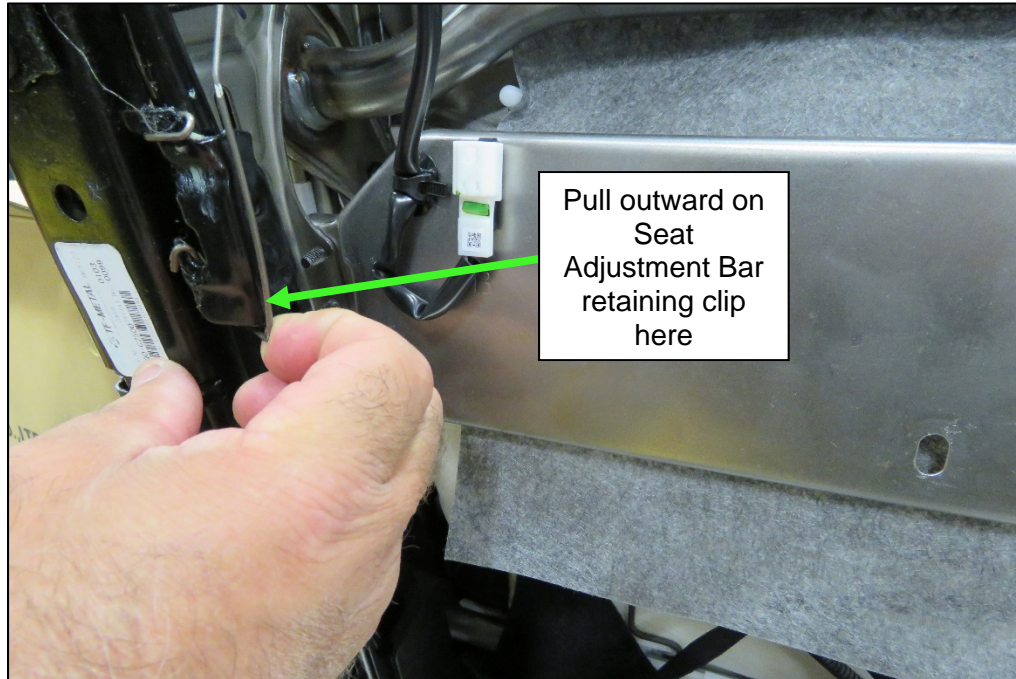
Figure 3

4. Release some tension on one of the Seat Adjustment Bar retaining clips by pulling on the side of the clip, as shown in Figure 3.

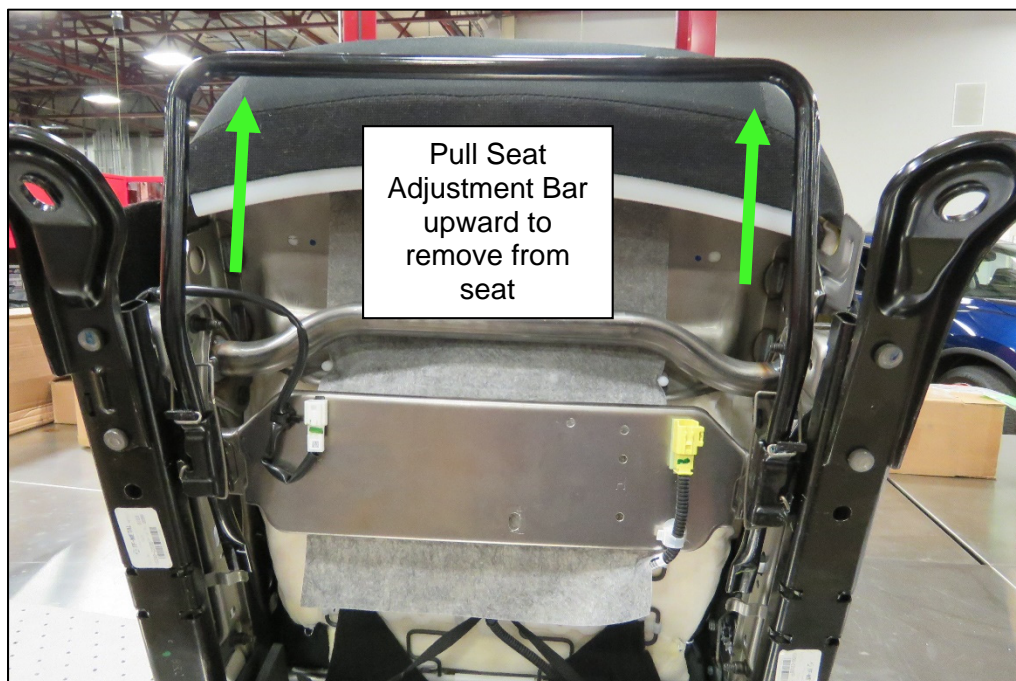
Figure 4

- a. While still pulling on the side of the retaining clip, pull straight up on the Seat Adjustment Bar on the same side of the seat.
- b. Release the tension on the clip.
- c. Repeat step 4 for the opposite side of the seat, and then fully remove the Seat Adjustment Bar from the seat.

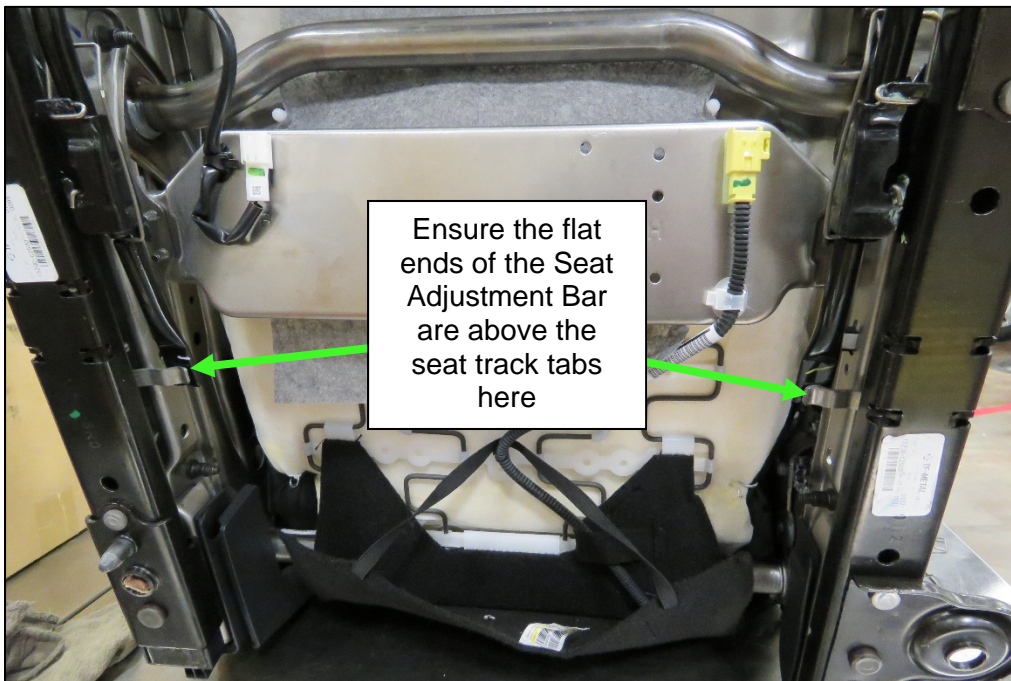
Figure 5

5. Slide a new Seat Adjustment Bar into the seat (see **PARTS INFORMATION** on the last page).
  - a. Ensure the flat ends of the Seat Adjustment Bar are routed above the seat track tabs when sliding the new Seat Adjustment Bar into the seat.
  - b. You may have to hold the seat track tabs down slightly to clear the Seat Adjustment Bar during installation.
  - c. You will hear a click from each seat track when the Seat Adjustment Bar engages with the retaining clips.
  - d. Ensure the Seat Adjustment Bar will not pull out and that it is fully seated.

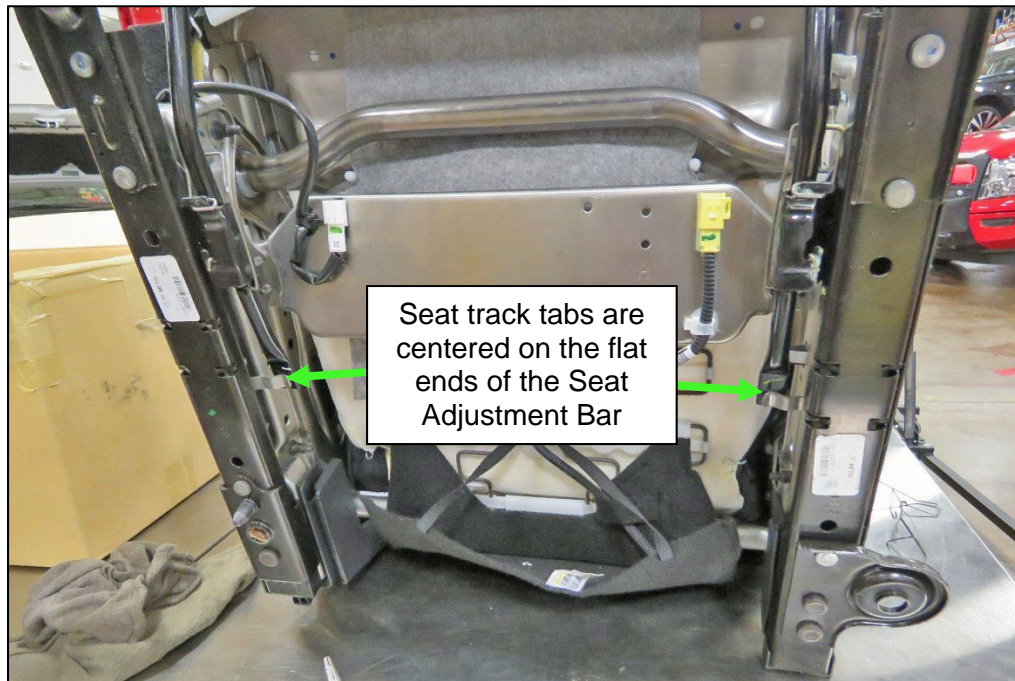
Figure 6

- e. Ensure the seat track tabs are centered on the flat ends of the Seat Adjustment Bar on both sides, as shown in Figure 6.
