SERVICE BULLETIN

AN21-011

HEADREST DVD DISPLAY ISSUES

APPLIED VEHICLES: 2016-2020 Pathfinder (R52)
APPLIED DATES: Vehicles built after July 11, 2016
APPLIED SYSTEMS: Rear Seat Entertainment

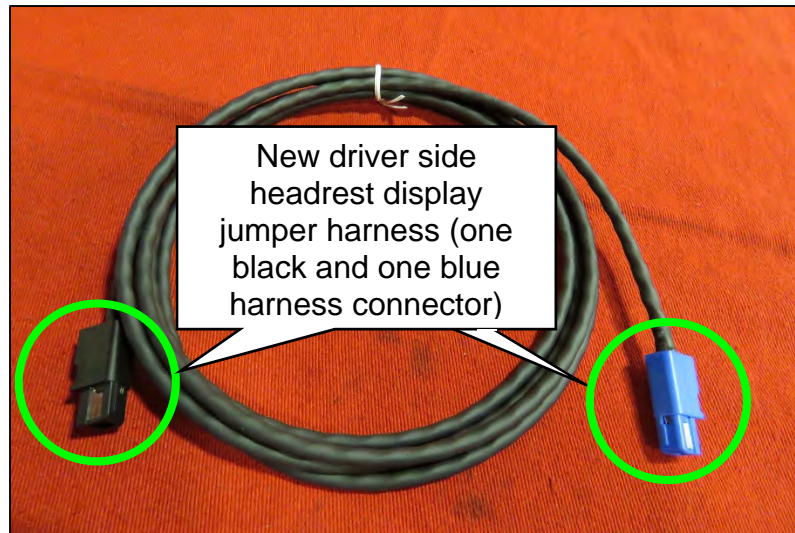
Figure 7

10. Obtain the new driver side headrest display jumper harness which has one blue and one black harness connector (Figure 7).

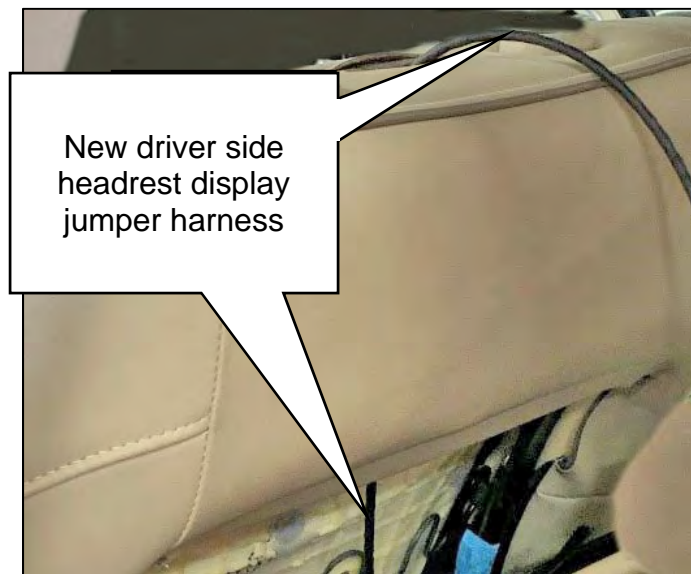
Figure 9

12. Starting with the blue harness connector, route the new driver side headrest display jumper harness down through the opening in the top of the driver side seat, and allow it to run down the center of the driver side seatback (Figure 9).

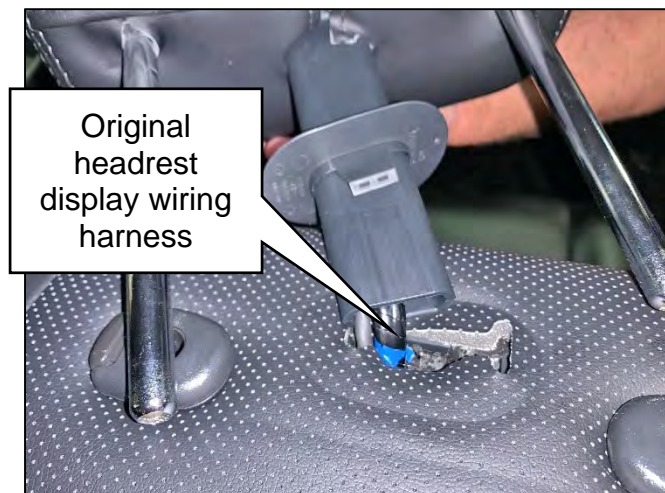
Figure 15

19. Guide the original headrest display wiring down through the center opening of the driver seat (Figure 15).

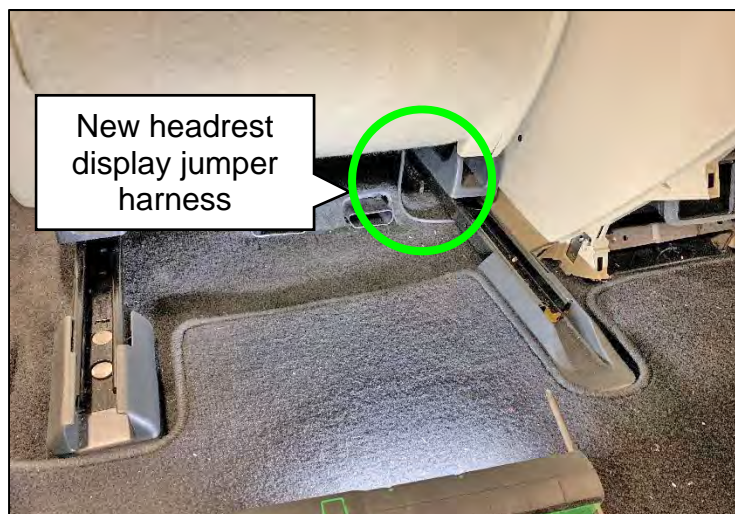
Figure 28

37. Ensure there is enough slack in the 2 new headrest display jumper harnesses under both front seats to allow for full travel of the seats (Figure 28).
- Do not leave excessive slack in the headrest display jumper harnesses under the front seats.
 - Place any excessive slack in the headrest display jumper harnesses inside the center console area.
