MAS003030 (MSC 22-11)

Service Campaign 499 MC20 – Engine Oil Blow-By Breather pipe check

DATE: April 11 2022

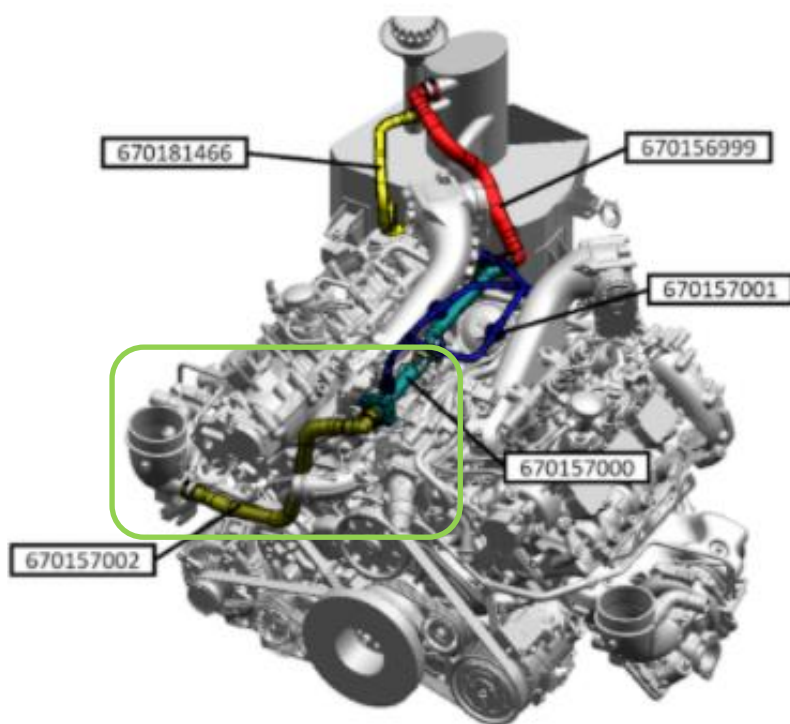
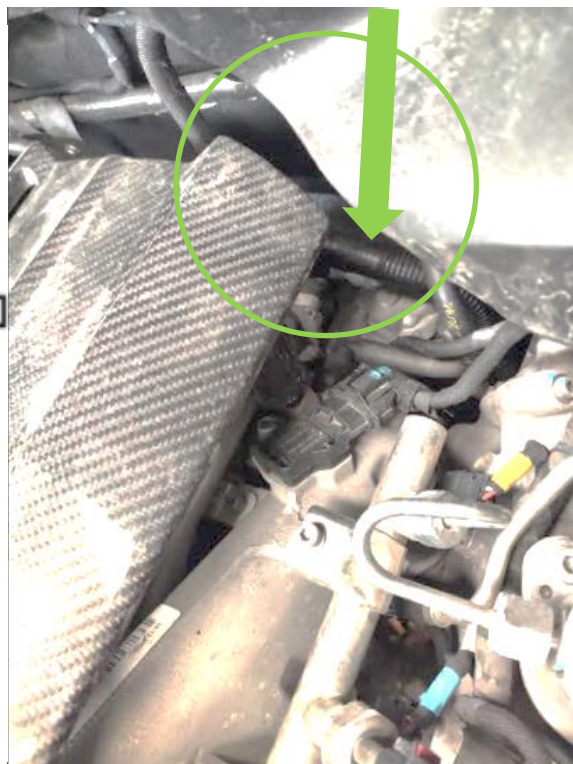
1. Open the Engine Hood Lid.
2. Locate the Engine Oil Blow-by hose located in the center of the block in correspondence with the throttle bodies.

3. Check for the presence of the hose:
 - OK: The hose is present. -> The inspection is finished. No other actions are required.
 - NOT OK: The hose is NOT present. -> continue to **Step 4**.
4. Install new Engine Oil Blow-by Hose following the workshop manual procedure in Tech DOC section:
1.63.057.0 OIL VAPOUR SEPARATOR BREATHER PIPE
5. The procedure is completed.
