MAS003031 (MSC 22-10)

Campaign 492
FROM Maserati TSO
TO Maserati Network

Service Campaign 492 MC20 – Silencer bracket screws presence check

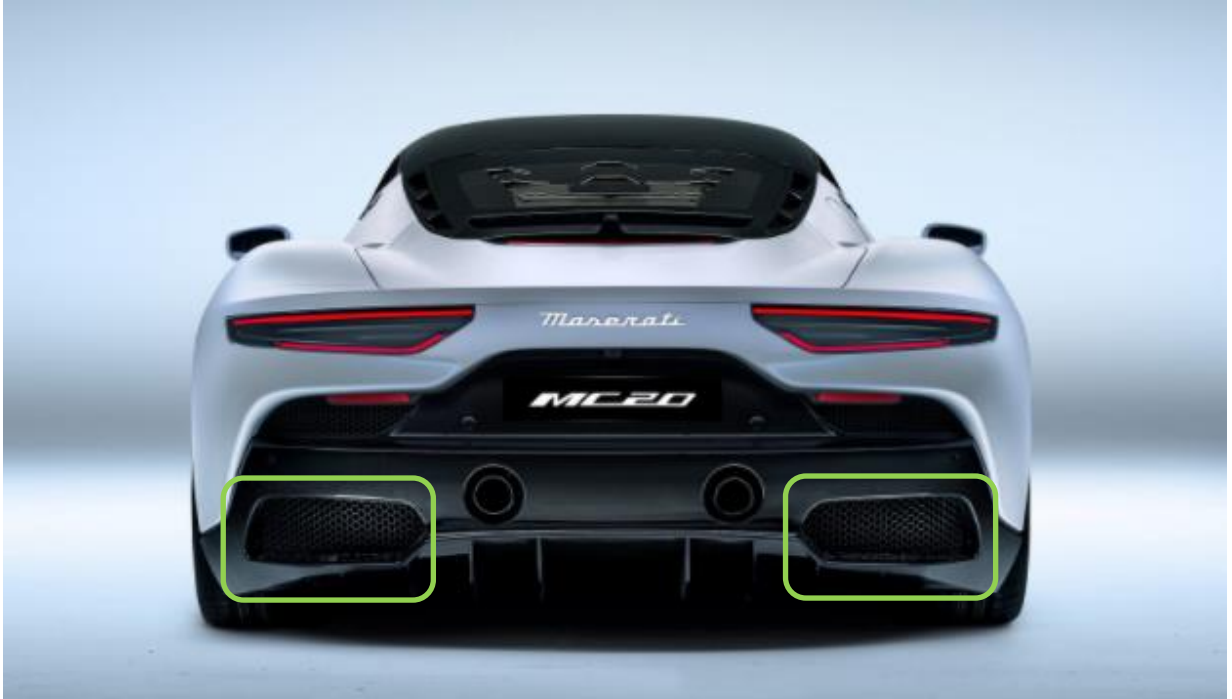
1. The visual check can be easily completed without any dismantling action and can be inspected from the ventilation grilles in the rear bumper.
