## SIB 46 01 22 TURN INDICATOR HOLDER LOOSE

2022-04-06

| Model | Model Description |
|---|---|
| K63 | S 1000 R |

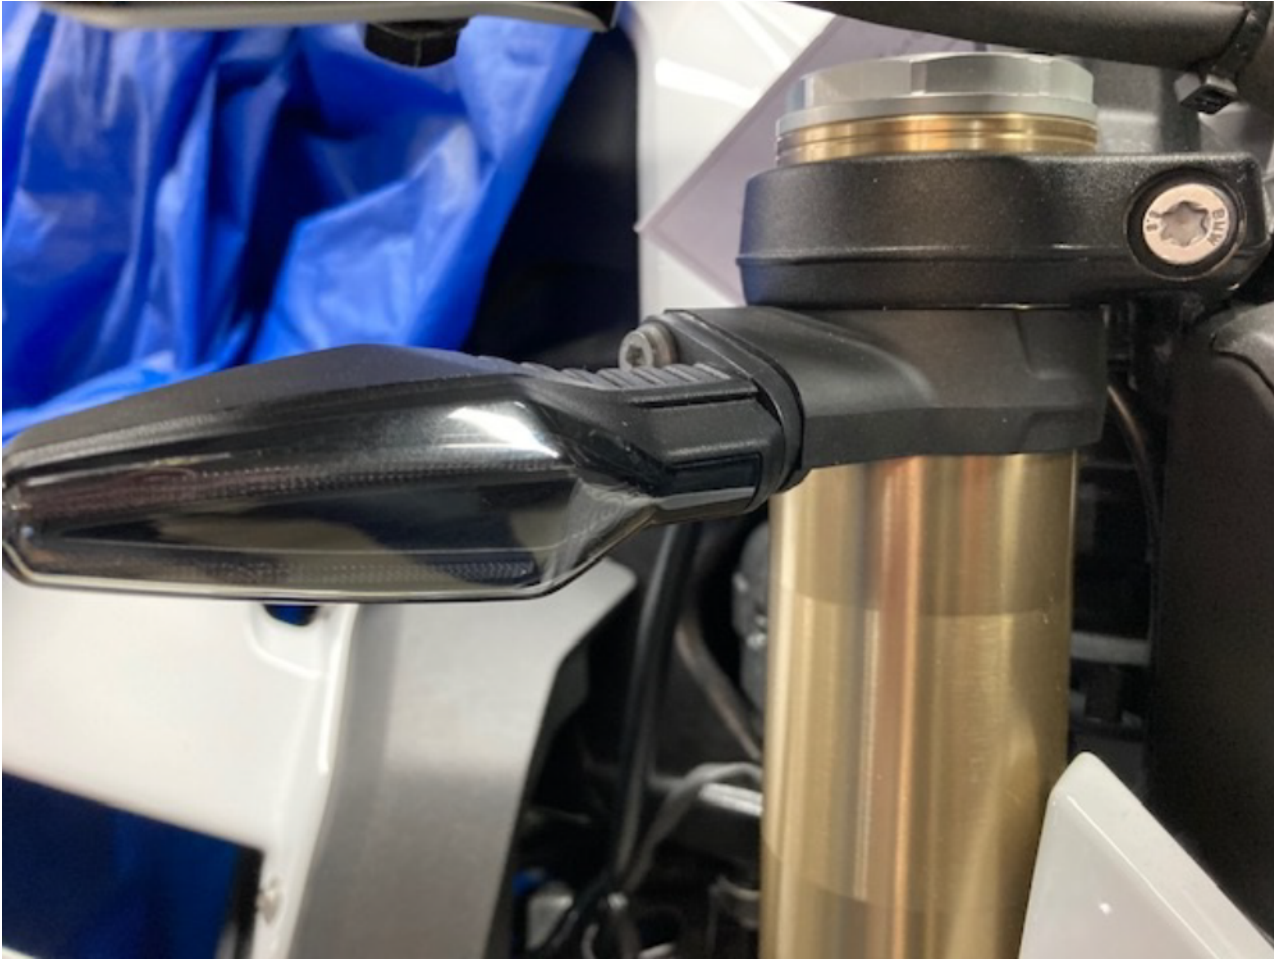
Over time, the turn indicator holders may become loose and shift away from their designated place on the fork tube.

Apply protective film to the fork tubes under the turn indicator holders.

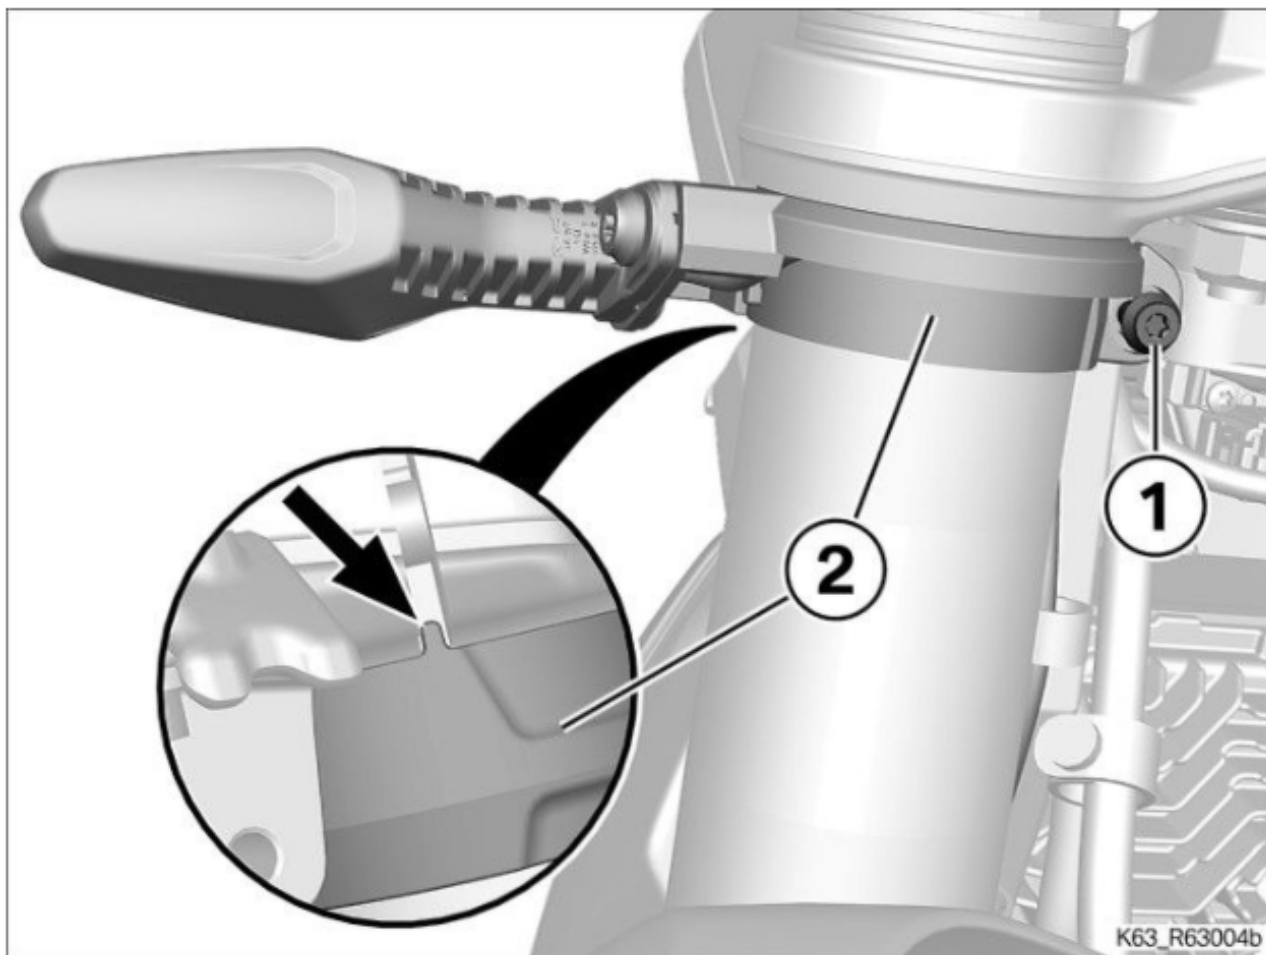
The turn indicator holders remain loose on the fork tube even if screw is retightened.
