Technical Service Bulletin

60 Rattle noise near the central roof area

60 22 60 2054270/9 May 19, 2022. Supersedes Technical Service Bulletin Group 60 number 21-57 dated November 12, 2021, for reasons listed below.

Model(s)	Year	VIN Range	Vehicle-Specific Equipment
A6	2019 – 2021	All	Not Applicable
A6 allroad	2020 – 2021		
RS 6 Avant	2021

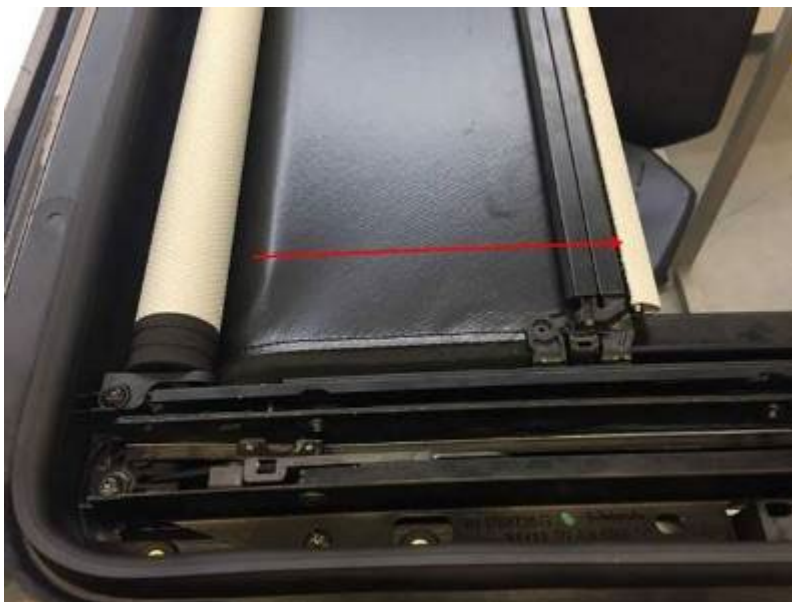
Figure 1. Closing the roller shade.

1. Remove the glass sunroof panel according to the Elsa Repair Manual instructions.
2. Close the roller shade by about 20cm (Figure 1).

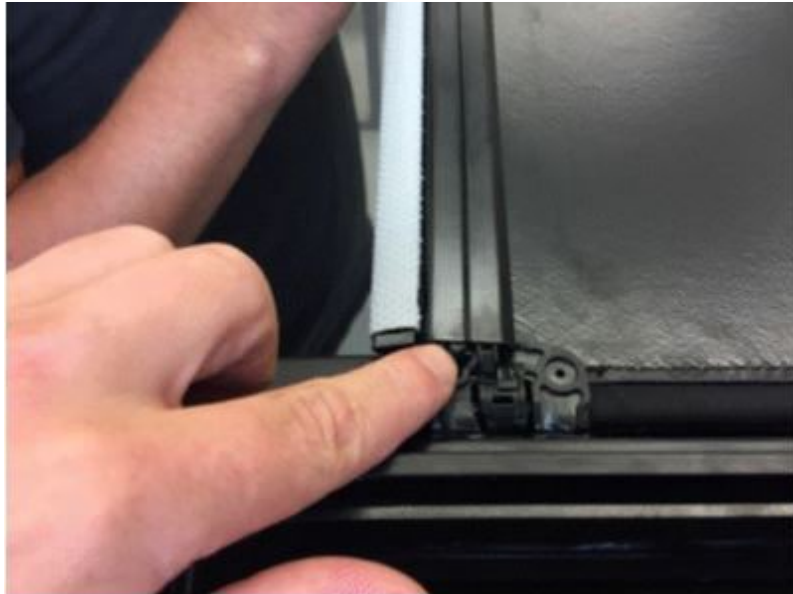
Figure 2. Move the beam off of the drive laterally.

3. Loosen the roller shade from the drive cable and push the material back until the bolts are exposed, then remove the bolts completely (Figures 2 -5).

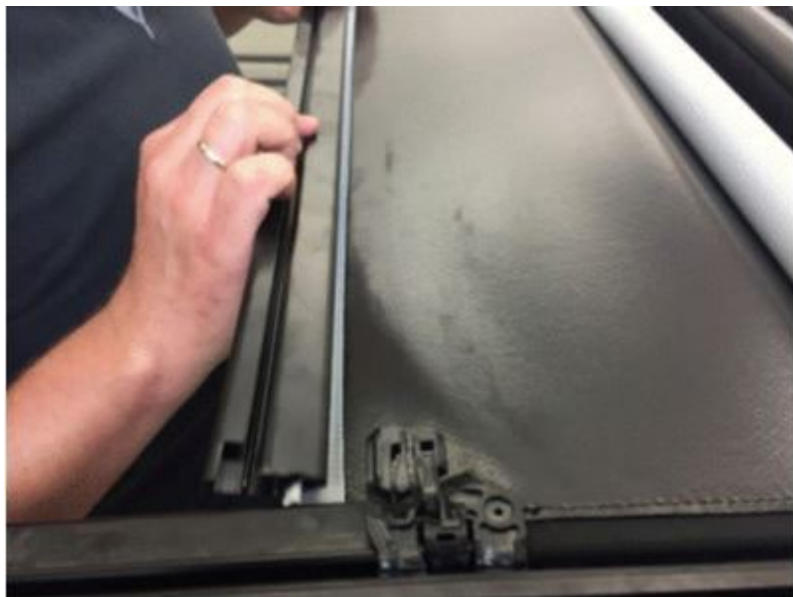
Figure 3. Beam removed from the drive.

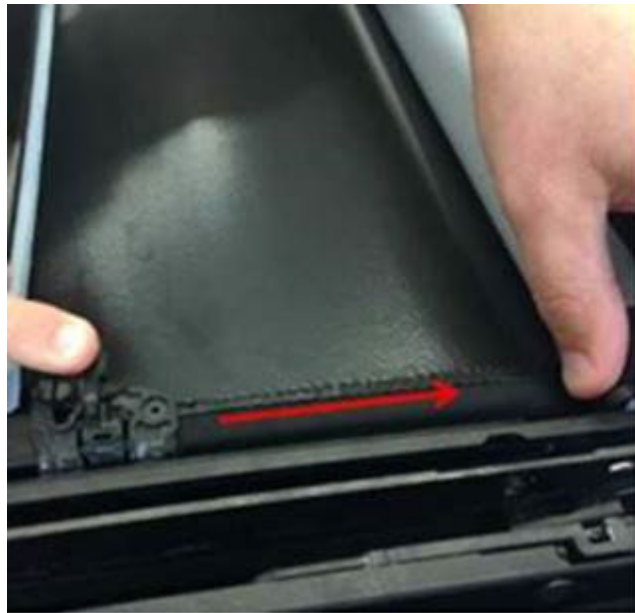
Figure 4. Push the material back to expose the bolts.

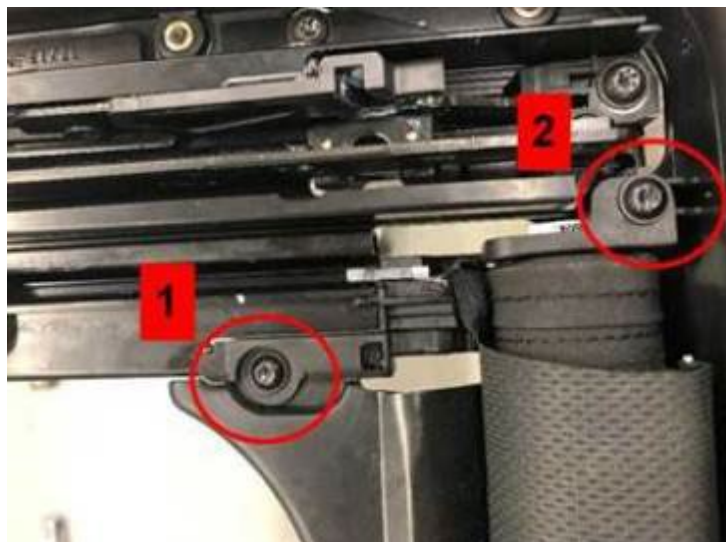
Figure 5. Remove the bolts.

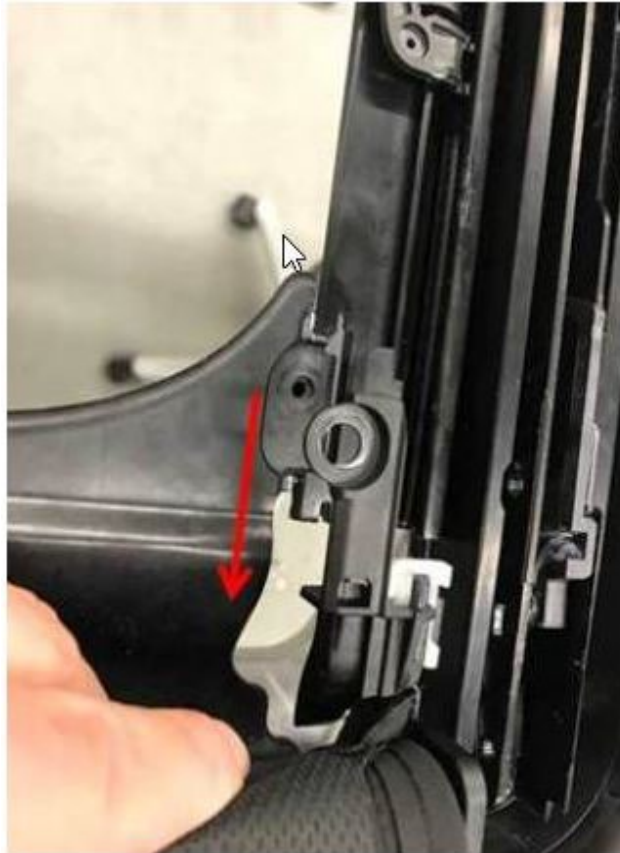
Figure 6. Slide roller shade backward.

4. Remove the roller shade by sliding it backward and clean the mounting points as shown in Figure 6 and 7. Use the cleaning solution D 009 401 04 or equivalent surface preparation solvent (e.g. isopropyl alcohol or adhesion promoter) to prepare the surfaces for adhesive-backed felt strip material.

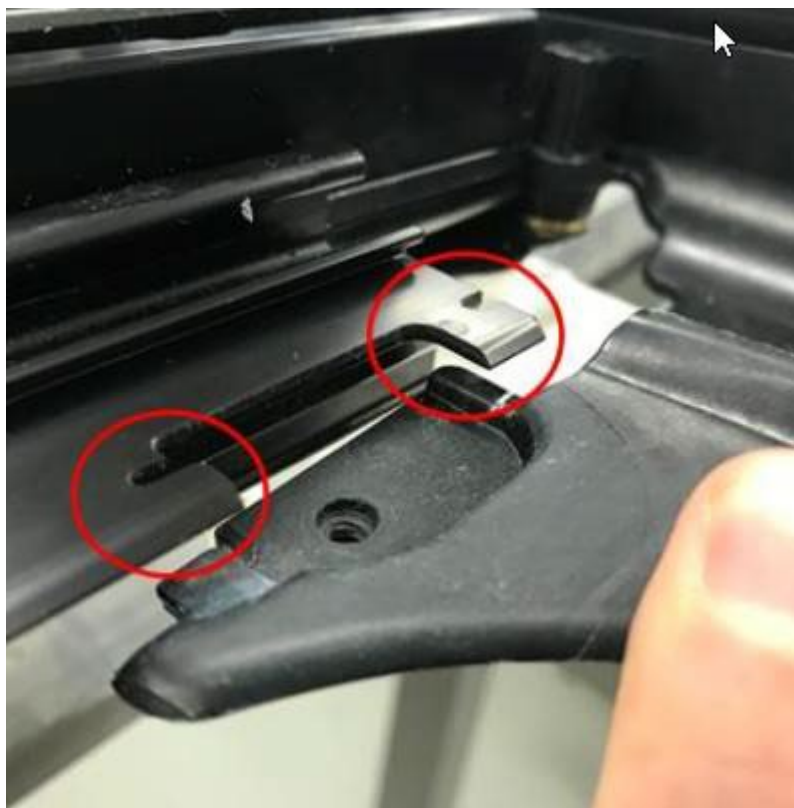
Figure 7. Areas to clean using cleaning solution D 009 401 04.

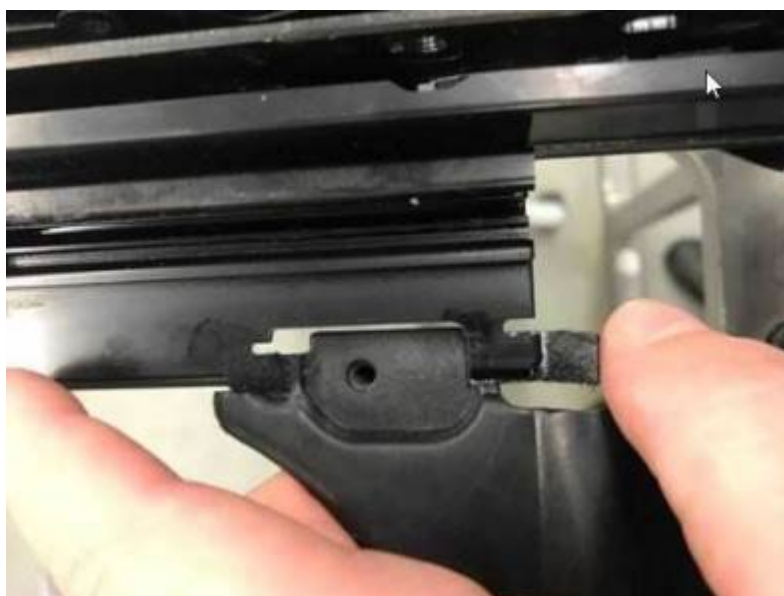
Figure 8. Applying felt tape.

5. Push down on the roller shade pan and starting from the bottom of the guide rail, wrap the areas shown in figure 8 with sections of felt tape 000 979 950 and fold them forward and over to the top of the guide rail such that both the top and bottom of the tabs are isolated (Figure 8 and 9).

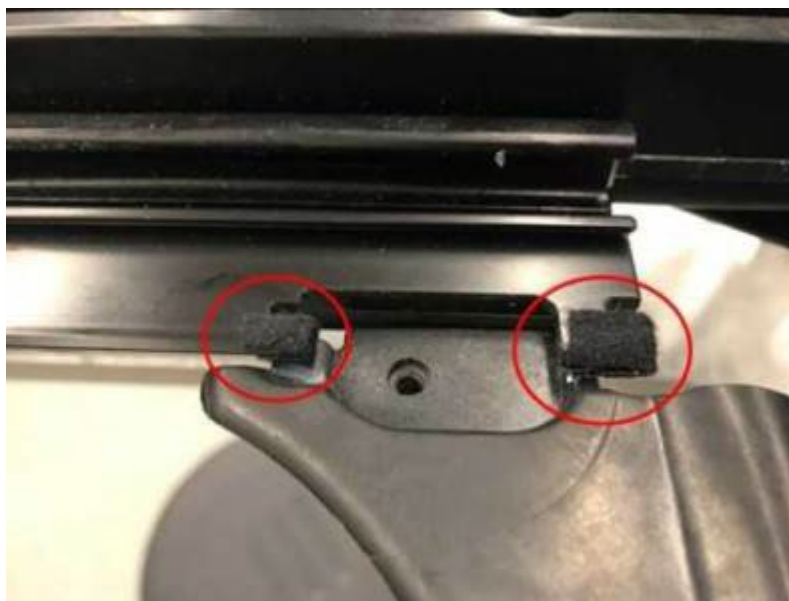
Figure 9. Apply felt tape on points shown. The tops and bottoms of the tabs must be isolated.

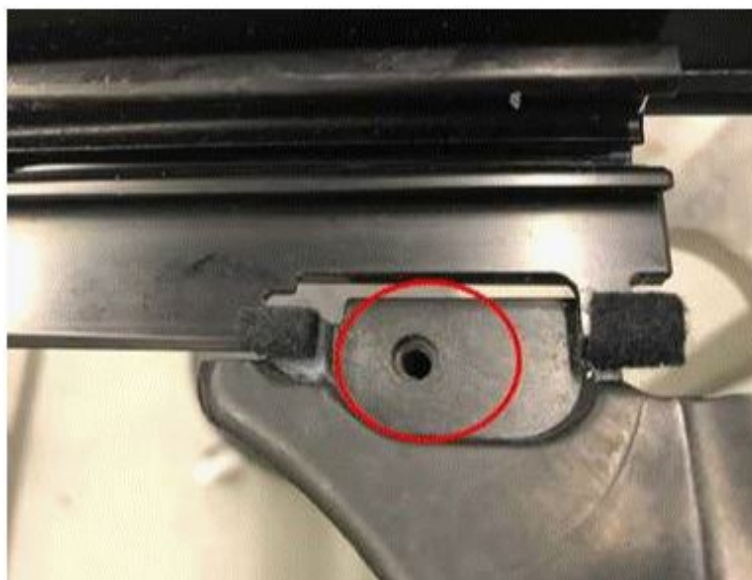
Figure 10. Apply thread locker in this area.

6. Apply thread locker to the screw hole shown in Figure 10. Reinstall the bolts to the roller shade and torque to 3Nm (Figure 11).

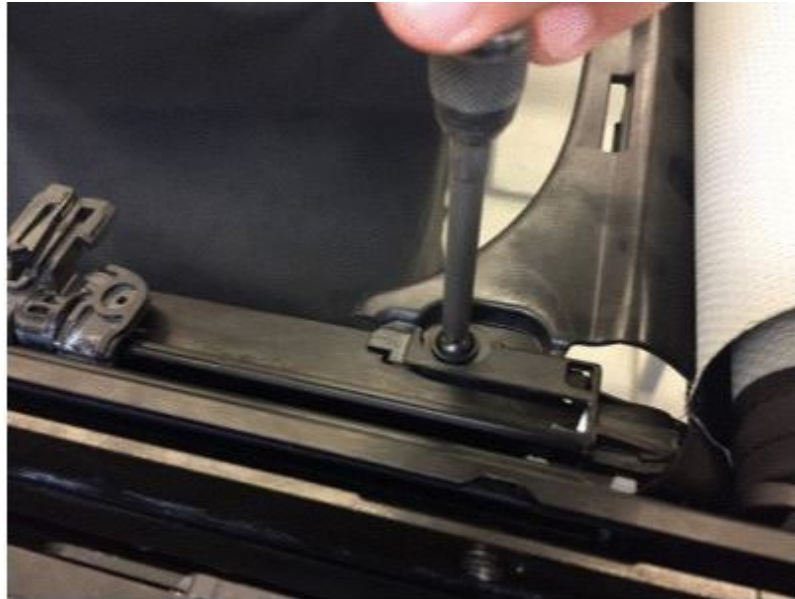
Figure 11. Torque screws to 3Nm.

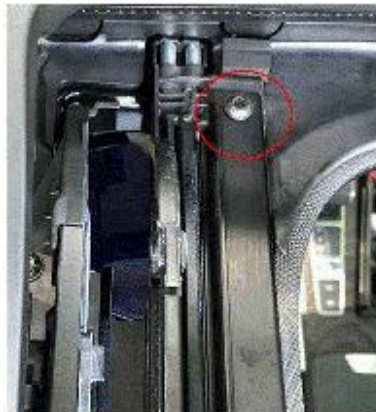
Figure 12. Loosen the bolt a few turns but do not remove the screw completely.

7. On the front of the sunroof guide rail, loosen that bolt a few turns but do not remove the screw completely (Figure 12).

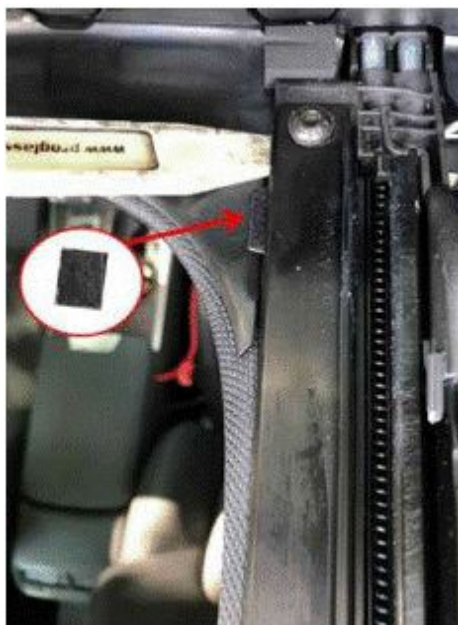
Figure 13. Isolation of guide rail and frame by the installation of a section of felt strip material.

8. Lift the guide rail slightly using a plastic wedge. Place a 20mm x 20mm section of felt strip material 533 867 910 A between the guide rail and the frame as shown in Figure 13. The backing for the adhesive side must be removed and the felt tape section adhered before the screw is tightened. Reinstall the screw and tighten it to 5 Nm (Figure 14).

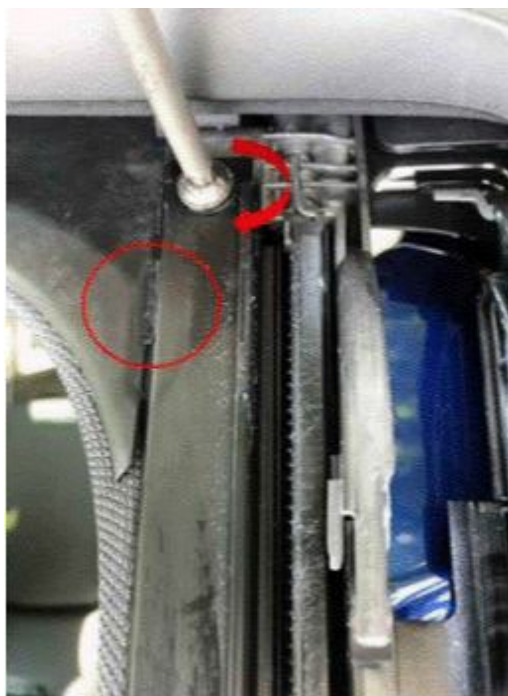
Figure 14. Tightening of the screw with the felt strip material isolating the guide rail and the frame.

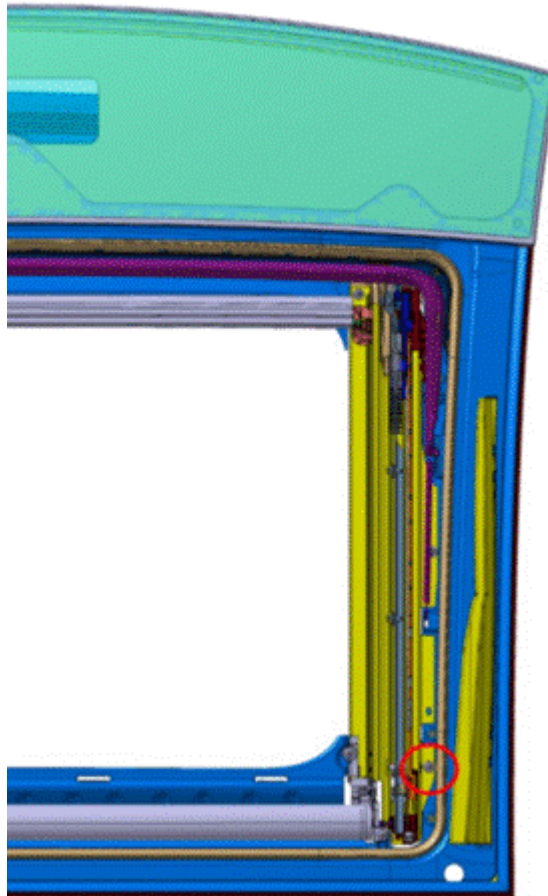
Figure 15. Loosen the bolt a few turns but do not remove the screw completely.

9. On the rear of the sunroof guide rail, loosen the bolt shown in Figure 15 for a few turns but do not remove the bolt completely.

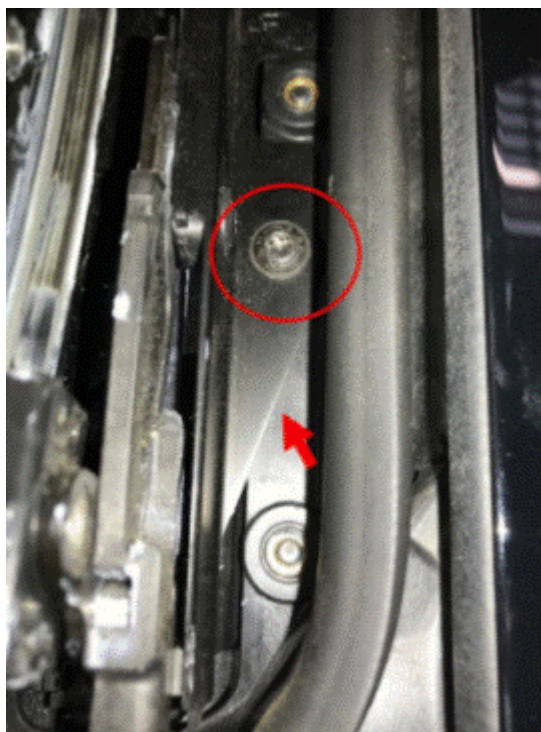
Figure 16. Location of rear guide rail bolt and area to be lifted with a plastic wedge.

10. Insert a small plastic wedge between the guide rail and the frame (red arrow in Figure 16). Separate the two parts slightly. Apply special lubricant G 060 567 A2 between the guide rail and the frame from the end of the rail to the bolt location. Tighten the bolt to 5 Nm.

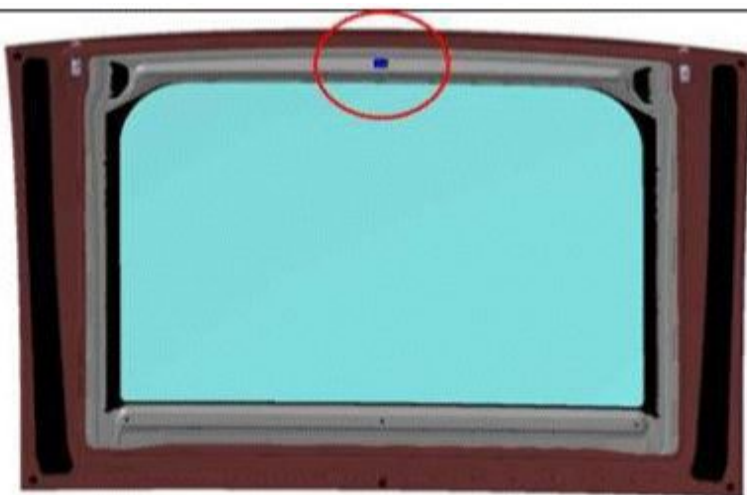
Figure 17. Area of sunroof glass panel structure to be prepared.

11. Measure and mark the center of the glass sunroof panel structure shown in Figure 15. Clean this area with cleaning solution D 009 401 04 or equivalent surface preparation solvent (e.g. isopropyl alcohol or adhesion promoter) to prepare the surfaces for adhesive-backed felt strip material. Apply a 20mm x 20mm section of adhesive felt strip material 533 863 288 A to this central area of

the glass sunroof panel structure as shown in Figures 17 and 18.

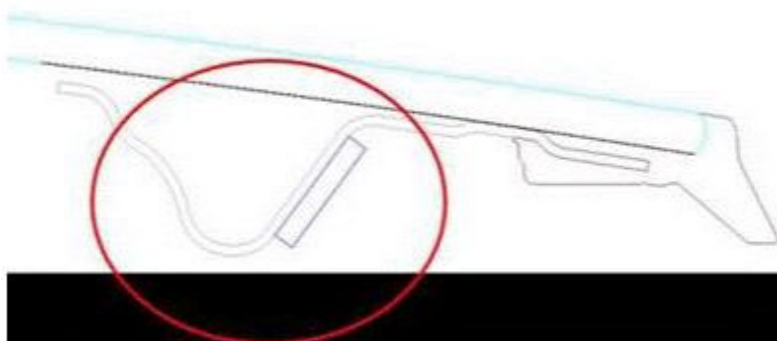
Figure 18. Affix adhesive felt strip material to the area shown.
