Thor Motor Coach Technical Service Bulletin

TSB #	TSB 22-06		
Description/Title:	Axis/Vegas Bluetooth Mic		
Affected Product Line(s):	Certain model year 2021 – 2023 Axis/Vegas		
Service Campaign # :	RC000264	Released Date:	5/23/2022
Codes:	Inspect Only: TMCTS80275Y Inspect with Repair: TMCTS80275W	Document Date:	5/19/2022
Time Allowed:	Inspect Only: 0.1 Inspect with Repair: 0.3	Document Revision:	A

2021 – 2023 Axis/Vegas may have a Bluetooth mic that is not installed.

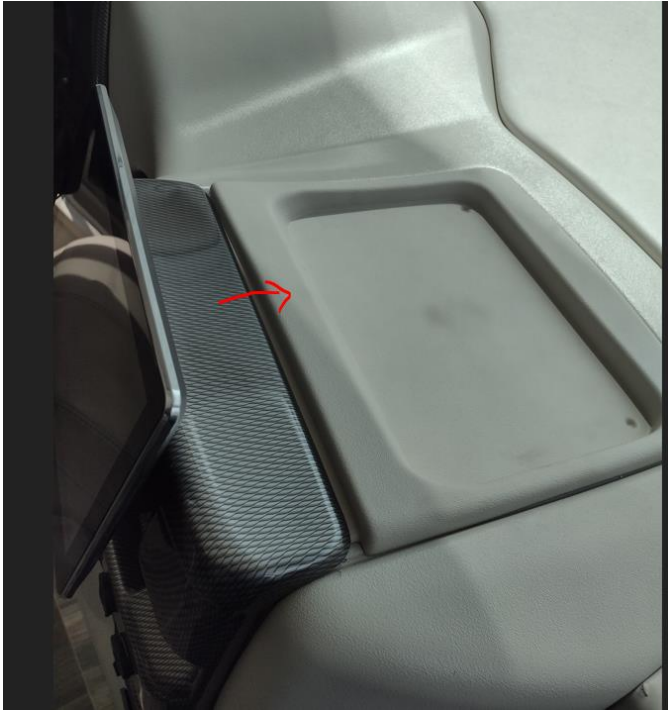
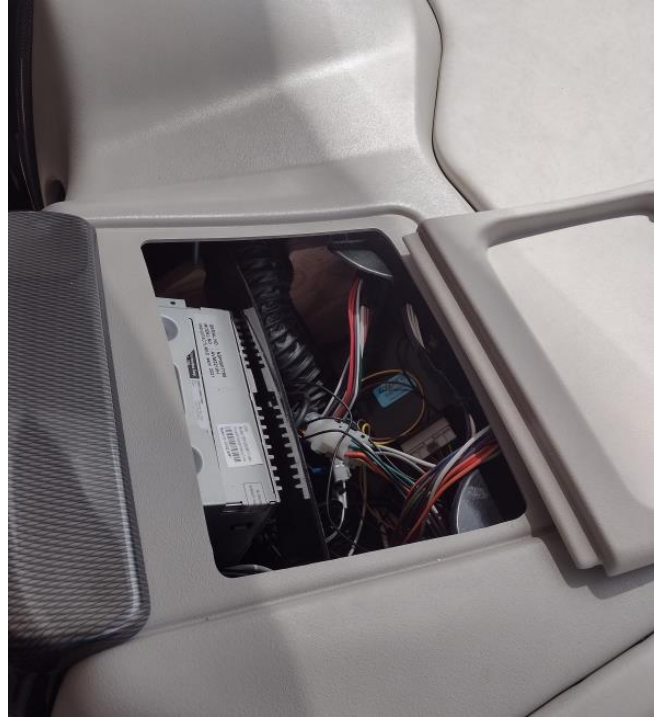
1. Remove dash access cover behind radio.

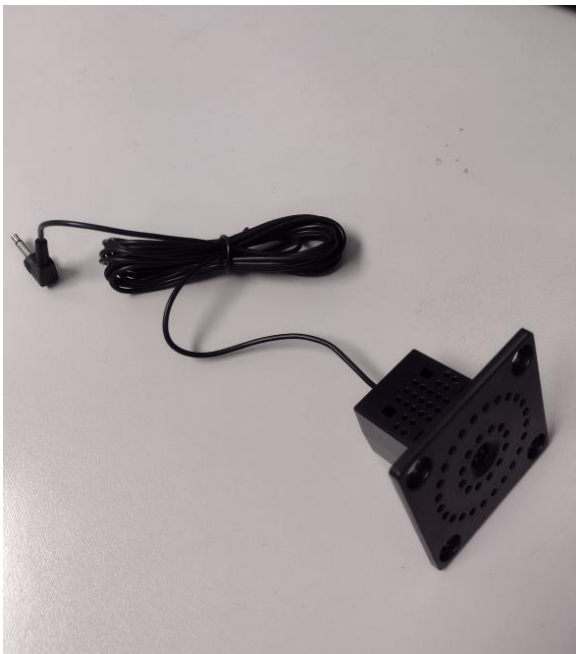
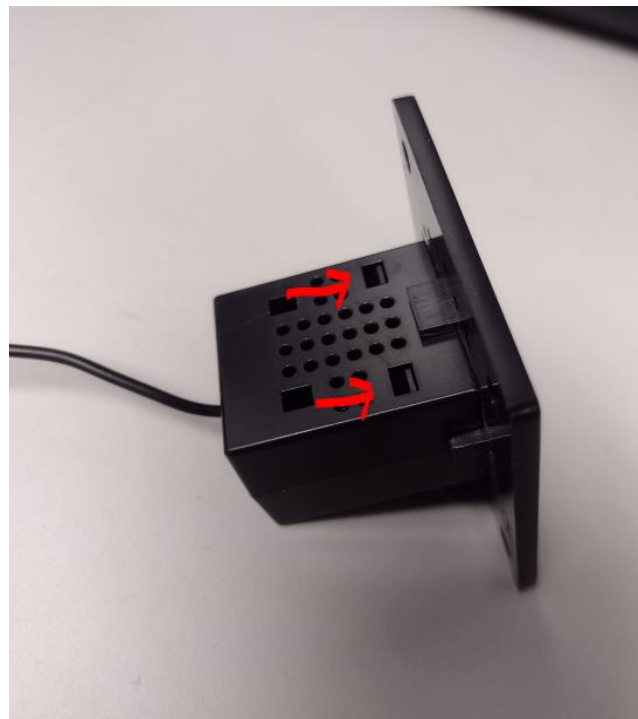
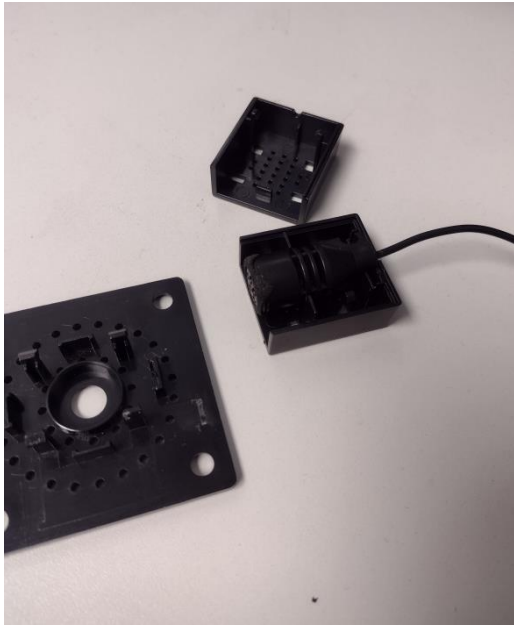
2. Remove mic from its mounting “box”. Do so by pressing tabs on both sides of “box”.

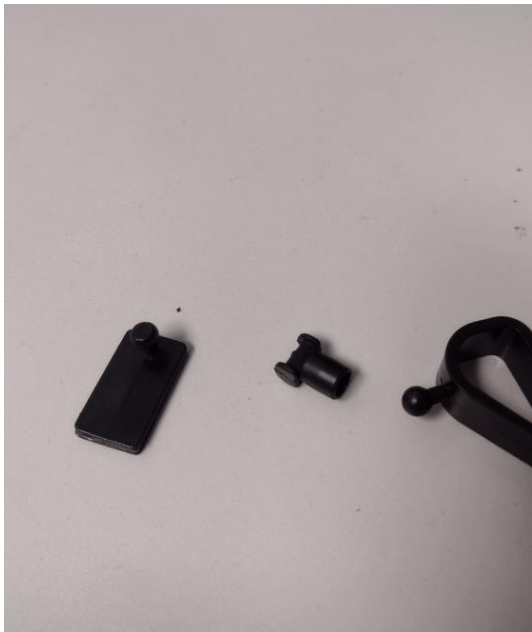
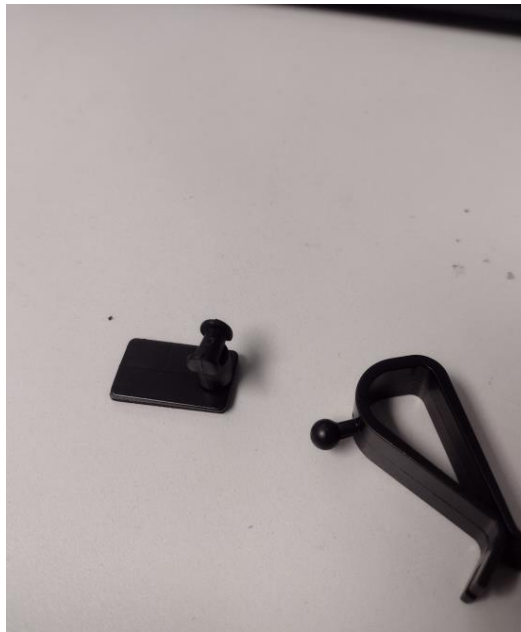
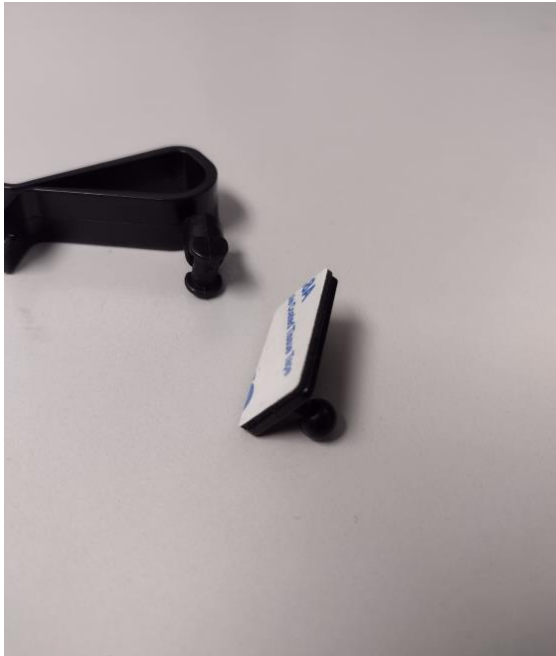
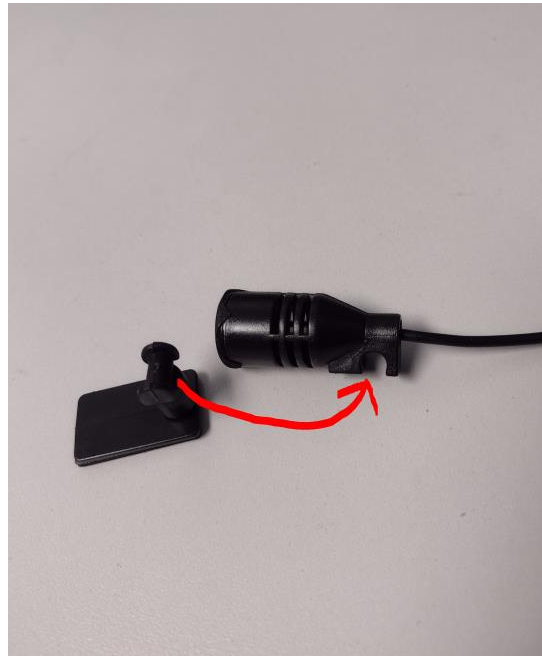
3. Insert mic into the smaller plastic mic holder with tape.

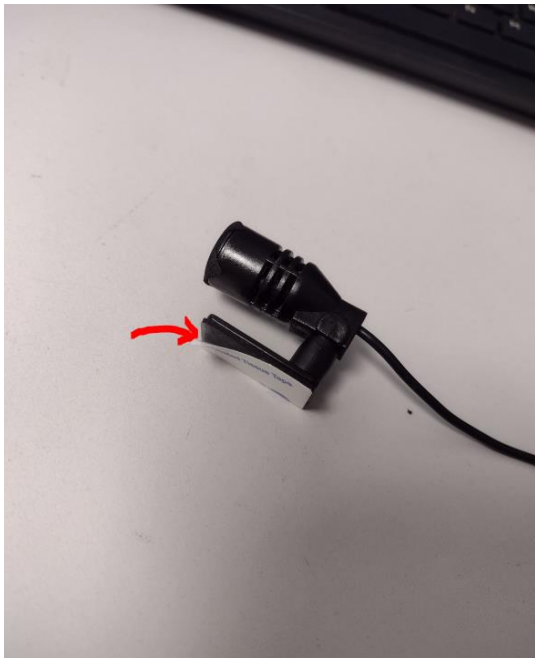
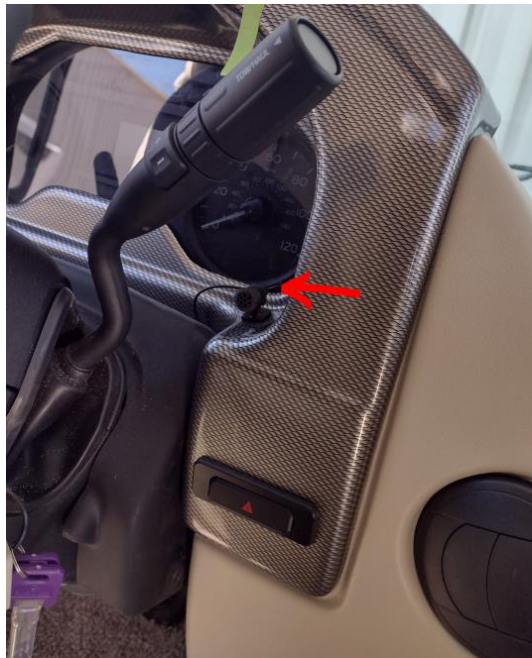
4. Remove tape from mic holder and stick at desired location.

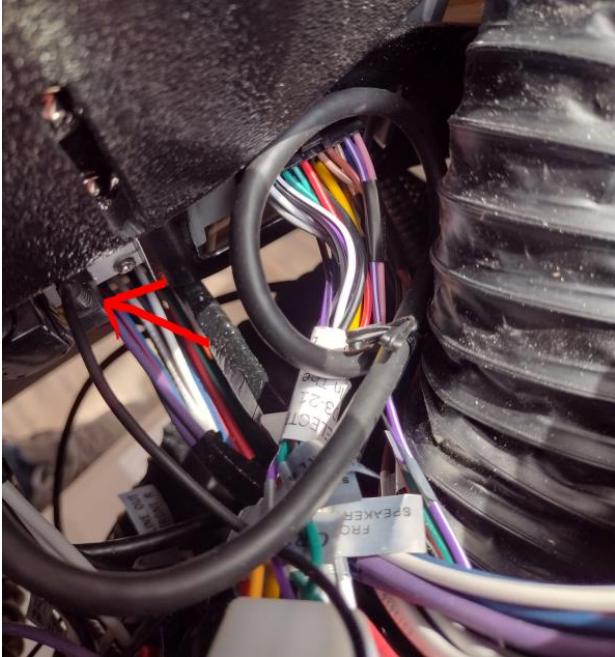
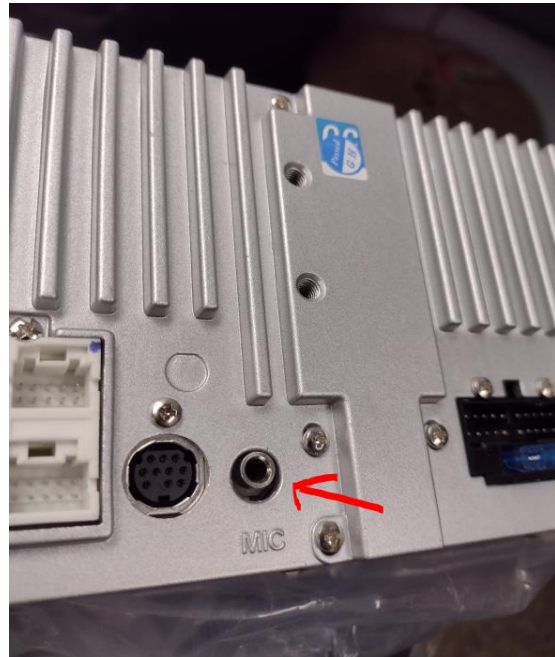
5. Run mic wires to behind the radio. Insert mic behind the radio. Secure excess wire.
