87-18-12 - HVAC, Unpleasant Odor

Release date: 5/18/2022

Unpleasant odor is coming from Heating and Ventilation system. Odor mainly occurs after vehicle has been sitting (unused) at least 5 hours and within 20 to 60 seconds after vehicle is first started.

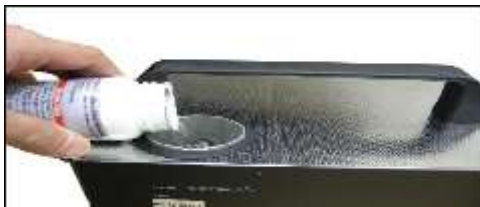
1. The vehicle should be cool, if necessary cool it down with the air conditioning to about 72°F
2. Dry the evaporator by running the ventilation (air conditioning "OFF") at the highest blower level for about 30 minutes.
3. Remove the activated carbon filter or pollen filter according to the repair manual. Close the cover on the AC duct without filter.
4. Open all vents, align them to the passenger compartment and select them with the control panel.
5. Leave the air conditioning switched off. Set the fan speed to level 1 and switch on the recirculation so air is not brought into the vehicle. Run the engine during the complete cleaning process or switch on the ignition and connect a battery charger.
6. Remove the neck (long black pipe) of air conditioning cleaner VAS 6189A / VAS 6189B and fill with a bottle of cleaning fluid part number 30208 (observe instructions on bottle).

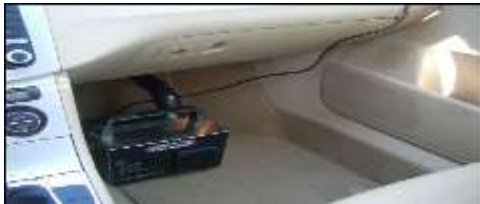
7. Place the air conditioning cleaner on the floor underneath the passenger glove box and point the neck towards the front of vehicle (see illustration).

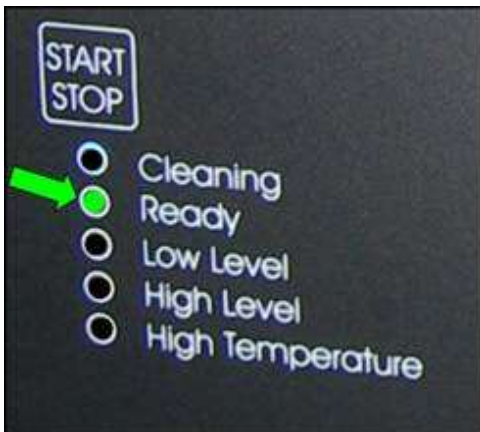
8. Route the cable of cleaner through the side window to the outside. Close the side window and connect the power cable. A self-test starts; when a green arrow lights up the unit is operational.

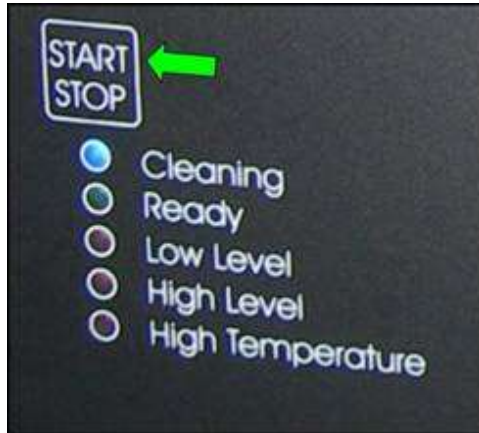
9. Start the cleaner (VAS 6189A / VAS 6189B), the warning light "Cleaning" comes on. Close all doors and windows.
