Service Bulletin

Date: **18 February 2022**

Subject: **Steering damper frame bracket kit**

Product: **Superveloce AGO**

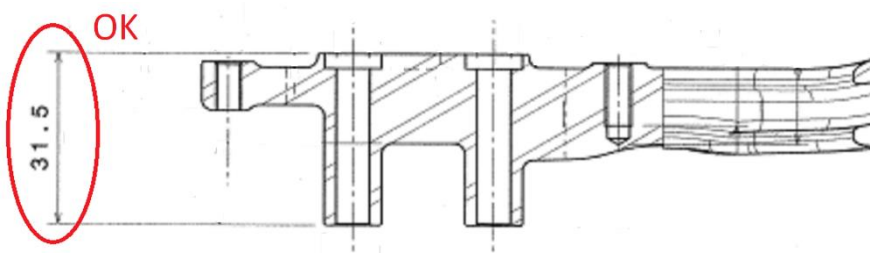
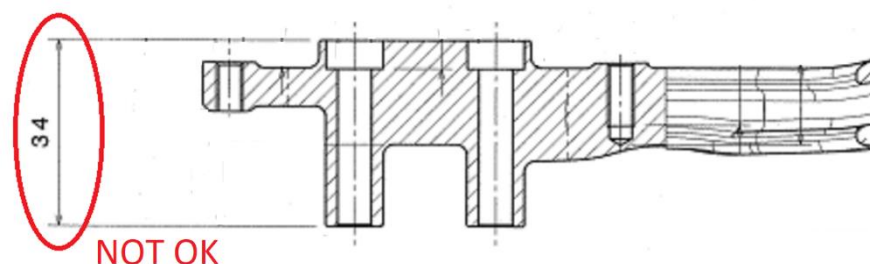
You can check the conformity of the component to be installed by checking the dimension shown in the drawings below. **THE CORRECT DIMENSION is 31.5 mm.**

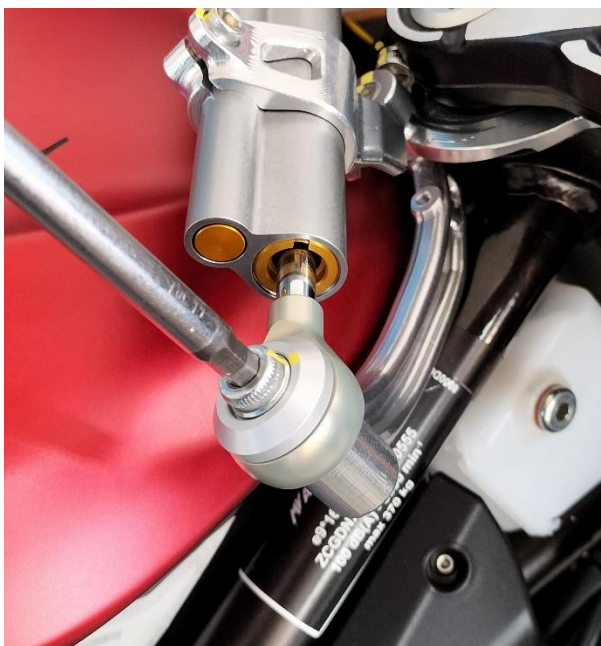
- Support the bike with a special front stand positioned under the triple clamp
- Remove the screw securing the steering damper to the frame:

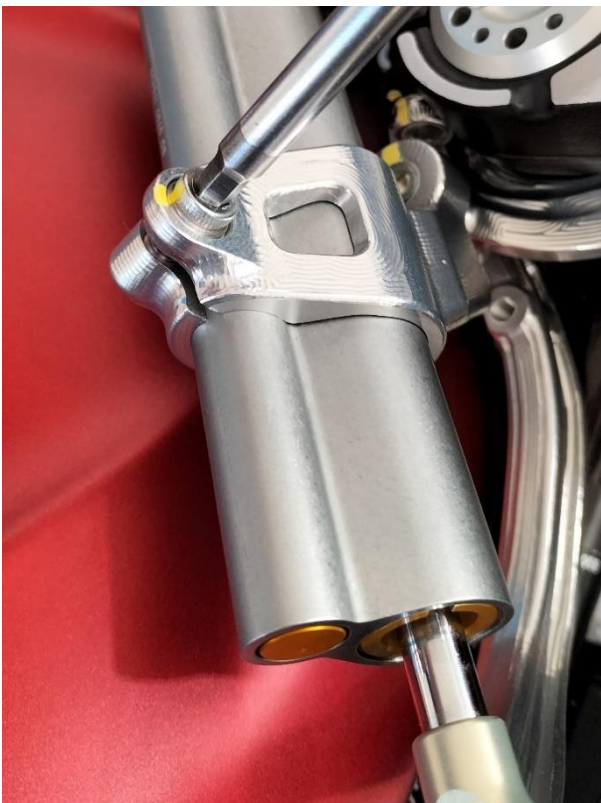
- Loosen the steering damper support screw:

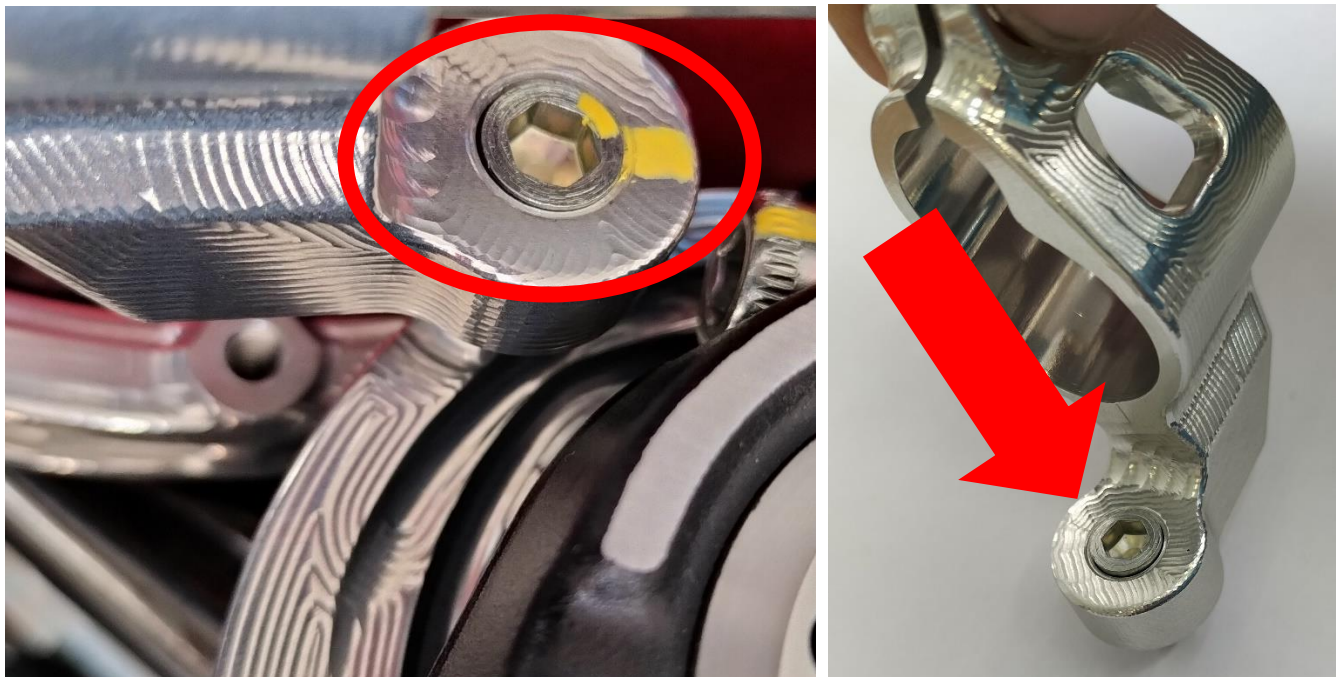
- Remove the steering damper by pulling it sideways to gain access to the screw securing the bracket; remove the screw and remove the steering damper bracket:

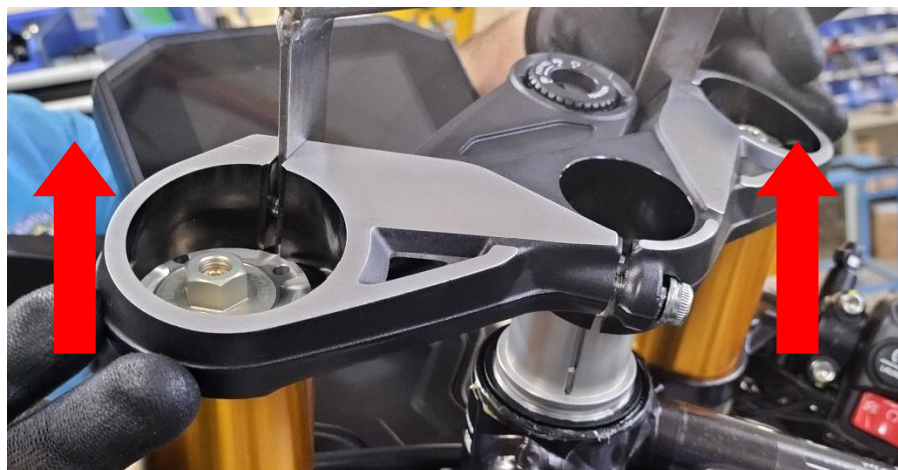
- Then remove the complete triple clamp together with the ignition lockswitch. If necessary, use a rubber mallet to remove the triple clamp:

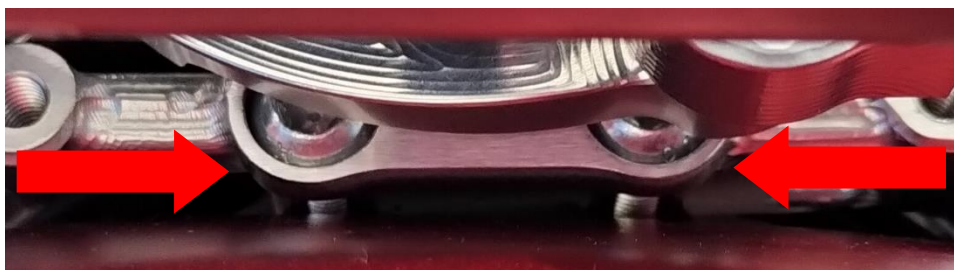
- Undo the two M6 screws and remove the steering damper fixing bracket supplied with the vehicle. **DO NOT re-use the removed steering damper fixing bracket and the two removed M6 screws:**

- Mount the new steering damper fixing bracket code 8000D0201 using the two new screws code 60NDB2740, with a light coat of Loctite 243 on the threads, and tighten at a torque of 8 Nm.
- Position the triple clamp in place, following the removal operations in reverse order, taking care to bring the clamp into contact.

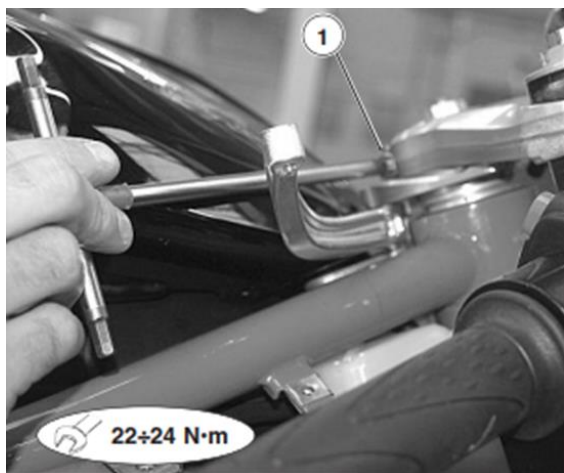
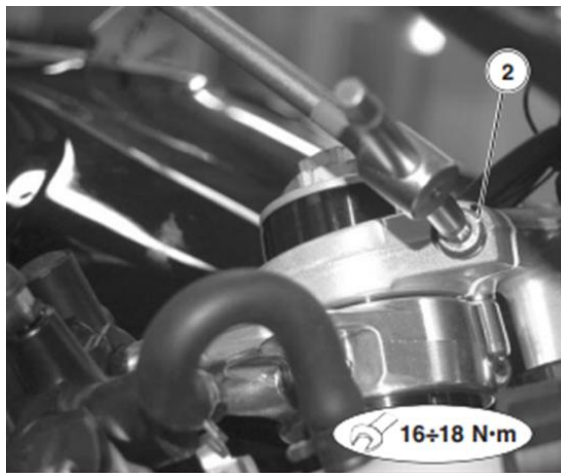
- Tighten the central screw (1) securing the triple clamp to a torque of **22 ÷ 24 Nm**
- Tighten the two front screws (2) securing the triple clamp to a torque of **16 ÷ 18 Nm**

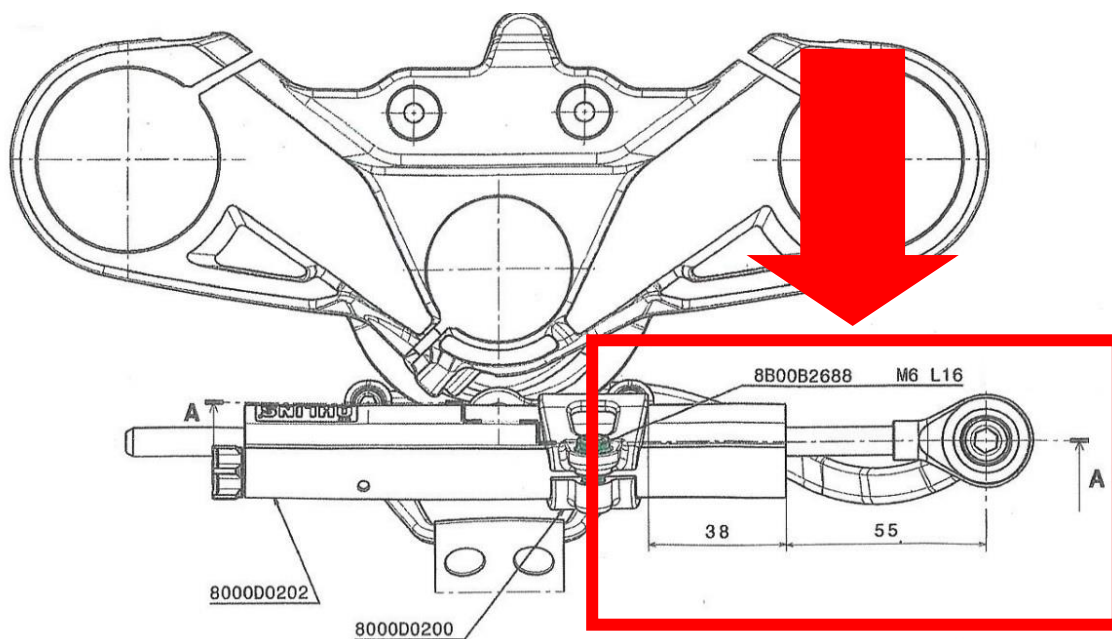
- Refit the steering damper bracket, **tightening the screw to 8 Nm using strong threadlocker 270.**
- Refit the front tank belt support **by tightening the two M5 screws to a torque of 6 Nm using Loctite 243 medium thread locker.**
- Reposition the steering damper into place, **taking care to stick to the positioning dimension of 38mm from the right edge of the damper** (see diagram below); **then tighten the steering damper fixing screw 8000B2688 to a torque of 4 Nm:**

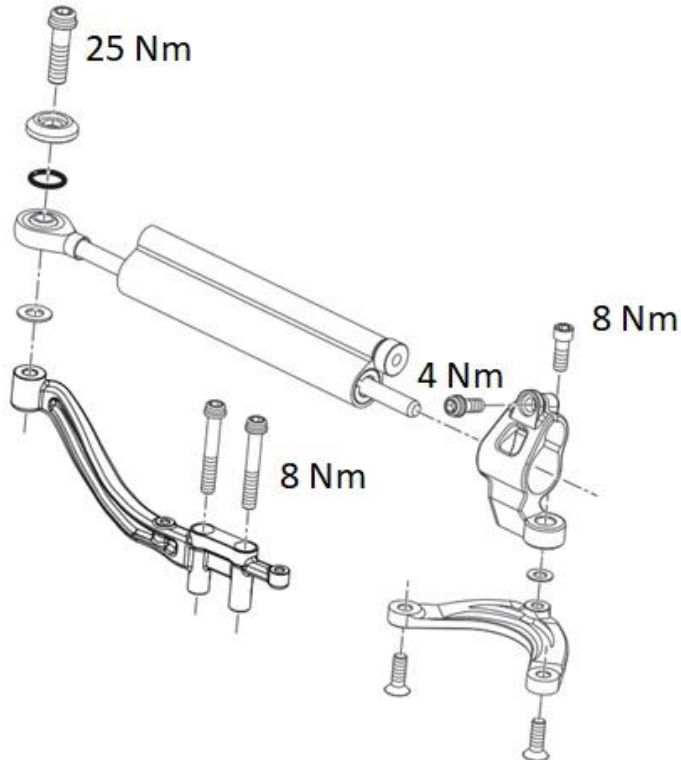
- Overview of tightening torques for the steering damper and its mountings:
