## STAR ONLINE PUBLICATION

**Case Number:** S2223000016

**Symptom/Vehicle Issue:** Bump In Center Of Front Fascia Bumper

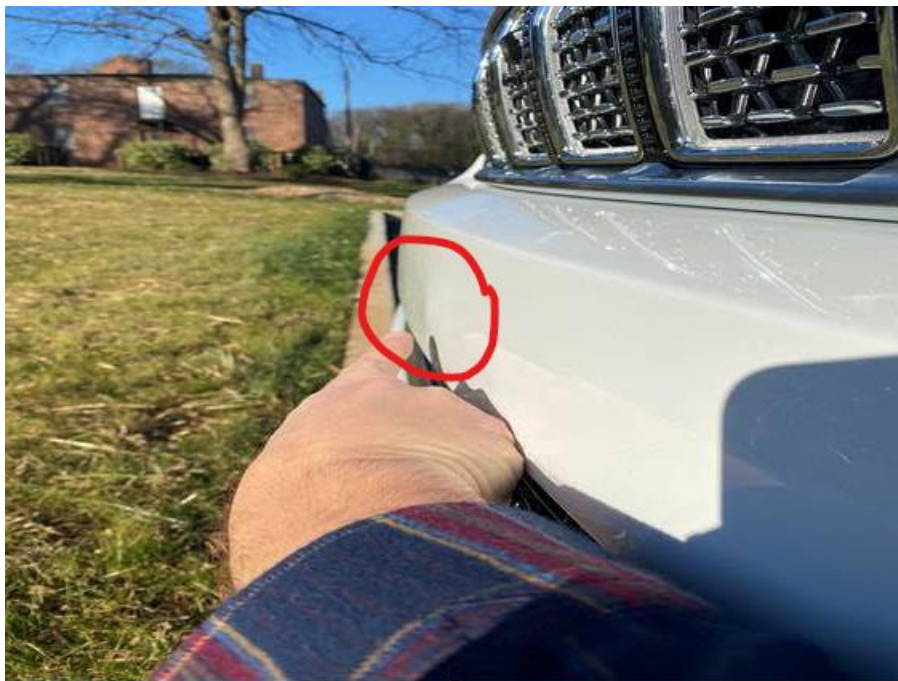
**Discussion:** Bulge on front fascia due to night vision washer hose being trapped between fascia and grille. This would only be applicable vehicles equipped with night vision (sales code XNT). To correct the condition the fascia must be removed and

washer hose routing corrected. Refer to 13 - Frame and Bumpers / Bumpers / FASCIA, Front / Removal and Installation.
