STAR ONLINE PUBLICATION

Case Number: S2223000018

Symptom/Vehicle Issue: 2nd Row Seat Will Not Pitch N Slide For Easy Entry And Or Electronically Fold Flat With Fold Flat Button Press

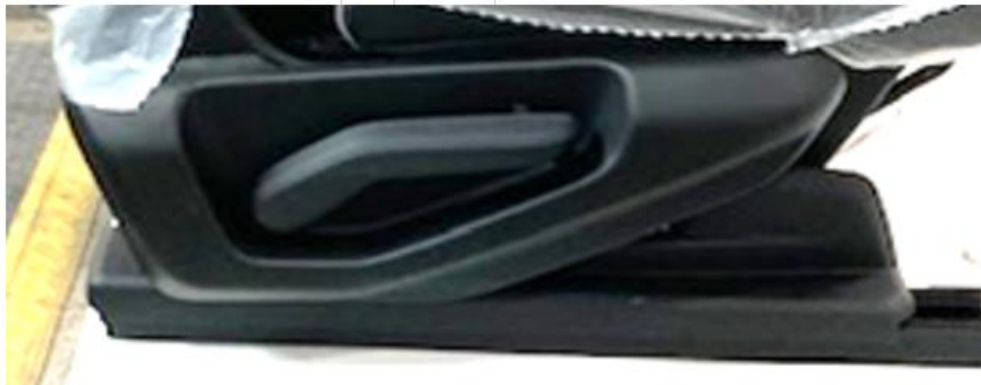
Fig 1

Seat lower side shield. Use screw driver to remove screws.

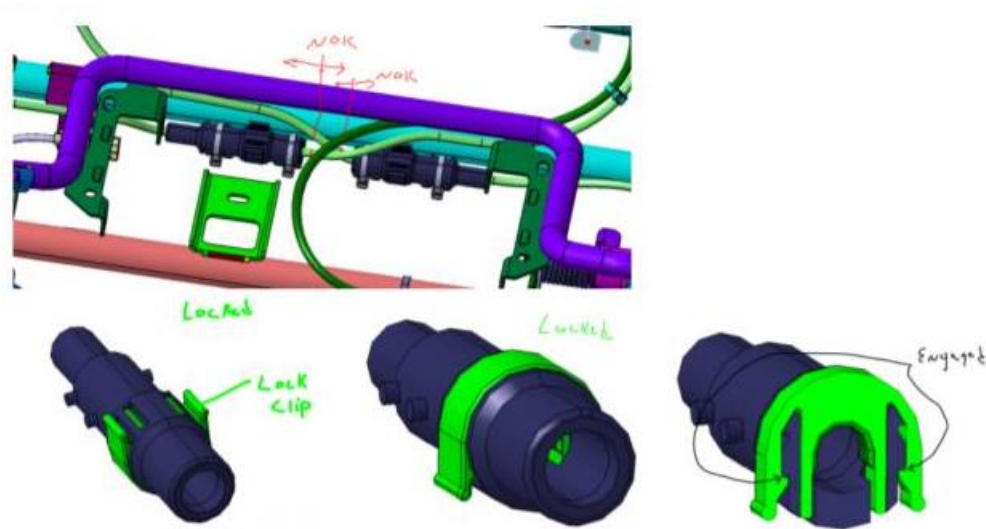
When easy entry/exit button is pressed there should be no movement into or out of the cable adjusters located in the bite line of the frame. Only the metal cable clip ends attached to the bracket should move. If the cable sheathing is seen to move or the cable adjuster lock clip is not fully clipped and locked into place, then inspect the Cable adjuster lock clips. **The Cable adjuster locking clips must be fully clipped for the seat release mechanism to work properly.** Inspect the cable end to obtain the correct cable stick out of 5-8mm. Adjustment steps are below

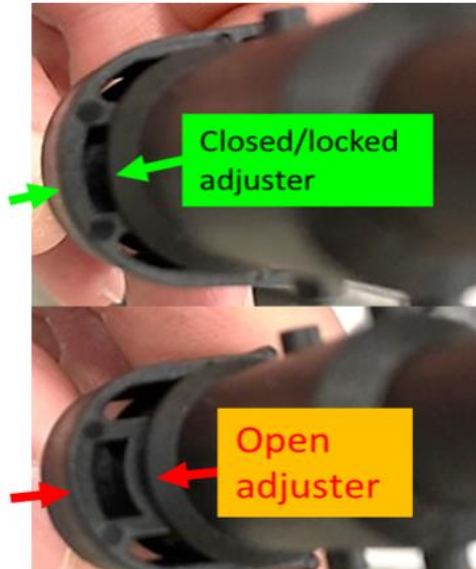
Fig 2

Seat Cable adjuster and adjuster lock clip.

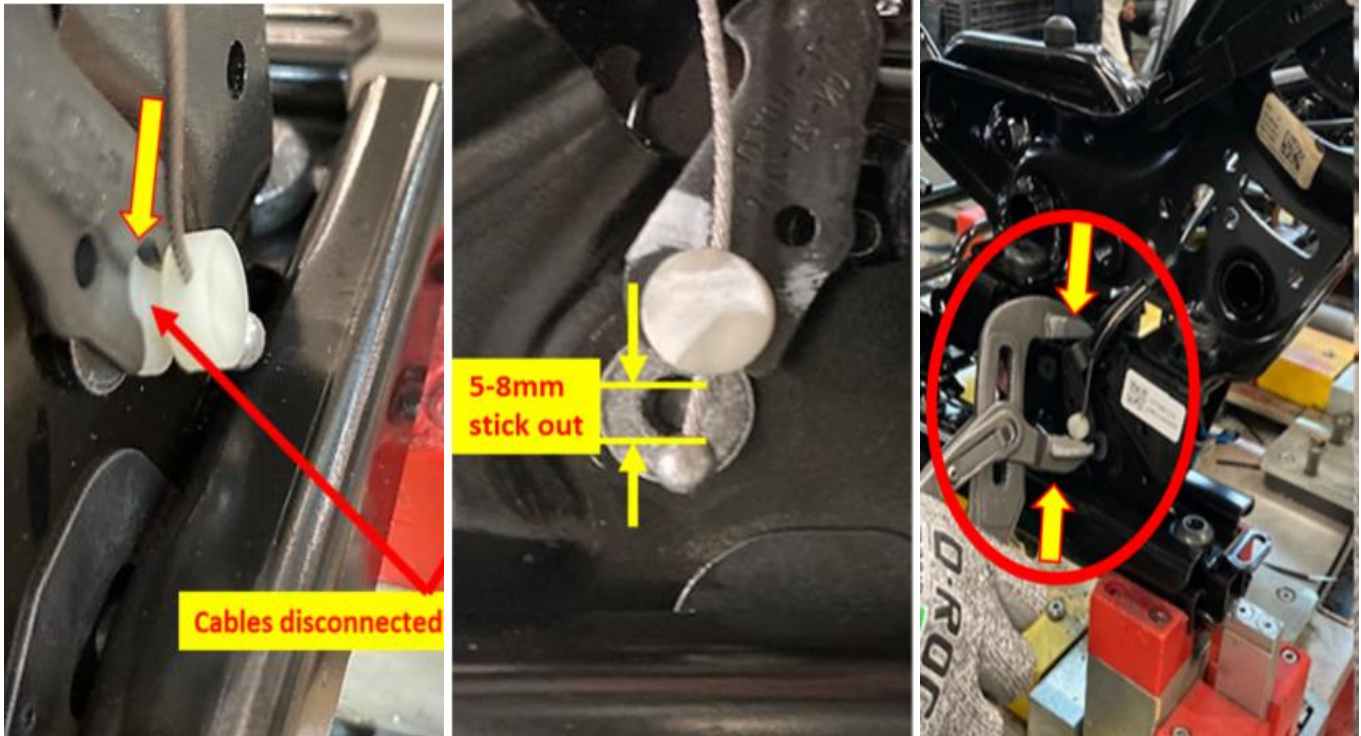
Fig 3

Adjusting the cable: Remove zip ties from the cables and adjusters using diagonal cutters (Fig 4). With latches locked move the adjuster to set excess cable length on the latch and lock the adjuster clip fully into place. Target stick out is 6mm (Fig 3). Use a pair of pliers to make sure the cable end is snapped in to the bracket (Fig 3)

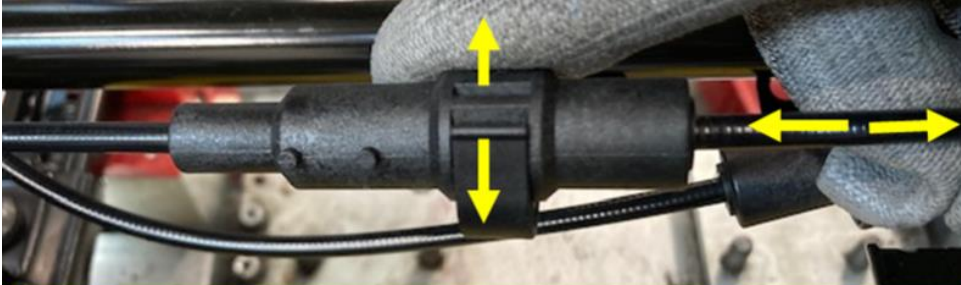
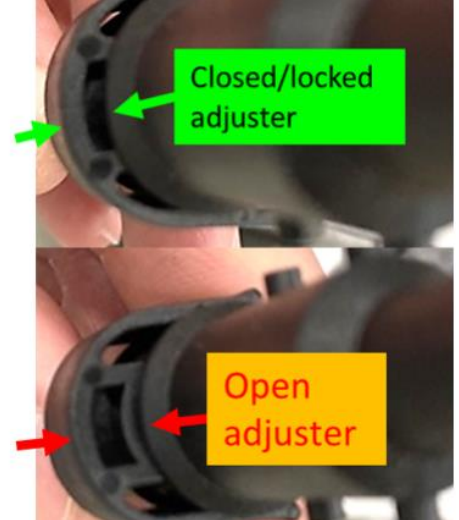
Fig 5
Adjustment

- Open/unlock the retainer clip by splitting apart,
- Push, pull the Inboard side of the cable to adjust the cable stick out at 5-8mm
- Lock the adjuster retainer, verify it is fully locked and cable does move
- Repeat for the next adjuster

Adjust the cable stick out (5-8mm) by unclipping the adjuster locks and sliding the cable housing in or out of the adjuster till the proper stick out is obtained. Fig 5

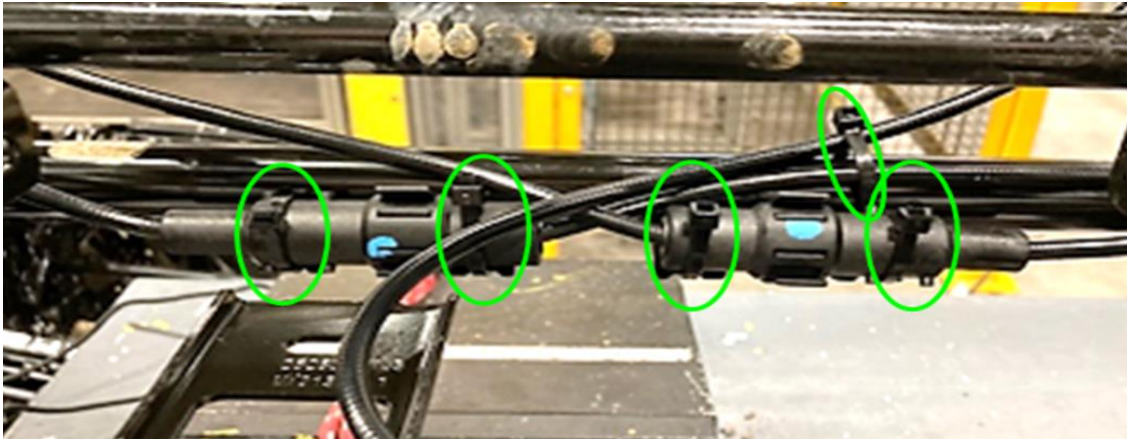
Fig 6

Install 5 zip ties through the bracket slots to attach the adjusters to the seat rails. 5th cable tie goes around the 2 cables as shown in (Fig 6).

<<<NOTE>>> The zip tie for the cables should guide the cables and be loose fitting-not be tight. The cables do move as the seat is moved.
