NUMBER: 23-009-22

Side Mirror Clicking or Inoperative

This bulletin involves trimming 75mm +/- 5mm (3 inches) of the lower lip of the side mirror's cut line rubber seal.

2022 (WS) Jeep Grand Wagoneer

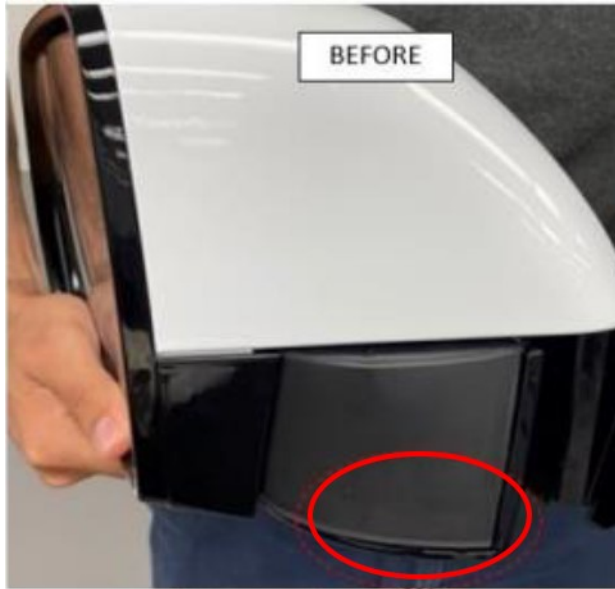
Fig. 1

2. Fold mirror outwards, towards the front of the vehicle (Fig. 1) .

Lip Seal On Mirror That Needs To Be Cut

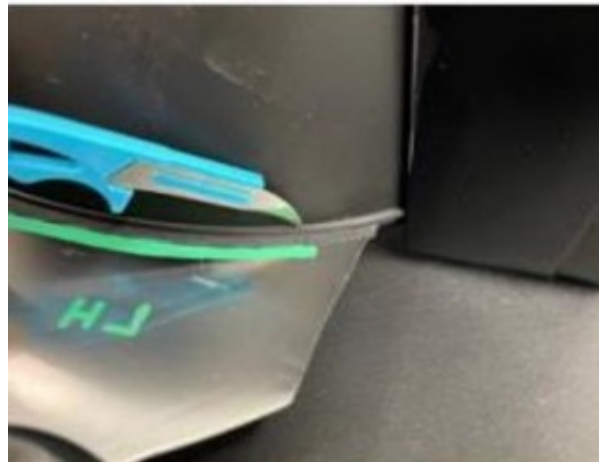
Fig. 2

Seal Cut

3. Cut away the rear 75mm +/- 5mm (3 inches) of the cut line lip using a straight edge and a utility knife.(Fig. 2) .

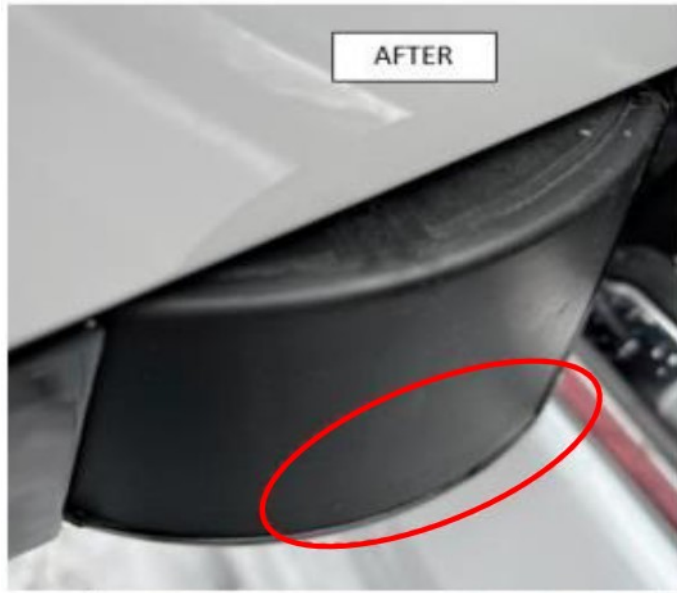
Fig. 3
After Seal Cut

4. After trimming, should look like this: (Fig. 3)
