NUMBER: 05-002-22

Front Click Noise at Low Speed Turns

This bulletin involves installing a friction disc kit on both front hub bearings and rotors.

2020	(WD)	Dodge Durango
2018 - 2020	(WK)	Jeep Grand Cherokee

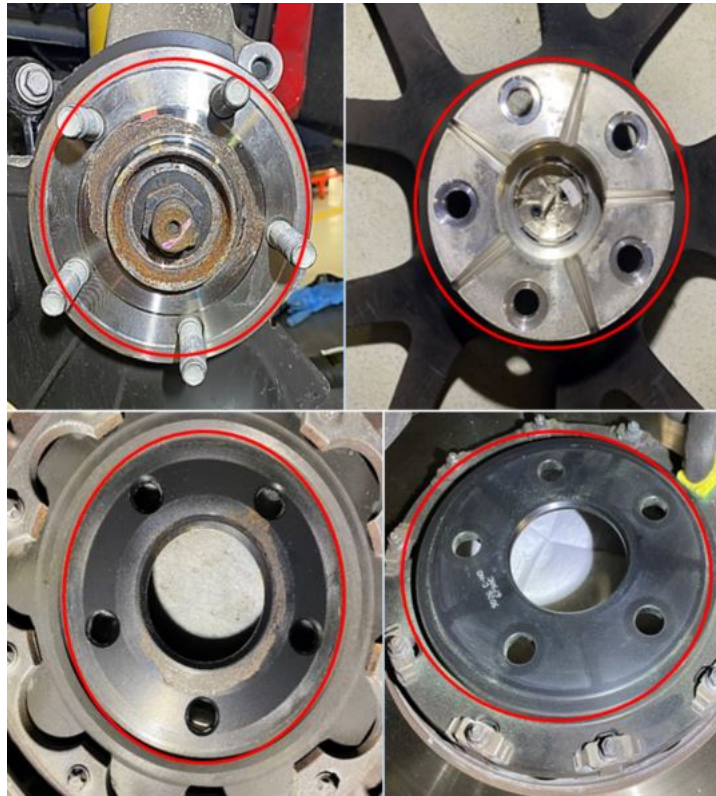
**Fig. 1****Areas That Needs To Be Cleaned**

1. Remove both front brake rotors and **discard the caliper mounting bolts**. Refer to the detailed service procedures available in DealerCONNECT/Service Library under: 05 - Brakes / 05 - Brakes, Base / Hydraulic/Mechanical / Rotor, Brake / Removal, Front - SRT.
2. Clean hub face where the rotor surface contacts the hub face to remove any dirt or corrosion, using scotch brite pad or similar style scouring pad that will not scratch the surface. Clean all mounting surfaces as seen in (Fig. 1) .

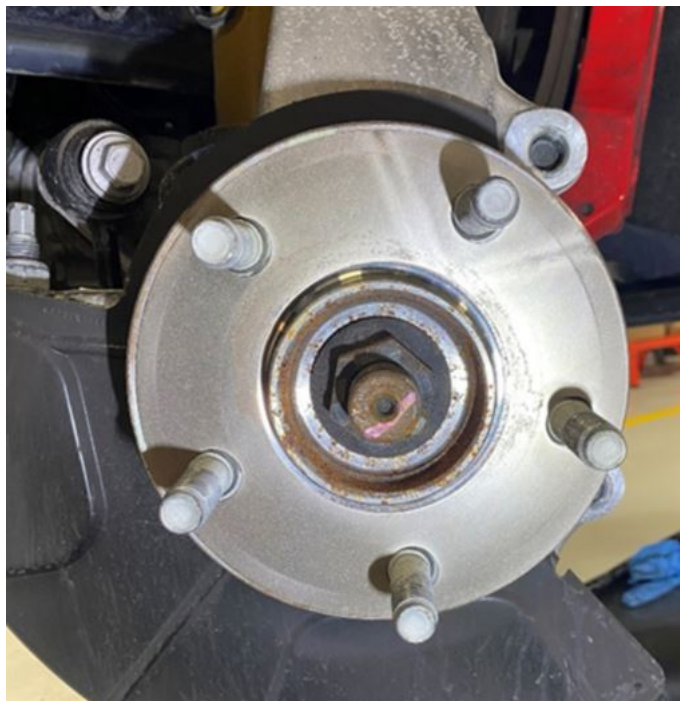
Fig. 3
Friction Disc Installed On Hub

4. Install the friction disc on to both front hub flanges (Fig. 3) .
