SIB 17 01 22

2022-02-09

SERVICE ACTION: INSPECT AND MODIFY OPTIONAL ACCESSORY
COOLER GUARD

Radiator, Cooling Systems

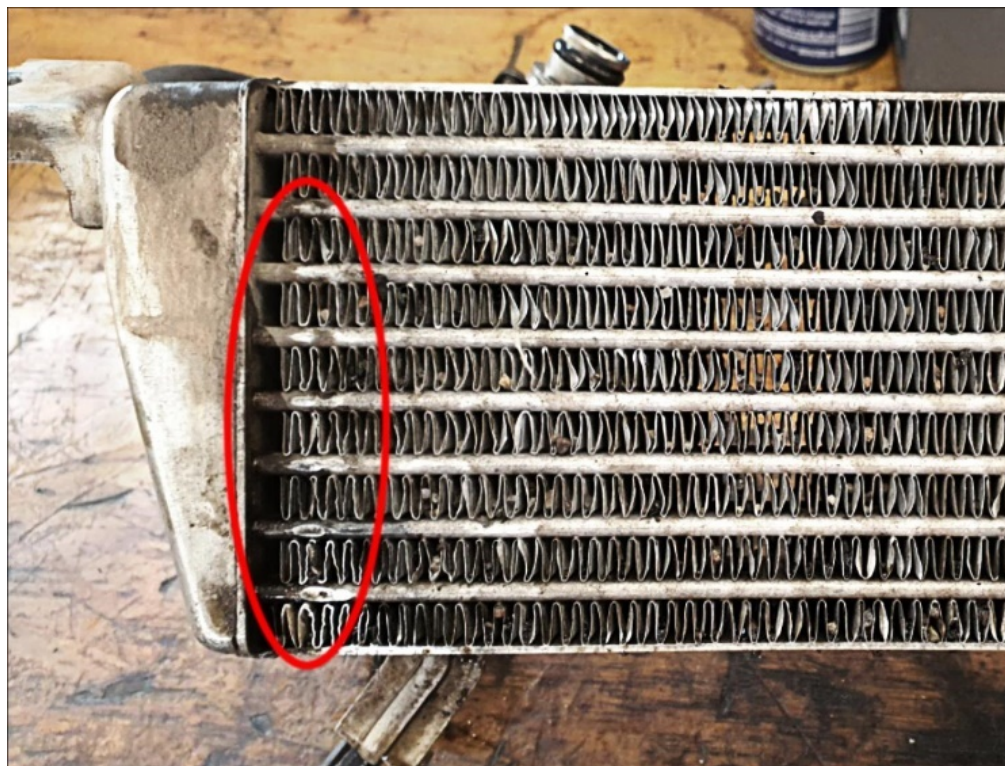
Installation of the accessory oil cooler guard from the BMW Motorrad Special Accessories Catalog may result in chafe marks on the cooler.

New installation instructions require use of special spacers to prevent chafing marks on the oil cooler.

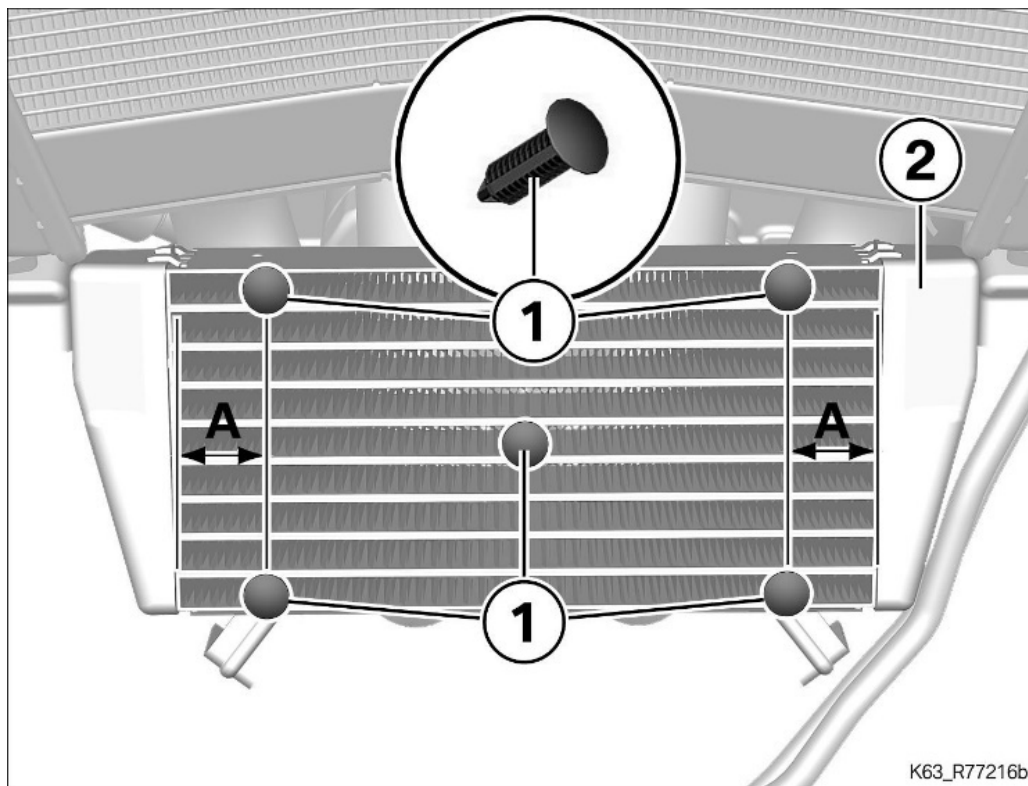
If the accessory oil cooler guard is installed, please reinstall it with five (5) spacers, part number below. Follow instructions "77 14 006 – Installing the radiator protection" in AIR, which were updated in February 2022.

Once the oil cooler guard is re-installed with spacers, please confirm that the guard is not touching the oil cooler.

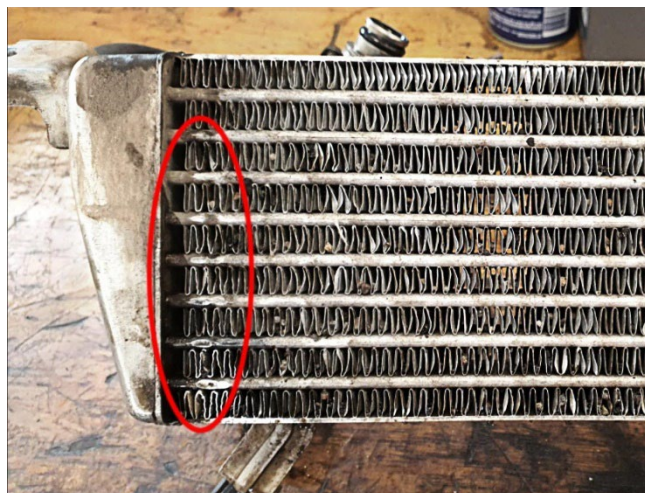
Installation of the accessory oil cooler guard from the BMW Motorrad Special Accessories Catalog may result in chafe marks on the cooler.

New installation instructions require use of special spacers to prevent chafing marks on the oil cooler.

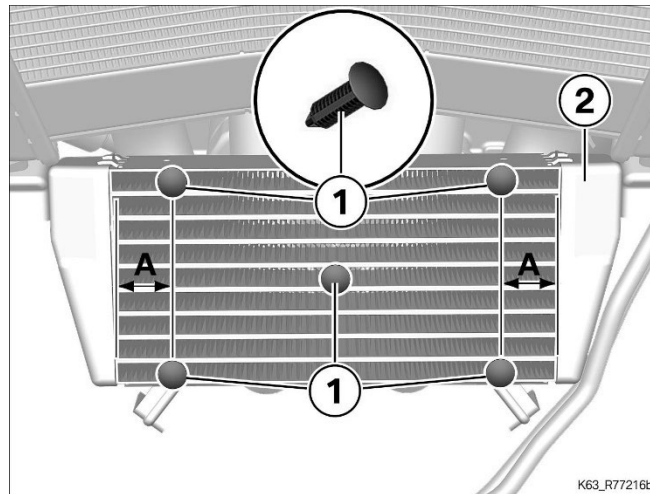
If the accessory oil cooler guard is installed, please reinstall it with five (5) spacers, part number below. Follow instructions “77 14 006 – Installing the radiator protection” in AIR, which were updated in February 2022.

Once the oil cooler guard is re-installed with spacers, please confirm that the guard is not touching the oil cooler.
