# Service Bulletin

Bulletin No.: 22-NA-012

**Subject:** Information on Stone Chip/Membrane Damage, Broken Connector and/or Sensor Retaining Tabs, and/or Paint Damage of Park Assist Sensors

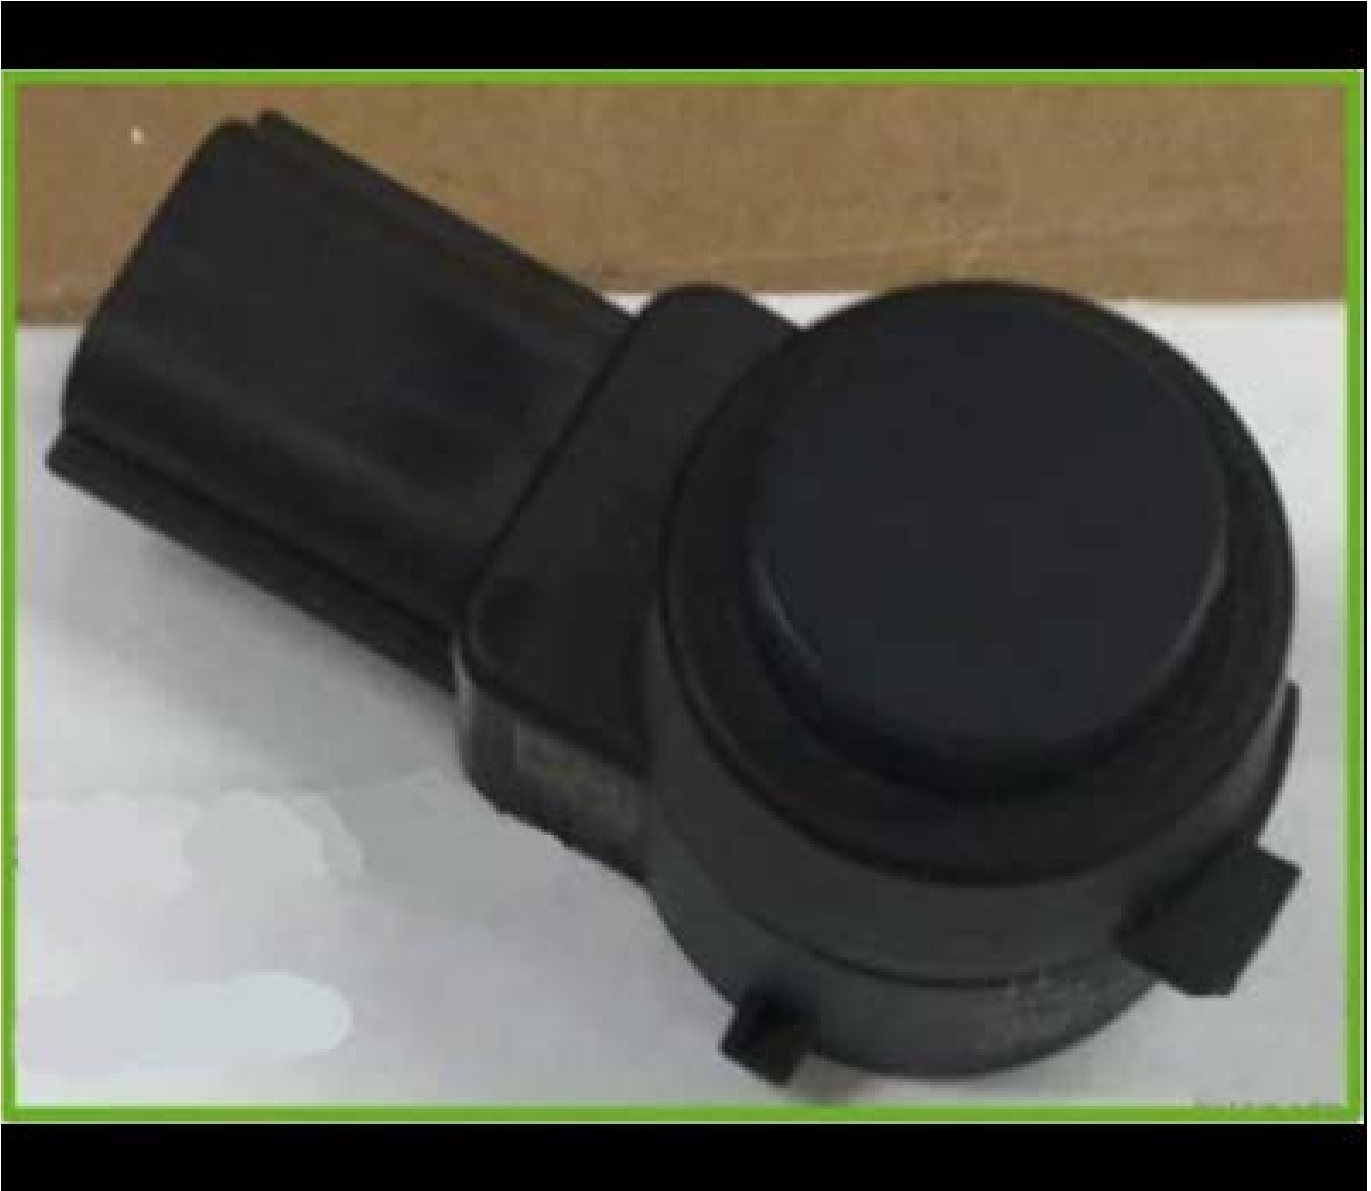
– Good sensor with no damage.

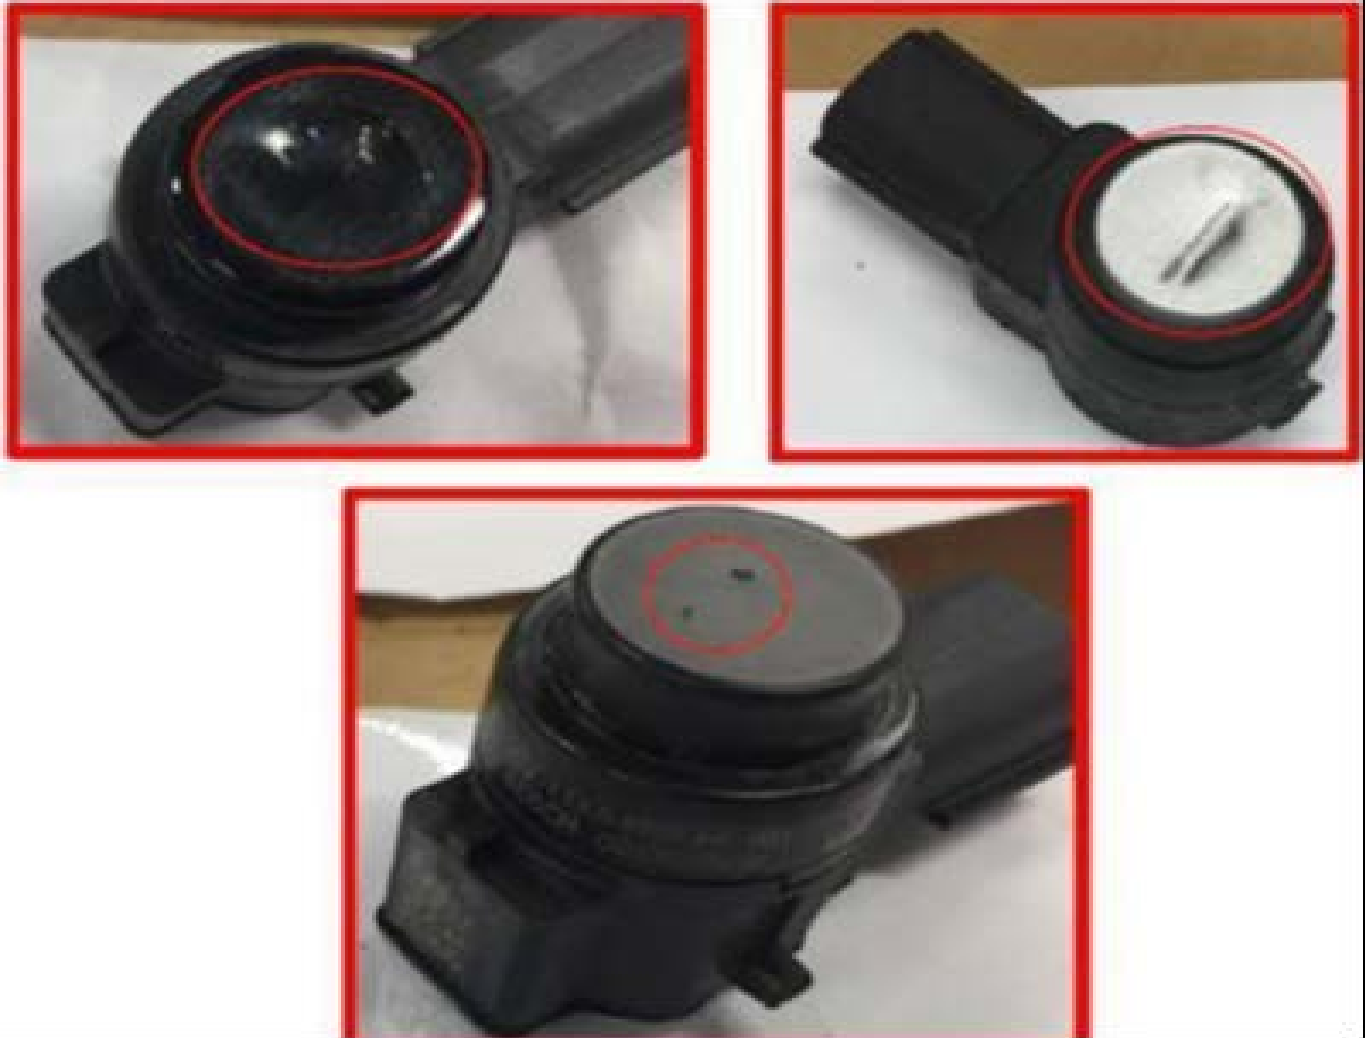
– Bad sensor with stone chip and membrane damage – not considered warrantable.

**Note:** Any sensor with visible impact damage is not considered warrantable.

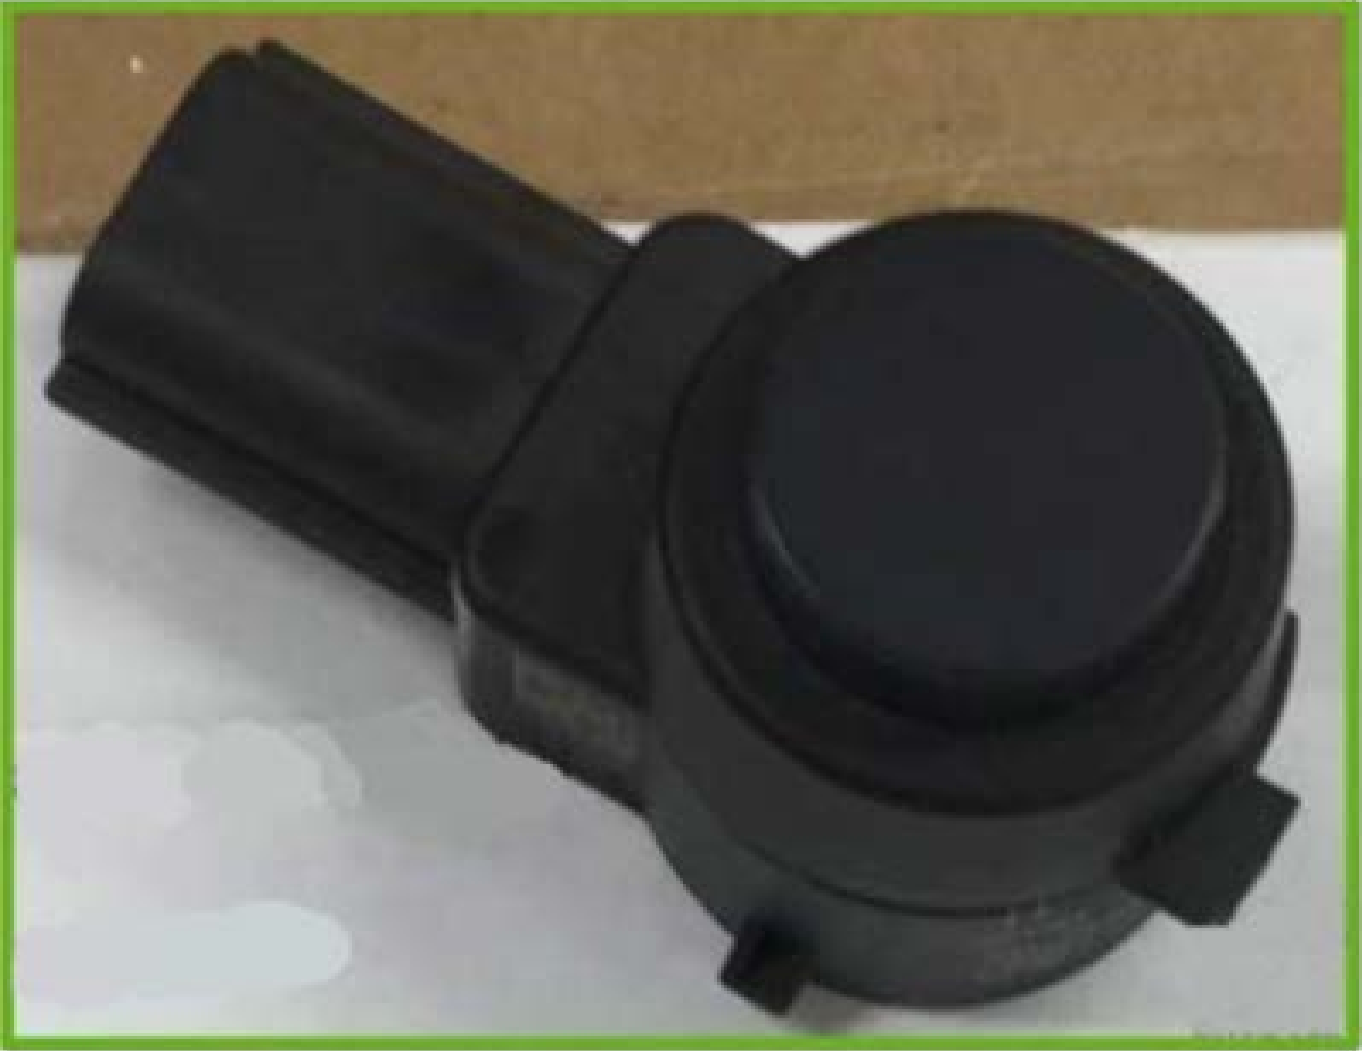
5932111

– Good sensor with no broken sensor connector.

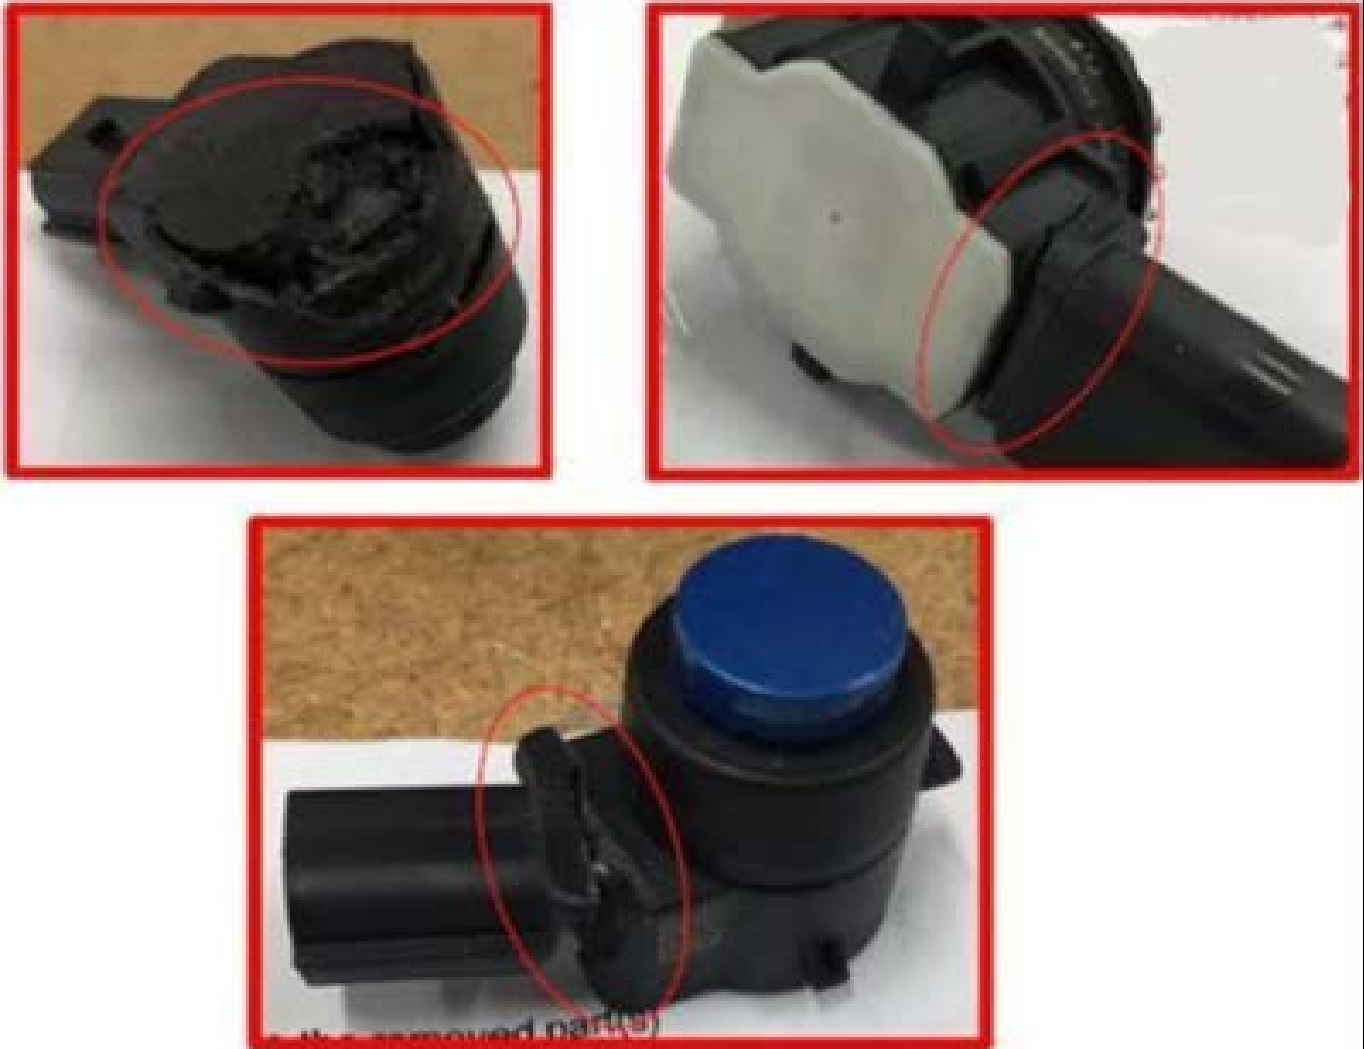
5931335

- Bad sensor with damaged connector – not considered warrantable.
- Broken Sensor Retaining Tabs

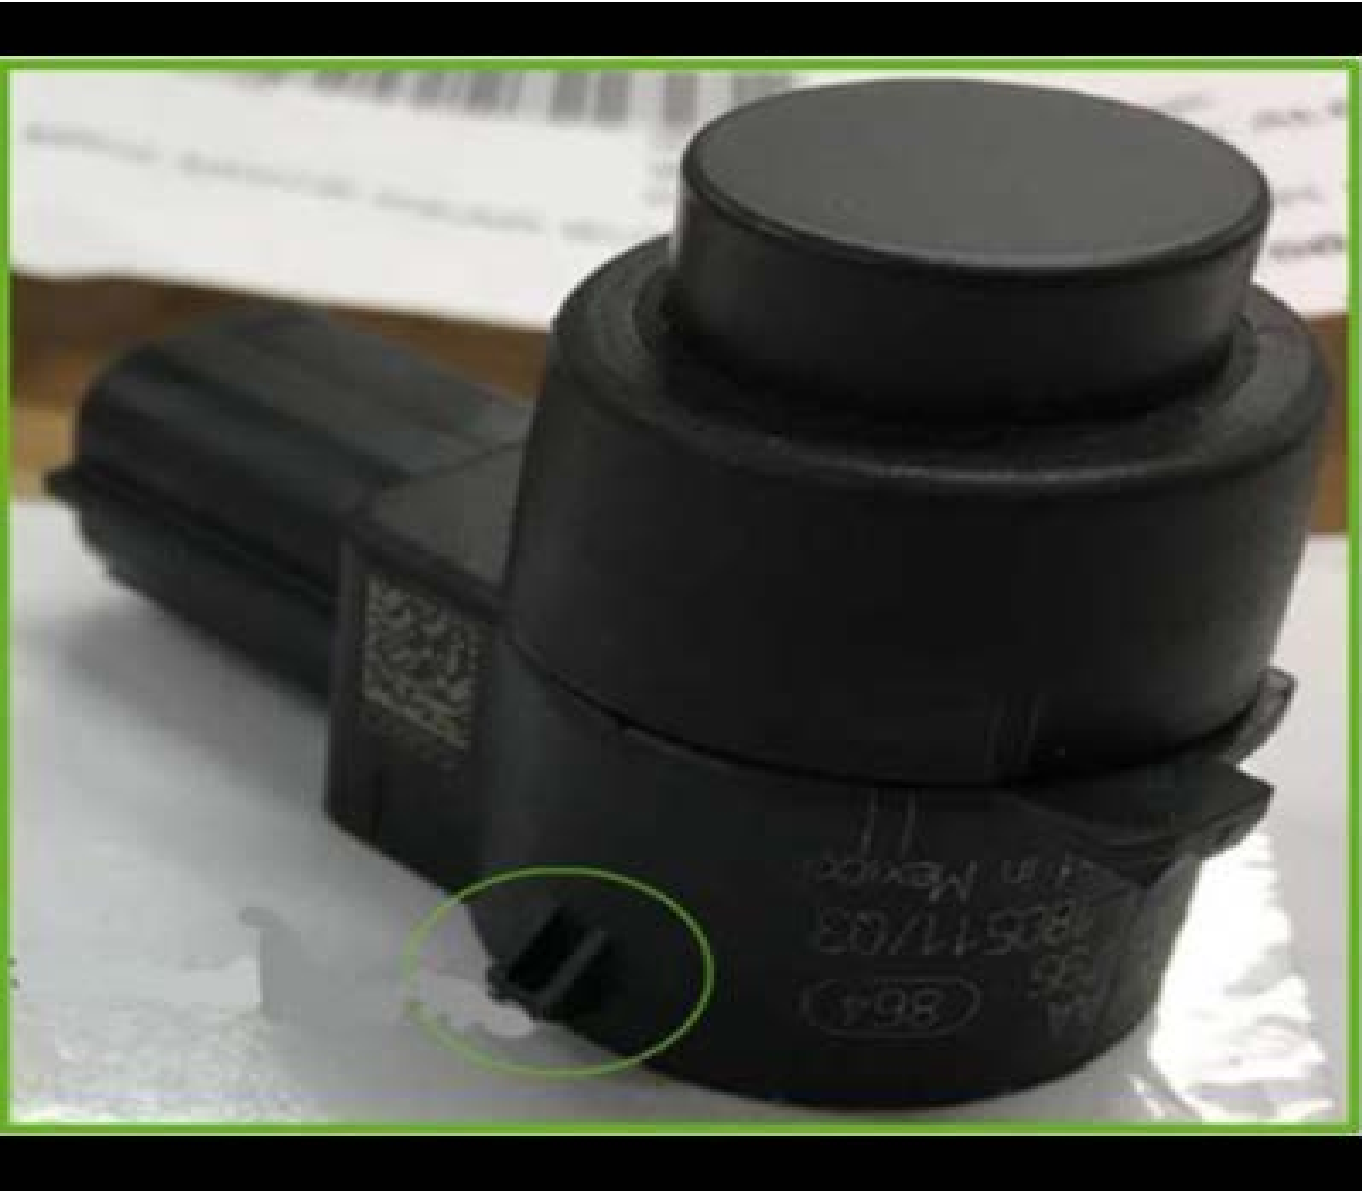
5932077

– Good sensor with no retaining tab damage.

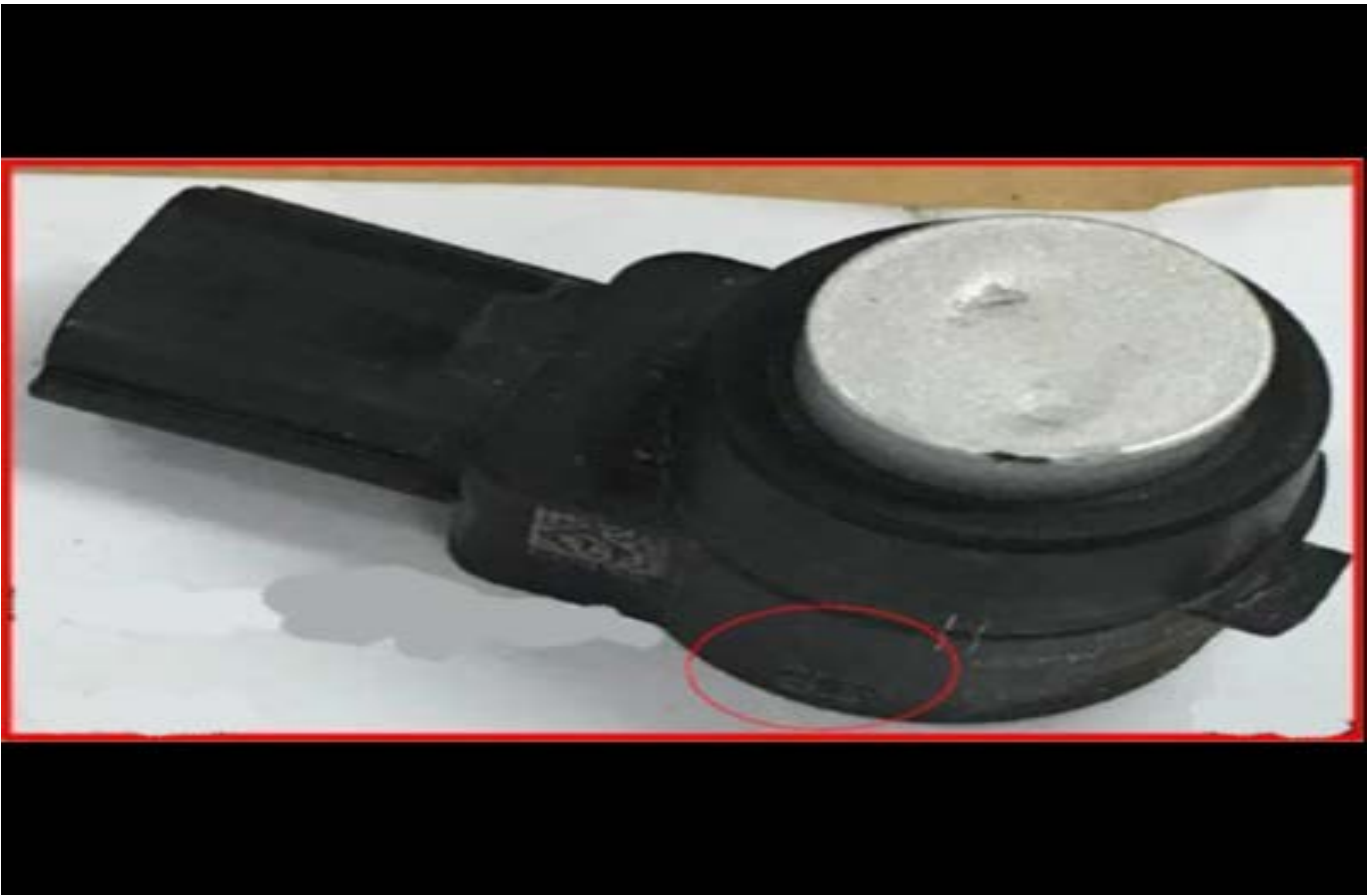
5931323

– Bad sensor with damaged retaining tabs – not considered warrantable.

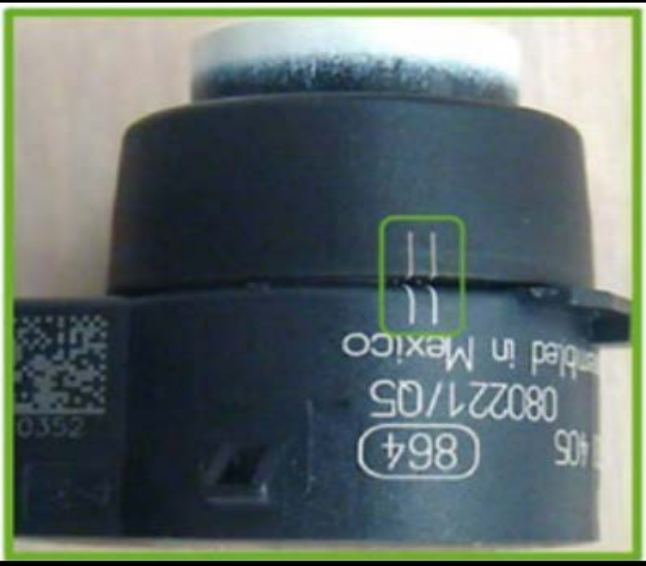
5932078

– Good sensor untwisted, double markers aligned.

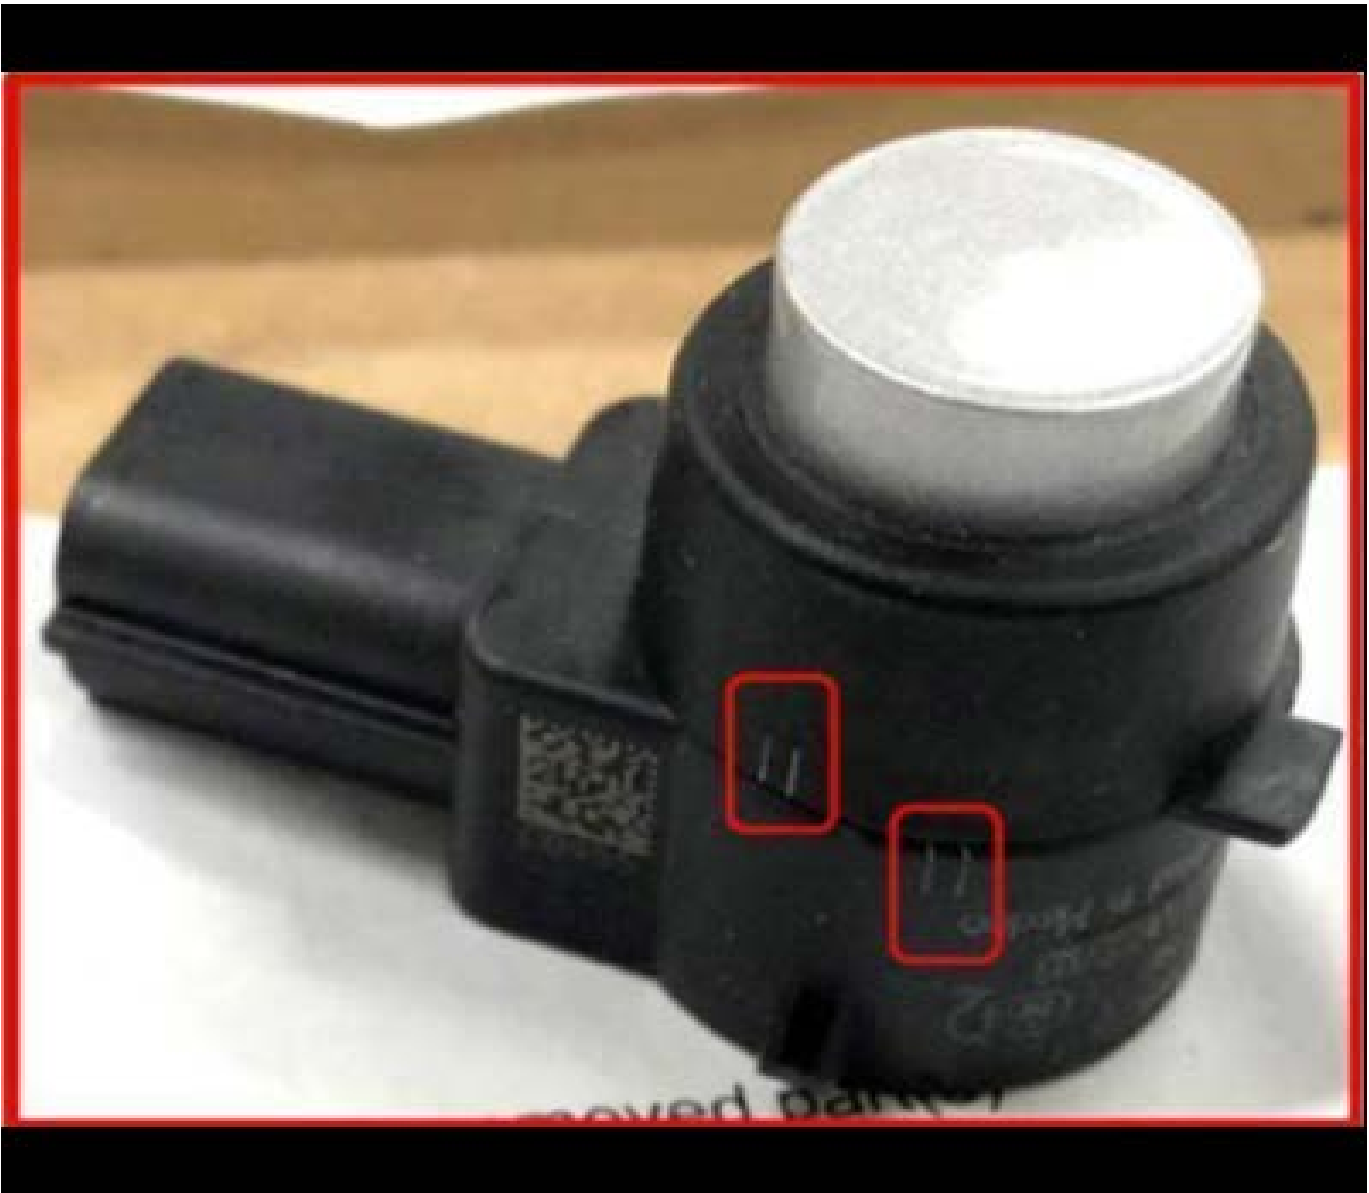
5931328

– Bad sensor twisted – not considered warrantable.

**Note:** A twisted sensor is typically caused during sensor removal if the repair procedure is not precisely followed.

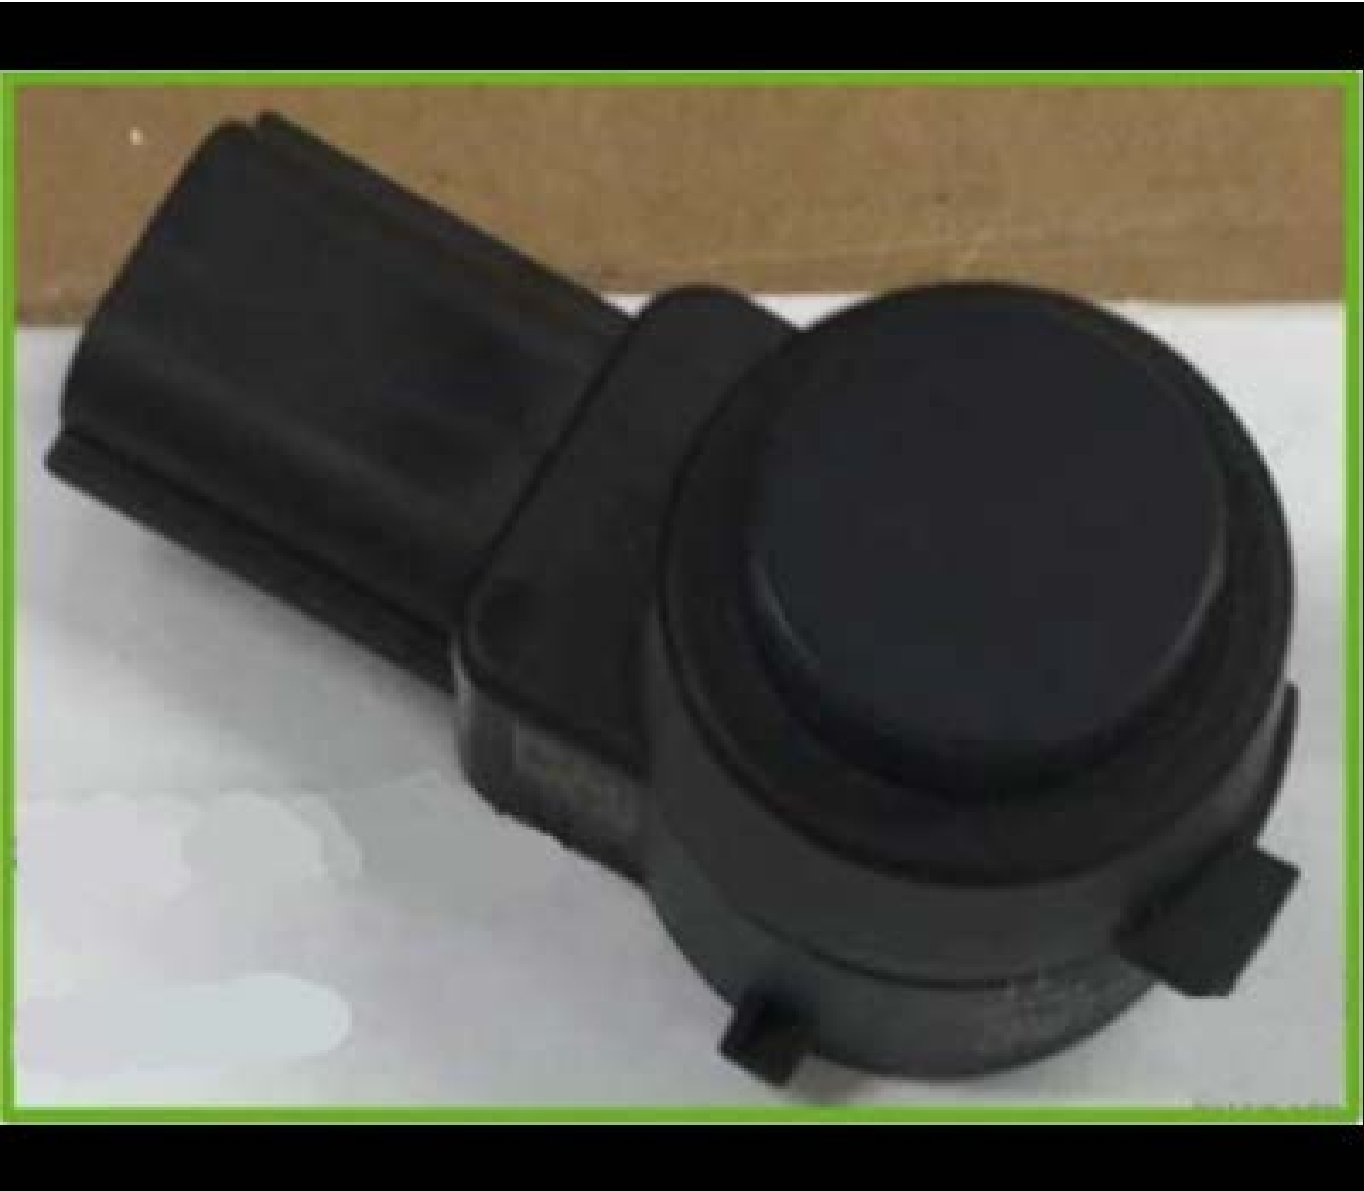
5932111

– Good sensor with correct amount of paint.

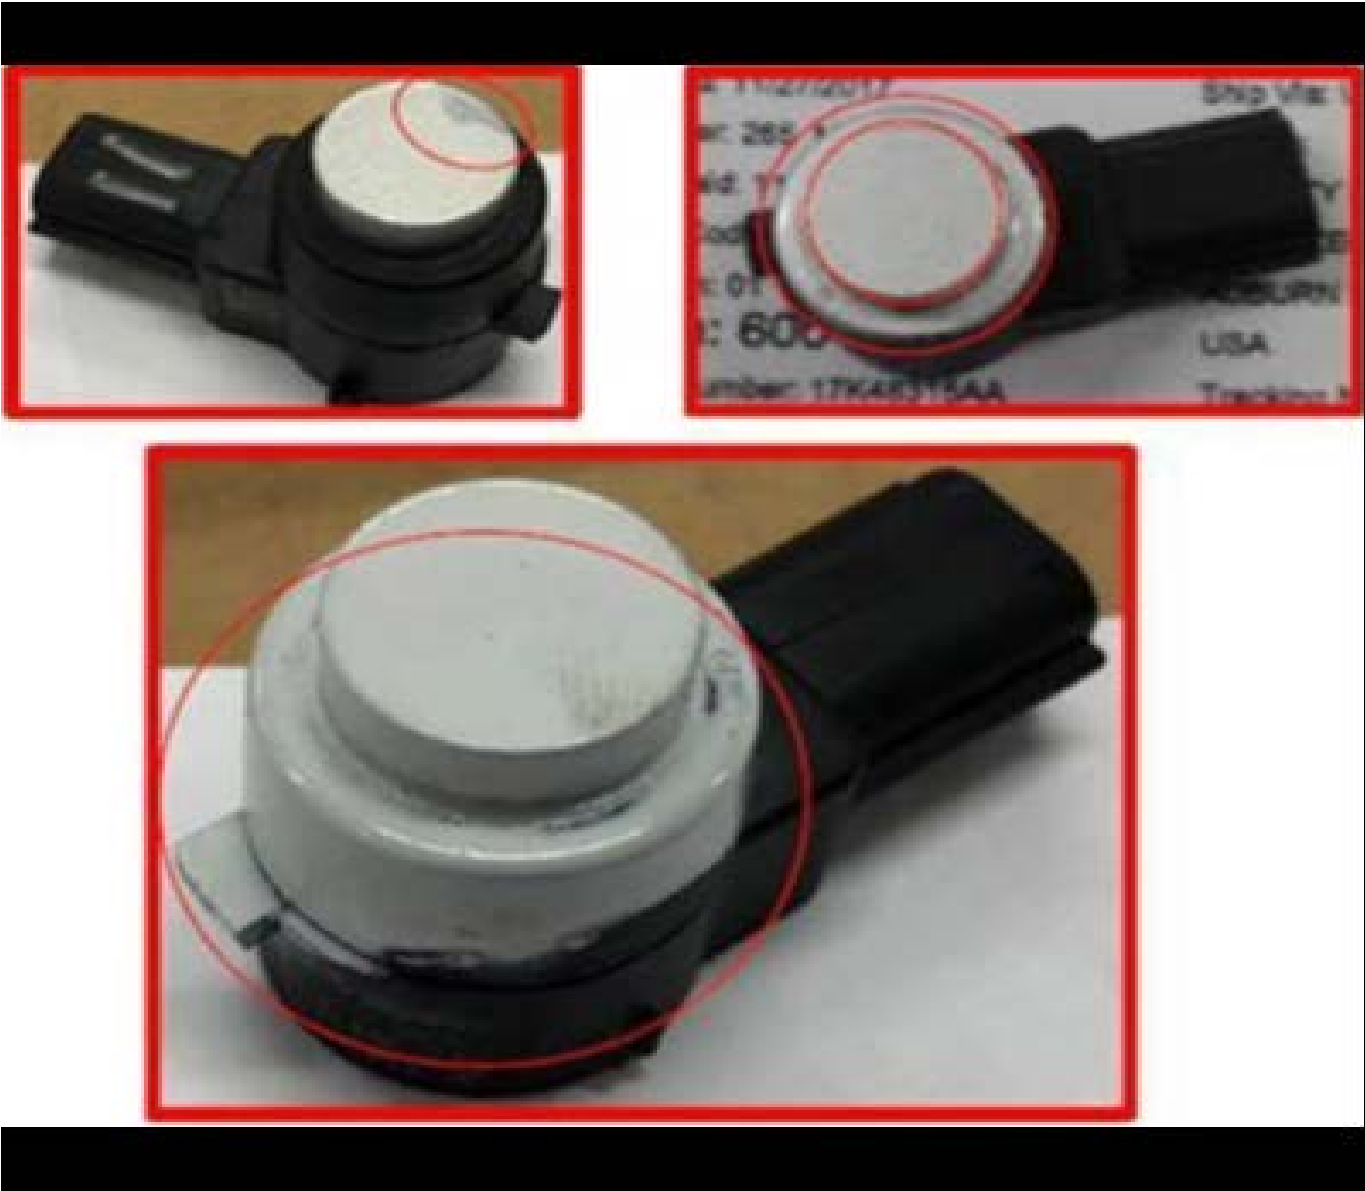
5931324

- Bad sensor with overspray, grinding, and/or re-painted incorrectly – should not be considered warrantable.
- Hardware and Software Interfaces

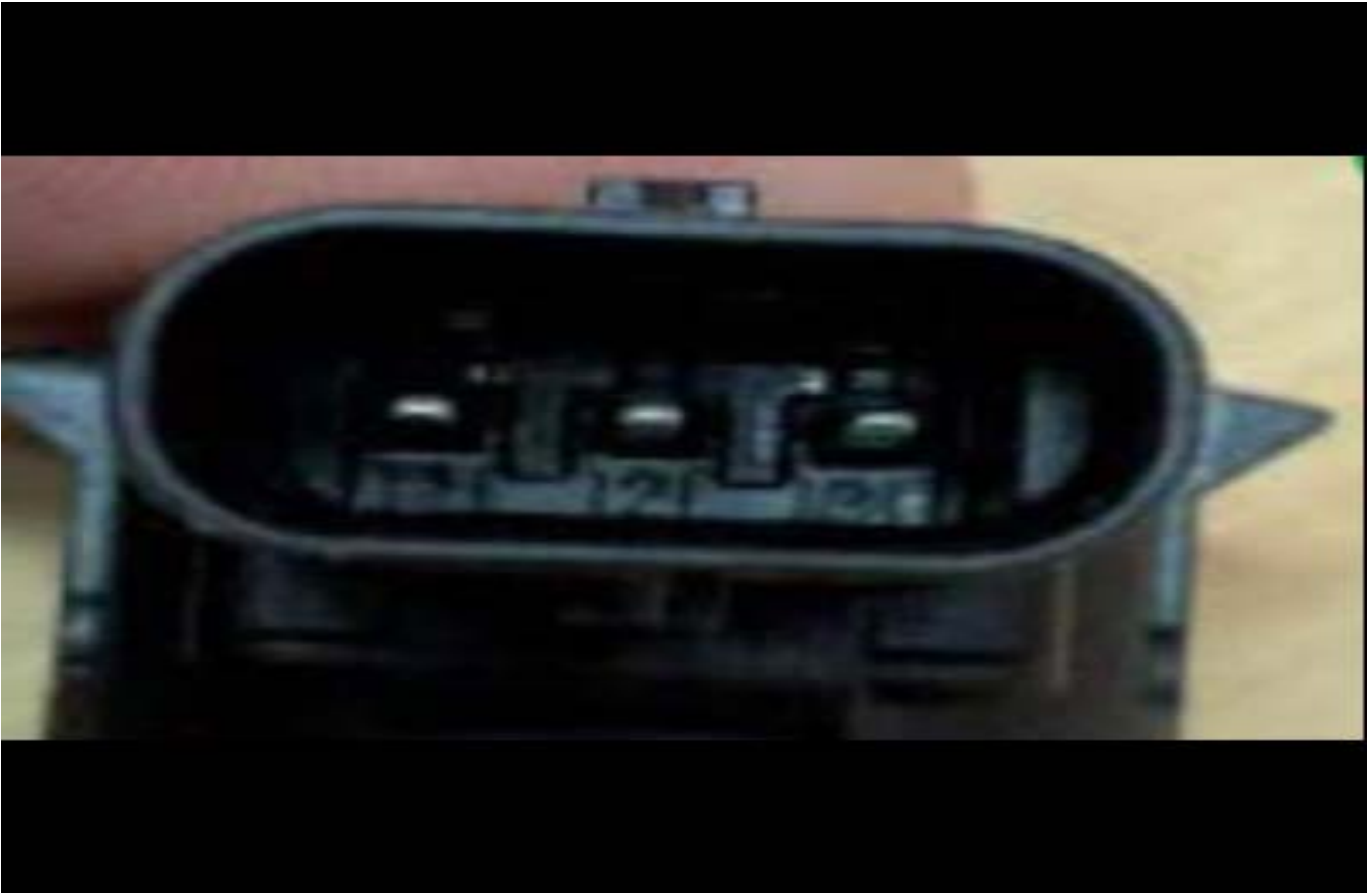
5931913

– Example of a good sensor connector with no damage by outside environment.

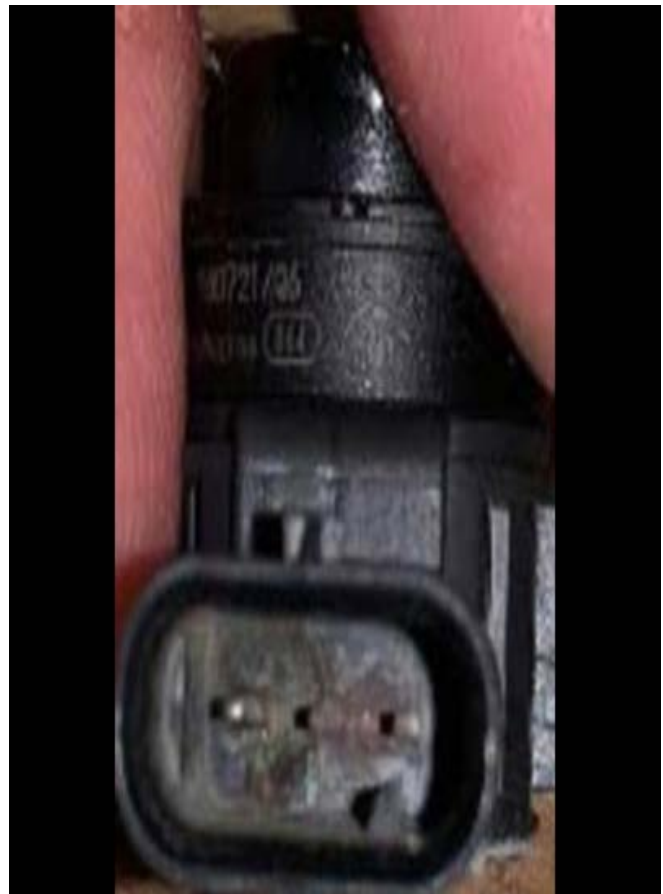
5931365

- Example of a damaged sensor connector with corrosion that should not be considered a warrantable sensor connector item.
