SIB 01 07 22

2022-04-28

Plastic Fuel Tank (B46/N26) Limited Emission Wty Ext To 15 Years/150,000 Miles

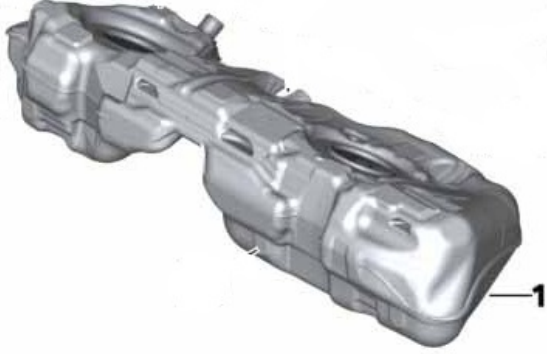
<p>For the eligible vehicles and for the issue described below, BMW of North America, LLC (BMW NA) is extending the limited emission warranty for the vehicle's <b>plastic fuel tank for leakage (item # 1, 328i Sedan N26 shown)</b> to:</p> <ul style="list-style-type: none"> <li>• <b>15 years/150,000 miles as determined by the vehicle's original in-service date.</b></li> </ul> <p>For eligible vehicles that are beyond the standard 4 year/50,000 mileage New Vehicle Limited Warranty, this extended limited emission warranty <b>does not</b> cover repairs that only address issues with the level of fuel being displayed or issues of fuel transfer/supply.</p>
---	---

The plastic fuel tank has two openings, one at the top right and the other at the top left.

The top right opening (passenger's side, serviceable) provides a mounting point and repair access to the intake fuel pump/level sensor assembly.

The top left opening (driver's side, non-serviceable) serves as an access point for the installation of the suction jet pump/level sensor assembly during the fuel tank manufacturing process. After these components are installed, the top left side opening is then permanently closed and sealed with the installation of a circular Coex biopolymer plastic cover plate which is welded into place.

Over time, the left side opening plastic cover plate weld may become damaged. Should this occur, there is the possibility of fuel leakage.

If a vehicle listed above arrives at your center with the issue described in this Service Information Bulletin, perform the corresponding diagnosis and when applicable, replace the fuel tank.
