TECHNICAL TOPICS

BODY/CHASSIS

Powered Loadspace Cover Does Not Open Correctly	22 – 23MY New Range Rover (L460)
<p><u>Customer Voice:</u></p> <ul style="list-style-type: none">– A customer may report that the powered loadspace cover does not open properly when actuated. <p><u>Technical Description:</u></p> <ul style="list-style-type: none">– The loadspace cover may not initiate the fold properly due to incorrect hinge break point angle. <p><u>Status:</u></p> <ul style="list-style-type: none">– Engineering is currently investigating this concern.– SSM 75746 has been published to provide an interim solution to the concern.

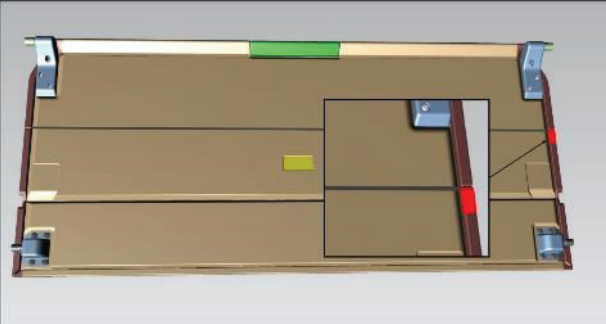
A technical cutaway diagram of the loadspace cover mechanism. It shows the cover in a partially open position, with various hinges, actuators, and structural components labeled with different colors (blue, green, yellow, red) to indicate specific parts of the assembly.
