Creaking Noise When Load Applied To Front Seat Cushion

Topic number	LI91.10-P-065540
Version	2
Function group	91.10 - Front seats
Date	5/26/22
Validity	BR217, BR223
Reason for change	Model series added to

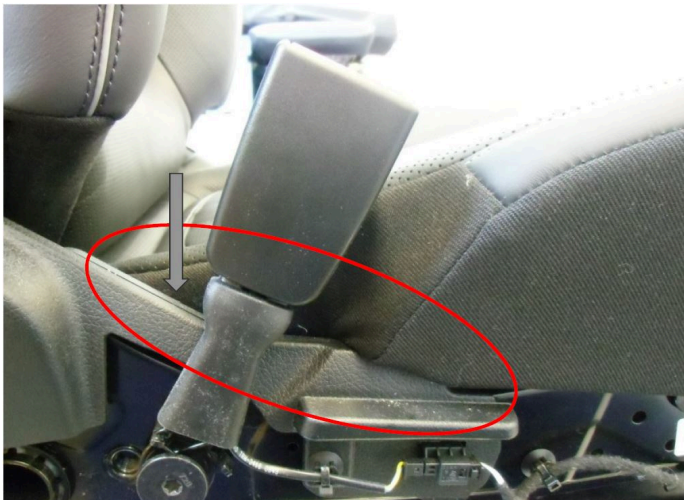
Soiling to the replacement fabric of the seat cushion cover means that friction on the seat side finisher mountings generates a creaking noise.

File	Description
1.JPG	Pic 1. Fabric cover generates friction on an seat side finisher mounting

1. Clean fabric cover and seat side finisher in marked area (Pic. 1)
2. Apply lubricant A 000 989 35 60 in area of inner plastic cover (reinforcement for cover at inner side of front seat - do not apply directly onto outer cover).
