9YA – Electric Parking Brake Warning in the Instrument Cluster

Models	Model Year	Model Type	VIN Range	Vehicle-Specific Equipment
Cayenne	2019 - 2021	9YA	n/a	All
Cayenne Coupe	2019 - 2021	9YB	n/a	All

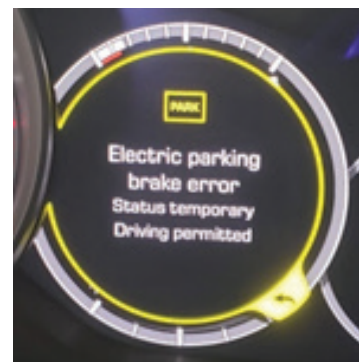
The customer complains of a yellow warning in the instrument cluster, stating that the electric parking brake is faulty.

Figure 1: Yellow Warning in Instrument Cluster

1. If the aforementioned fault codes exist, please verify the integrity the plug connections and all wiring for the parking brake motors.
2. If no faults are found with the wiring and plug connections of the parking brake motors, please replace both of the following parts:
 - 9A790761600 – Electric motor
 - 9Y0614508PY – PSM control unit (Hydraulic unit)
3. Check the part numbers of the faulty parts. If the faulty part numbers are **9A790761500** (Electric motor, right) or **9A790761600** (Electric motor, left), and **9Y0614508HY** (PSM control unit), please contact Ben Leimkuehler with PCNA Quality Engineering at ben.leimkuehler@porsche.us. These parts are currently desired for analysis to support the ongoing investigation mentioned earlier in the Technical Background section. Please use the subject “E3 Parking Brake Faults – Parts for Analysis” in your email.
