<b>Subject:</b>  RATTLE FROM SUNROOF AREA	<b>Service Alert No.:</b> SA-032/22
	<b>Last Issued :</b> 05/11/2022

2023 CX-50

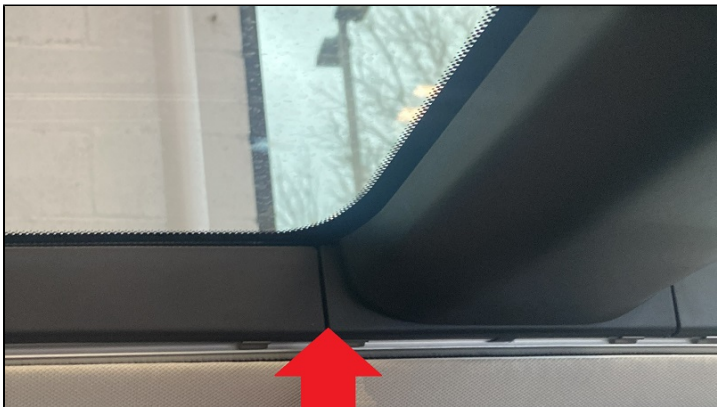
The noise comes from the side cover vibrating against the assembly at the location marked by the arrow due to poor retention of the cover clips.

1. Test drive the vehicle and if you hear the noise, press the area at the red arrow on both sides of the vehicle.

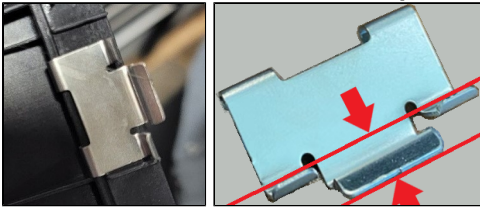
2. Remove the side covers from the sides of the sunroof assembly.
3. Bend the mount clips as shown below. If needed, remove them from the covers.

**CAUTION: DO NOT bend the clips too far or they will break.**

4. Reinstall the trim and retest for the rattle noise.

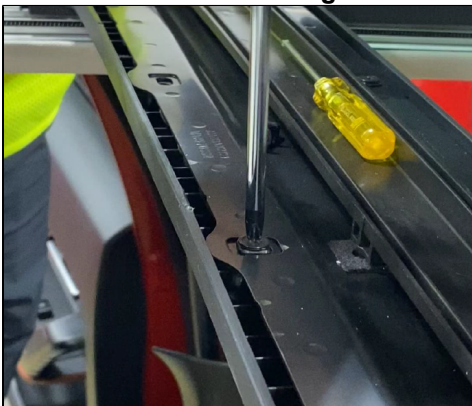
The noise comes from the cross brace cover after the vehicle has been driven and the clips loosen. Follow the instructions below to eliminate the noise.

3. Remove the pushpins and then remove the trim.

**CAUTION: DO NOT damage the trim as it is only available with the sunroof assembly.**
