# ***SERVICE PROCEDURE***

**22507  
MAY, 2022**

**SUBJECT: SAFETY RECALL**  
**Power Inverter Cables on certain International® LT® Series trucks built 10 February 2017 thru 25 February 2022 with a power inverter installed by Navistar's Truck Specialty Center**

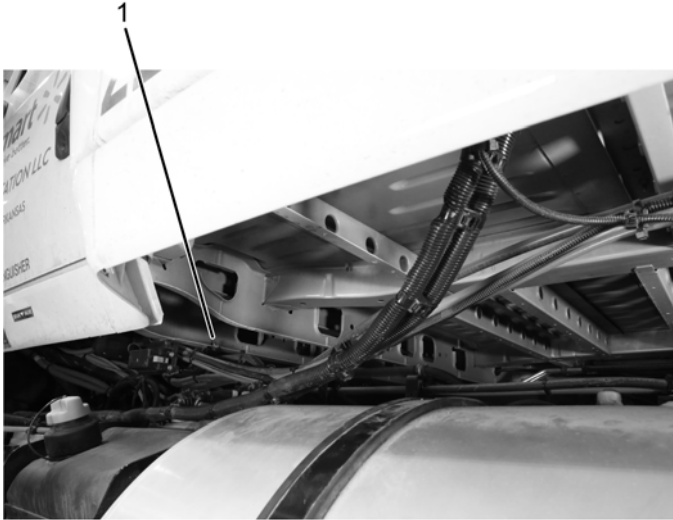
**Figure 2. Inverter Cable Crossmember Inspection**

1. Inverter cable

**NOTE: Harness depicted in Figure 2 shown unattached for clarity.**

**NOTE: Inspect entire length of inverter harness for signs of chafing or rubbing.**

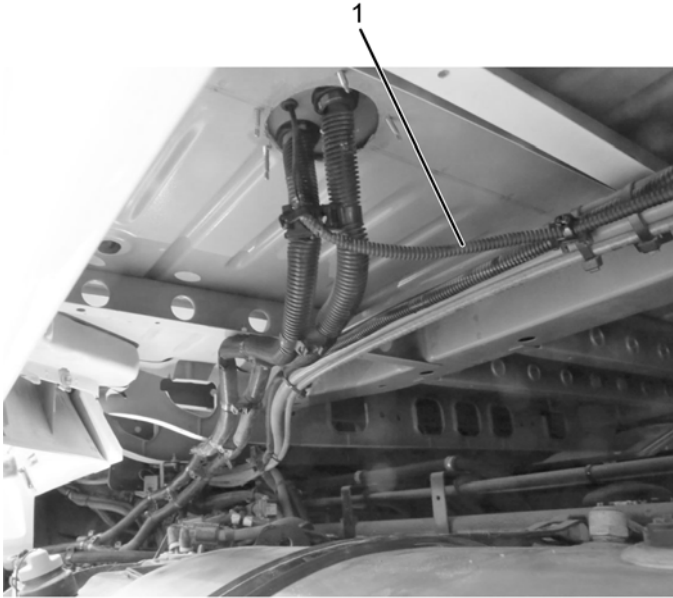
**Figure 3. Inverter Ground Strap**

1. Ground strap

9. Using side cutters, remove and discard cable ties securing inverter ground strap (Figure 3, Item 1).
10. Disconnect positive and negative inverter harnesses at vehicle batteries.
11. Using side cutters, remove and discard cable ties securing inverter harnesses at existing air lines / vehicle harnesses.

23. Using torque wrench, install bolt securing inverter assembly ground strap to frame (Figure 3, Item 1). Tighten bolt to 31 lb-ft (42 N•m).
24. Apply RED sealant paint and thoroughly coat frame bolt, bolt threads, nut, inverter assembly ground strap terminal ring, and frame.

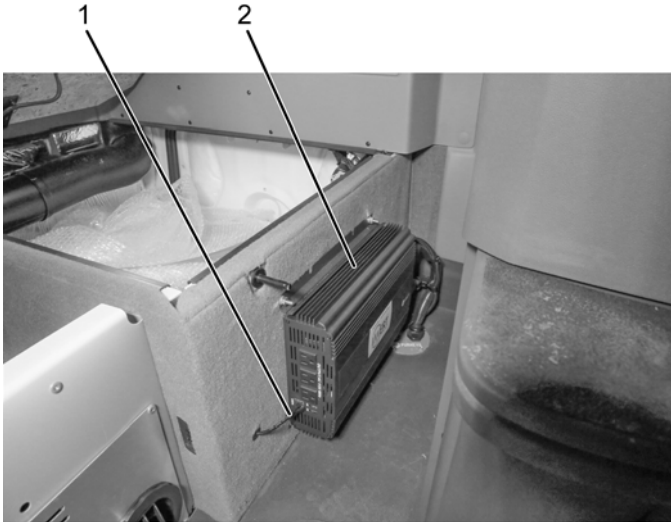
**Figure 5. Inverter**

- 1. Remote cable
- 2. Inverter assembly

- 13. Working from vehicle interior, reposition lower bunk mattress.
- 14. Lift and secure lower bunk to access inverter assembly (Figure 5, Item 2).
- 15. Unplug remote cable (Figure 5, Item 1) and any accessories from inverter.
- 16. Remove four fasteners securing inverter and reposition. Save fasteners for reuse.

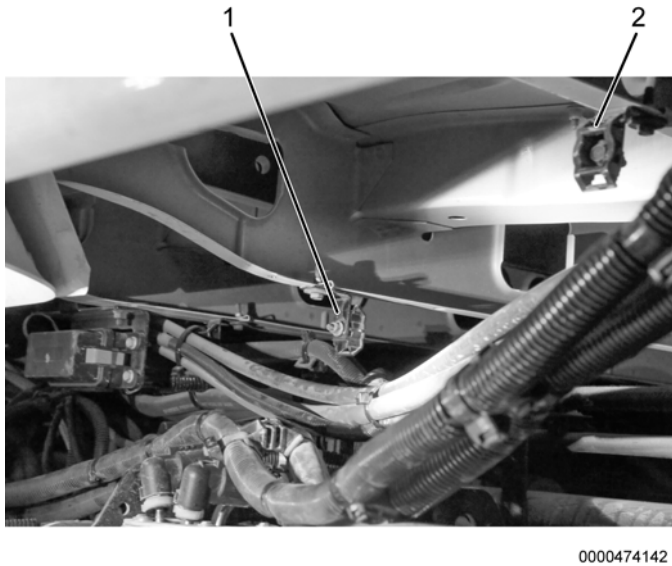
**Figure 7. Swivel Saddle Bracket Assemblies**

1. Bracket above DEF tank
2. Bracket above fuel tank

**NOTE: Brackets depicted in Figure 8 are located on driver-side sleeper cab crossmembers above DEF tank and fuel tank.**

26. Using sidecutters, remove and discard cable ties securing air lines and vehicle harnesses at saddle lock brackets (Figure 7, Items 1 & 2) located on sleeper floor crossmember.
27. Remove and discard swivel saddle bracket assemblies and speed nut / retaining clip. Using a paint pen or equivalent, mark and record existing hole locations on crossmember for installation of clip extension supplied with kit.
