### **Service Bulletin**

Bulletin No.: 22-NA-106

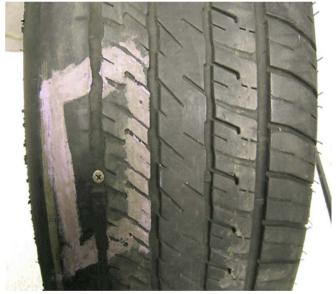
Tires replaced under warranty for non-warrantable conditions are subject to charge back. Inspection of tires replaced under warranty reveals that the most frequent non-warrantable condition claimed is road hazard, followed by improper wear. The following are photos of actual returned tires that DO NOT have warrantable conditions and a subsequent chargeback (debit) was processed after inspection.

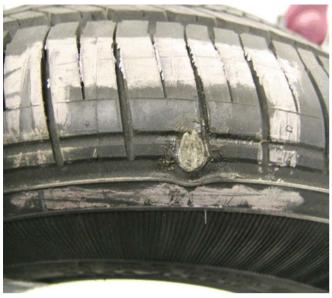
Page 4 May, 2022 Bulletin No.: 22-NA-106

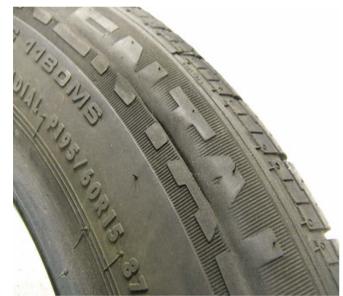
This tire was returned for air leakage. The source of the air leakage is a tire plug installed in a non-approved portion of the tire. This tire has been damaged by a road hazard and does NOT exhibit a warrantable condition .

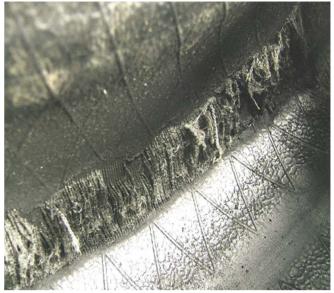
The above tire shows sidewall wear extending completely around the tire. This damage is the result of extended driving on a tire that is completely flat. The extensive sidewall wear is from contact with the road at that point. Minor indents on the sidewall of the tire are caused from the manufacturing splices in the tire. They are normal and do not negatively impact the performance of the tire. Refer to the latest version of PIT4261 for further details.

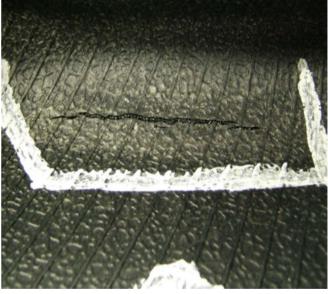
This tire was damaged by extended driving with little or no air, just as the tire above it was. This photo shows the inside view. Shredding of the inside may not always be accompanied by obvious exterior damage.

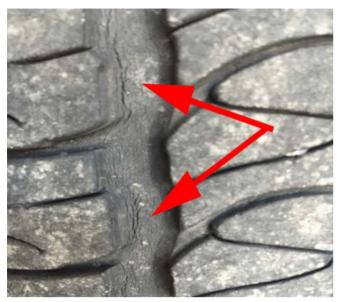
This final example of common road damage is called a "rim-pinch". The air leak is caused by the tire folding and contacting the rim. Frequently this type of damage will cause a sidewall bulge when the tire is inflated, due to internal cord breakage. It is common for this type of damage to only be visible from the inside of the tire. The pictured tire is properly marked and shows a typical tear in the cord.

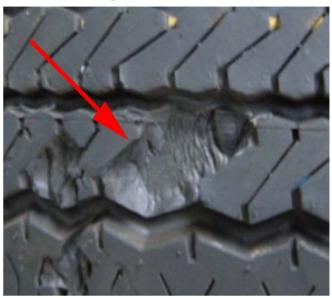
### **Tire Chunking on New Vehicles**
