## Active Noise Cancellation (ANC) Booms/Rumbles

### AFFECTED VEHICLES

Year	Model	Trim	VIN Range
2018–20	Accord (Except Hybrid)	ALL	ALL
2019–22	Insight	ALL	ALL

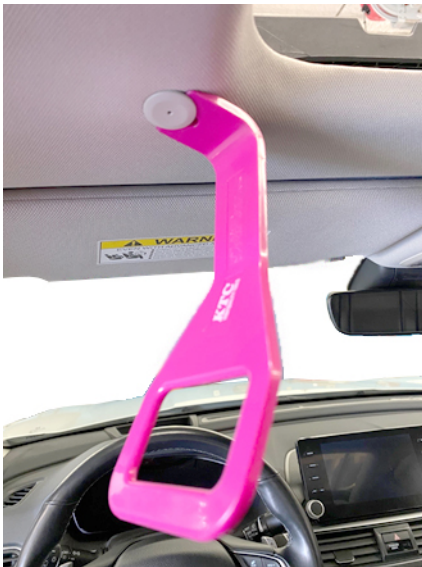
1. *Accord only:* Using the appropriate trim tool, gently slide it behind the **front** ANC microphone cover making sure not to damage the headliner, and pull down to release the cover.

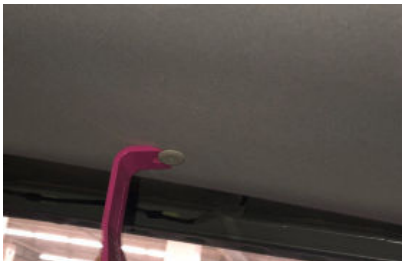
2. *Accord and Insight:* Using the appropriate trim tool, gently slide it behind the **rear** ANC microphone cover making sure not to damage the headliner, and pull down to release the cover.

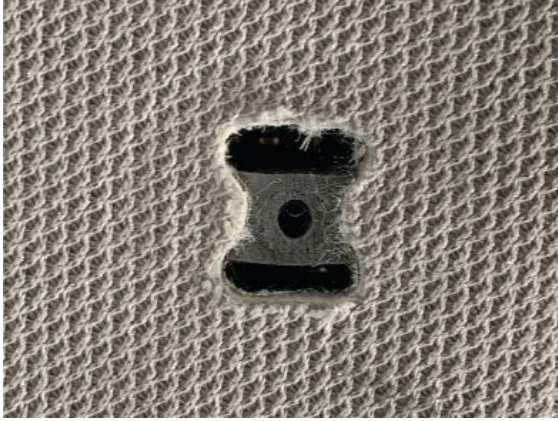
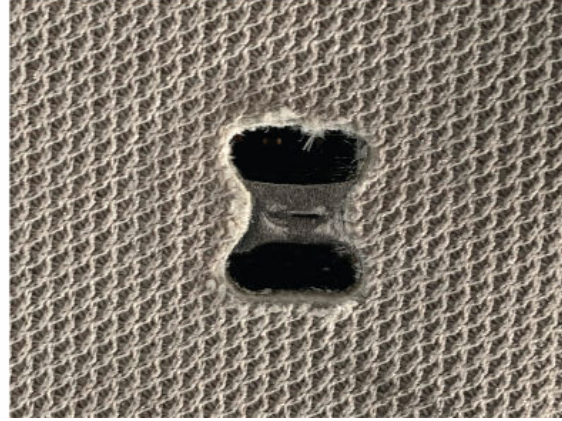
3. Inspect the ANC microphone(s) insulating foam through the opening in the headliner and verify if the foam is damaged or folded over.
- If the ANC microphone(s) insulating foam is damaged or folded over go to the REPAIR PROCEDURE and replace the ANC microphone(s).
  - If the ANC microphone(s) insulating foam is NOT damaged or folded over, continue with normal troubleshooting.
