Mack Chassis - Front Hub With Unit-Bearings (Unitized Wheel Bearings), Inspection Information And Guidelines - Model Year 2008 And Newer

Wheel Bearings, Check

Front Hub with Unit-Bearings

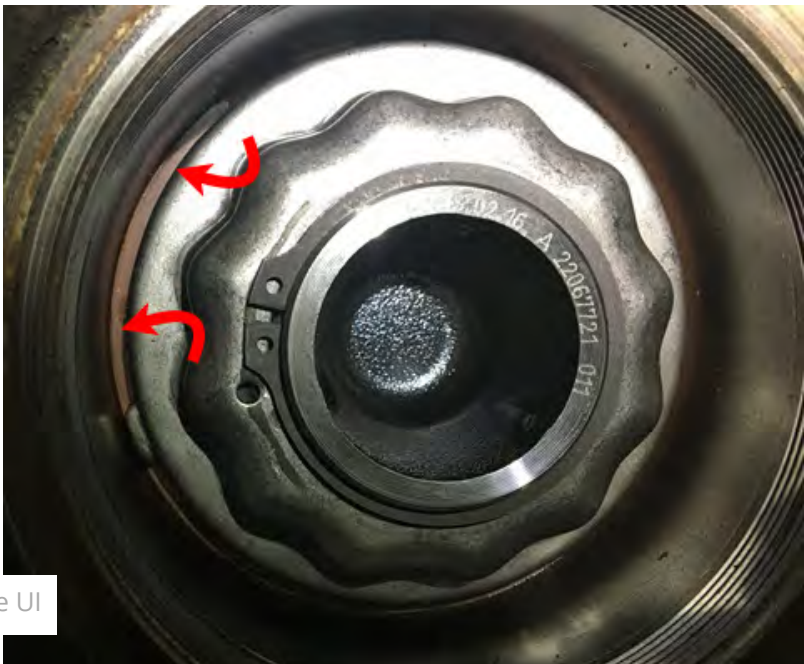
A. Reusable Bearing

Note that the o-ring does not show signs of grease or leaks.

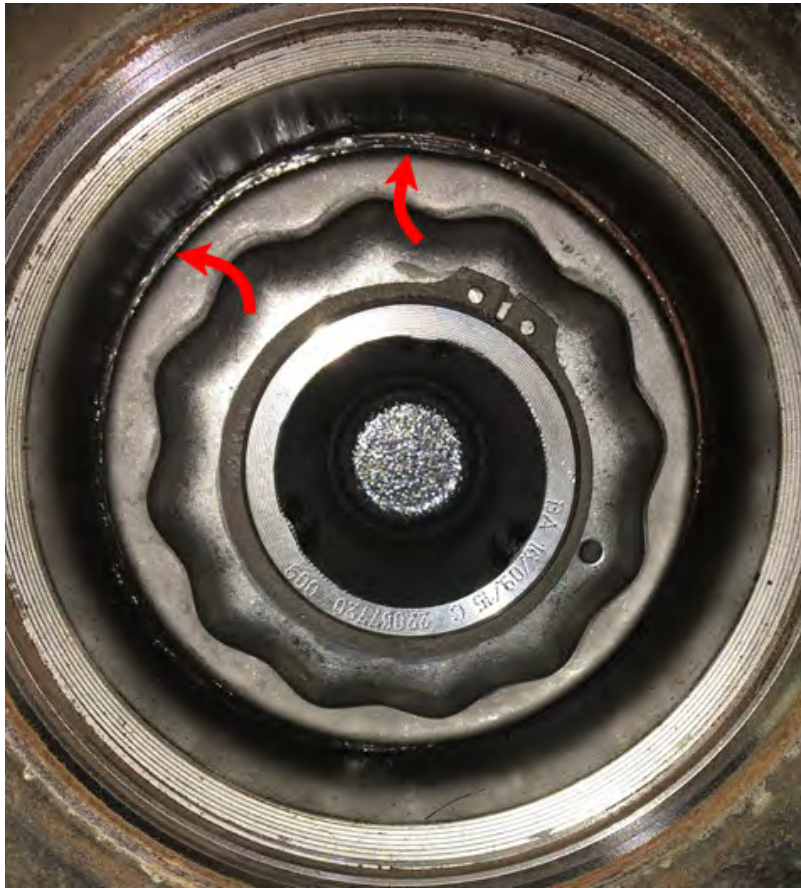
B. Bearing Requiring Replacement

Presence of grease around the o-ring indicates a leaking bearing

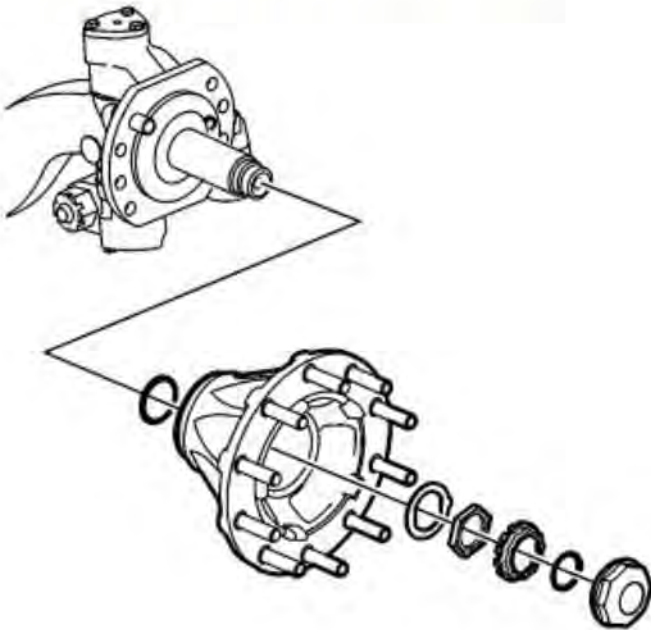
Note: The Unit-bearing is grease lubricated at the factory and does not need re-lubricating.

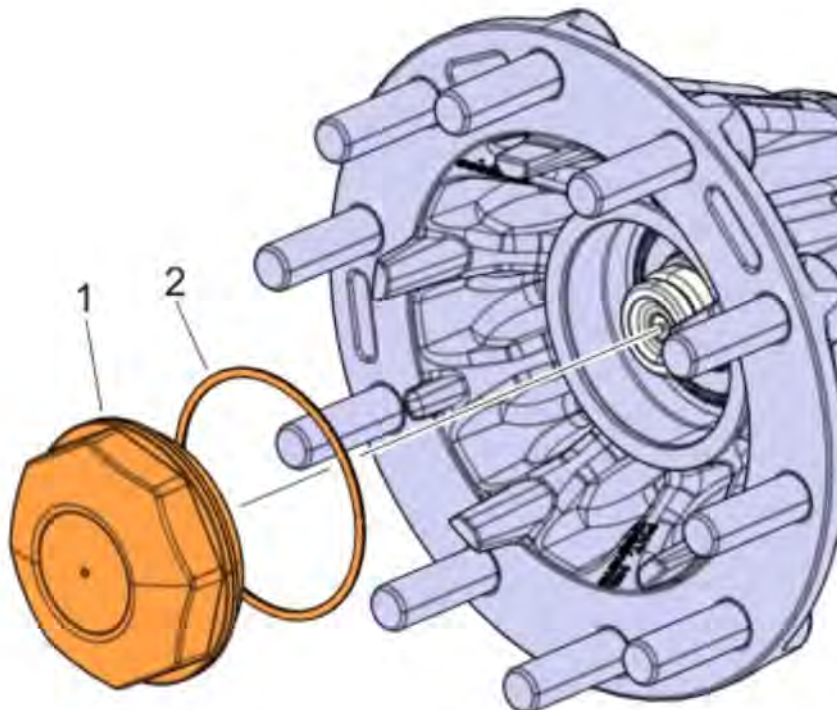
1. Remove the hub caps with hand tools.

Note: Using power tools could damage the cap.

2. Inspect O-ring for moisture / contaminant intrusion witness marks.

Note: Always use a new O-ring when installing the cap.

Note: Replace cap and O-ring if evidence of contaminant intrusion is seen.

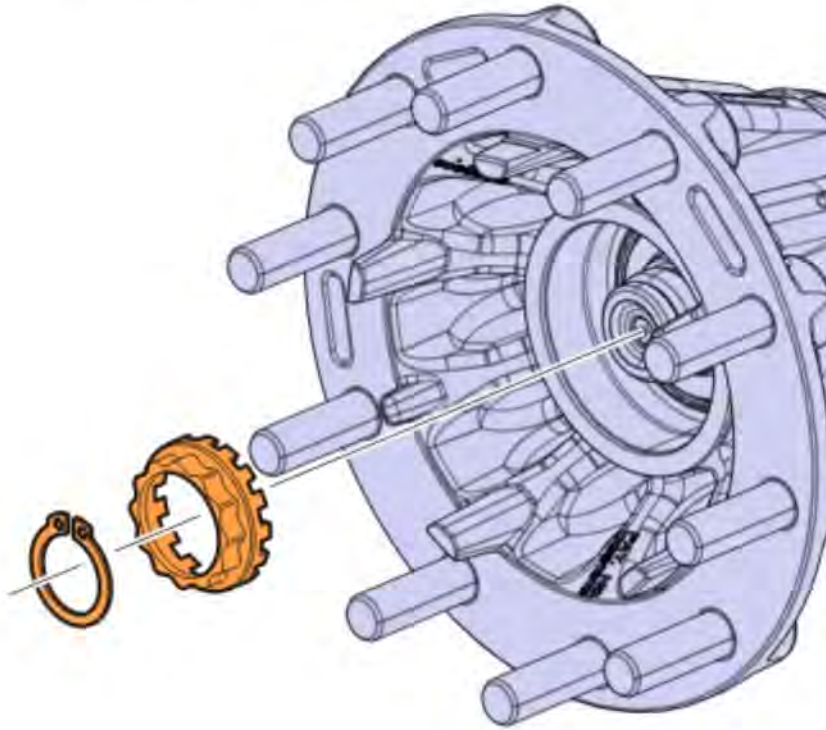
3. Remove the snap ring and retainer.

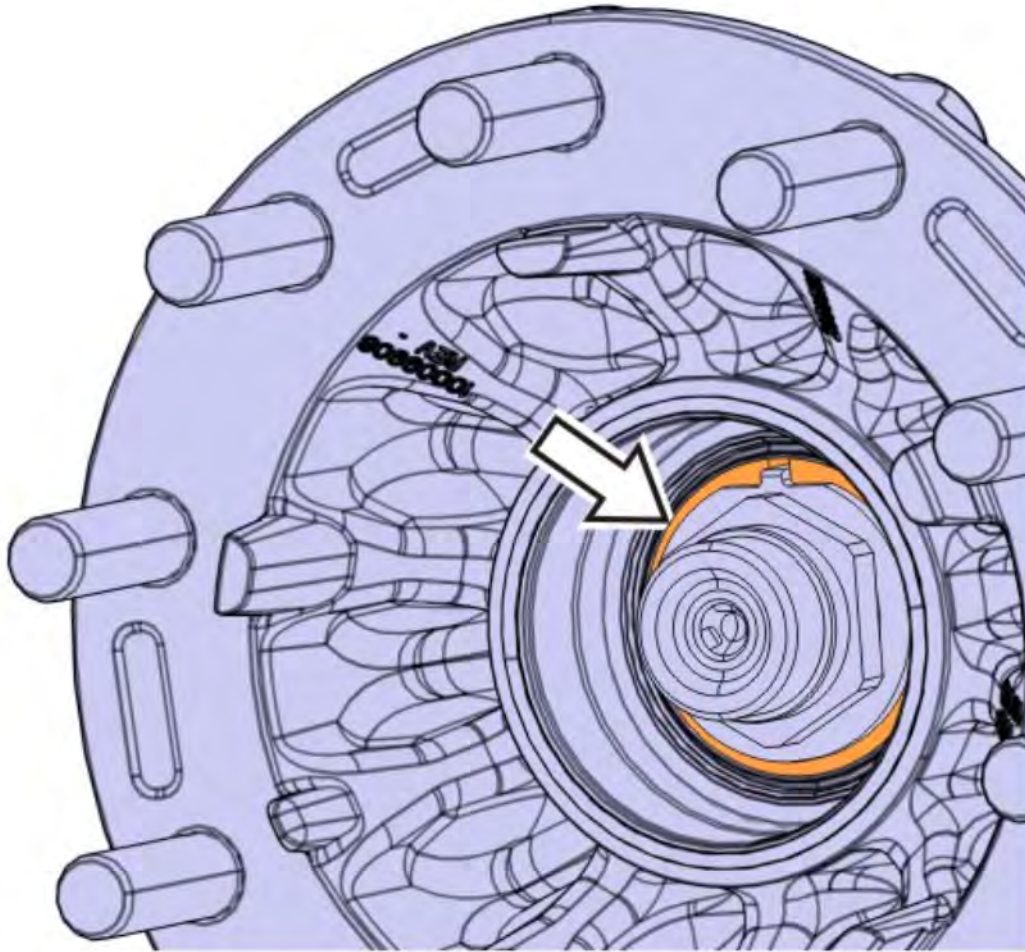
4. Inspect hub barrel for evidence of grease.

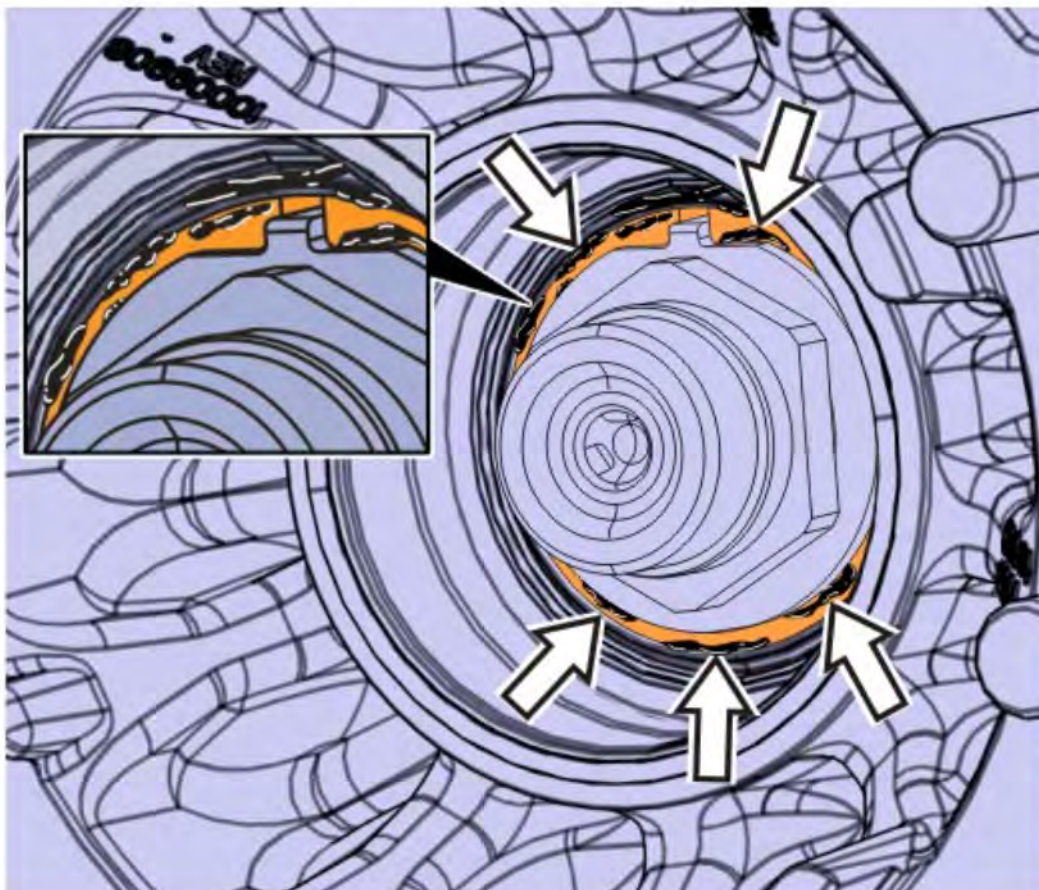
5. If grease is found, replace the bearing.

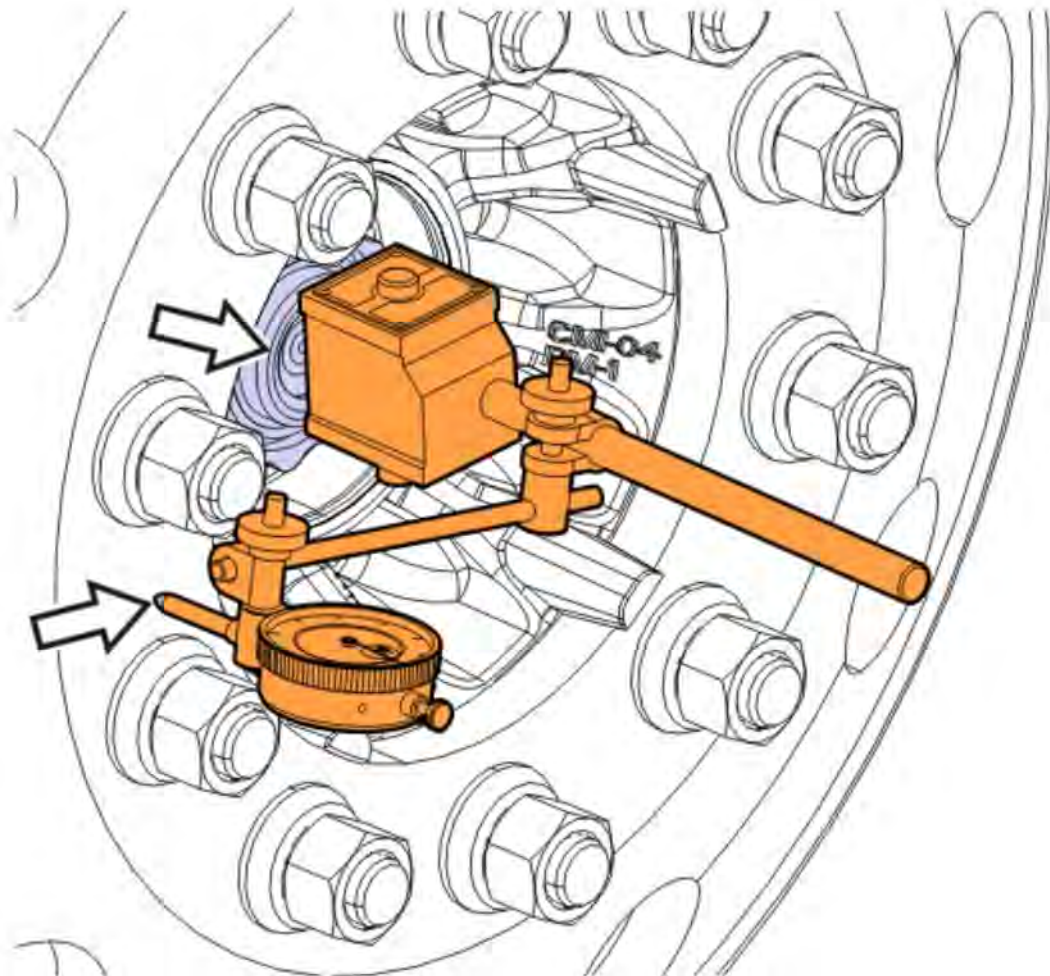
8. Check the play on the front wheel bearings by using a bar as a lever to lift and a dial indicator. The bearings should normally be pre-tensioned and there should not be any play in the bearings. Do not confuse play in the wheel bearings with play in the king pin bearings.

Note: If there is play in the bearing, the bearing should be replaced.

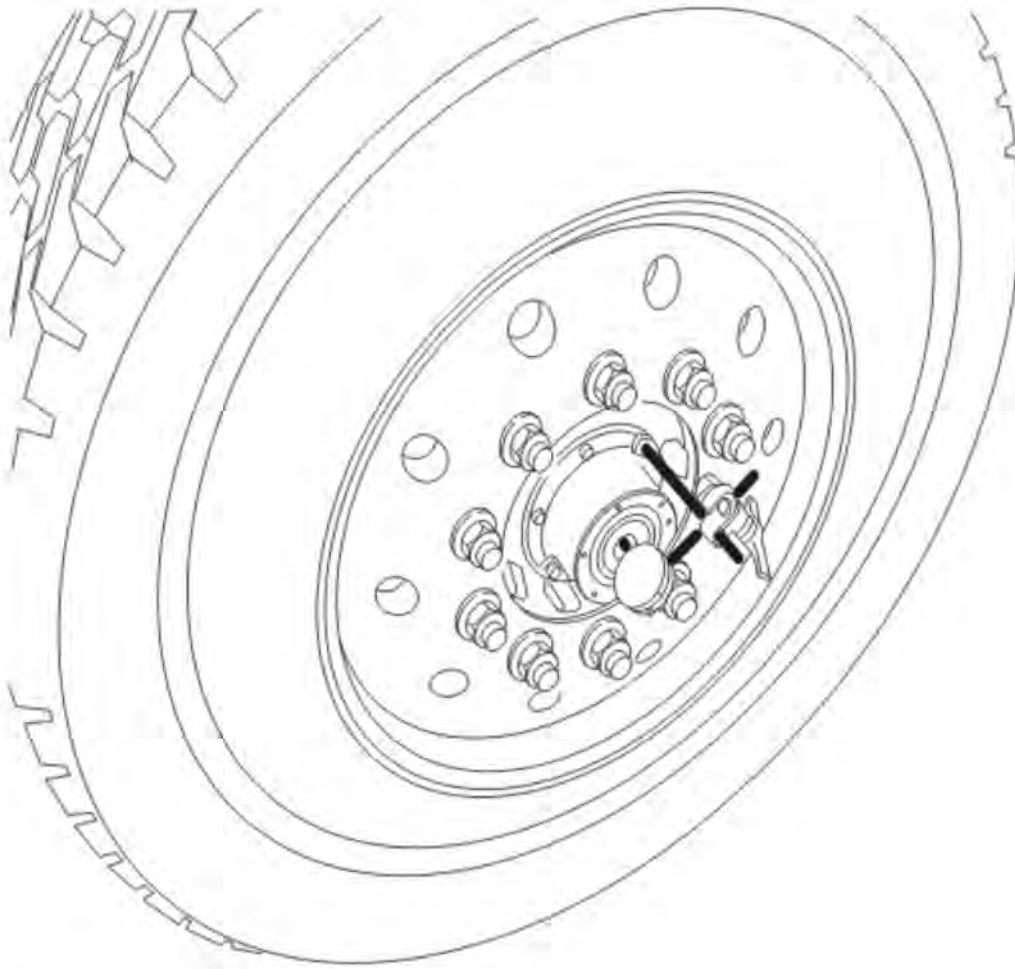
Front Hub with Adjustable Bearings

Check the front wheel bearings with a wheel spinner and listen to the bearings during the rotation. If there is an abnormal sound in the bearings, the hub must be removed to inspect the bearings.

If in doubt concerning the clearance of the front bearings, measure the bearing clearance with a dial indicator.

- Clean the hub cap.
- Remove the hub cap for grease lubricated bearings or the plug in the center of the hub cap for oil lubricated bearings.
- Place the measuring tip on the dial indicator against the spindle bolt when measuring.

Note: Oil lubricated wheel bearings: The axial clearance should be 0.04 – 0.12 mm (0.001 - 0.005 in.).

Screw tight the hub cap and the plug in the hub cap. Torque to 16.26 - 21.69 Nm (12 - 16 ft-lb).

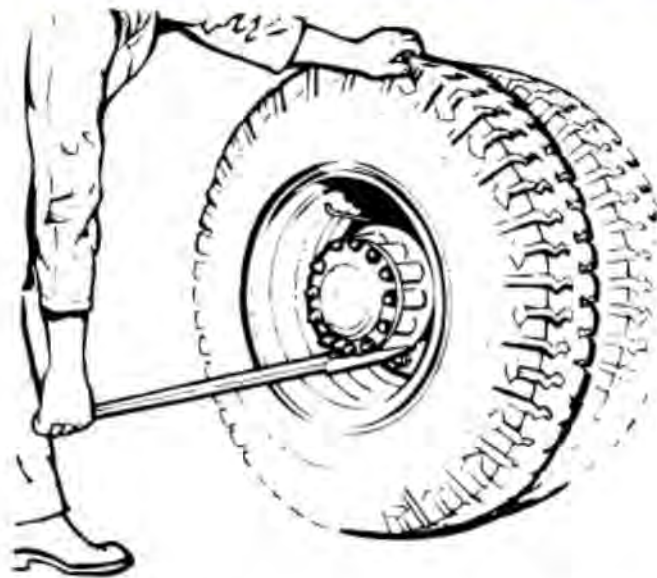
Rear Hub with Adjustable Bearings

Note: On certain vehicles a "clunk" sound may be heard when the lever is used. This sound is related to the internal moving parts of the axle shafts and the differential. This is not bearing noise.

Check the play on the drive and trailing wheels by using a bar as a lever to lift. If play can be felt in the rear wheel bearings this can be a result of wear in the bearings or because the bearing clearance is incorrectly adjusted.

Note: The axial clearance should be 0.04 - 0.12 mm (0.0015 - 0.0047 in.).

Check the trailing wheel bearings with a wheel spinner and listen to the bearings during the rotation.

Note: If there are any abnormal noises in the bearings, the hub must be removed and to check the bearings, otherwise the bearing clearance must be adjusted.
