TECHNICAL SERVICE BULLETIN

Classification: RS22-002	Reference: NTB22-032	Date: April 28, 2022
-----------------------------	-------------------------	-------------------------

SEAT BELT REMINDER SERVICE INFORMATION

APPLIED VEHICLES: 2021-2022 Armada (Y62)
2022 Pathfinder (R53)

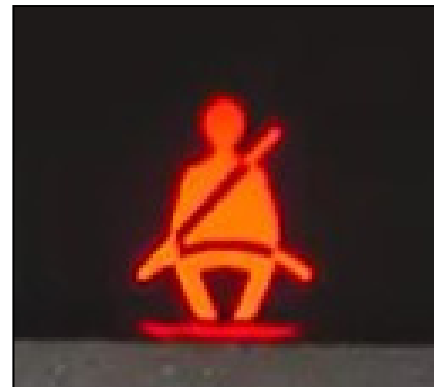
Figure 1

Seat Belt Warning Light for driver and front passenger.
