## Technical Service Bulletin

GROUP <b>CAMPAIGN</b>	NUMBER <b>22-01-048H</b>
DATE <b>MAY, 2022</b>	MODEL(S) <b>TUCSON (NX4A) SANTA CRUZ (NXT)</b>

**SUBJECT:** CRASH PAD INSPECTION AND REPLACEMENT  
(SERVICE CAMPAIGN T8J)

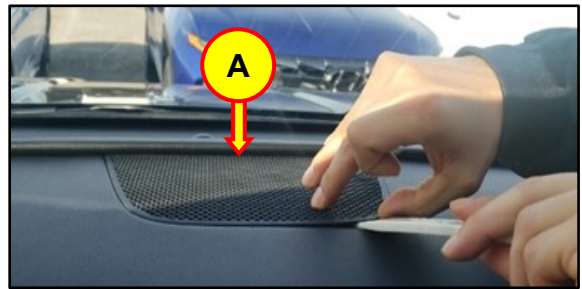
1. Remove the crash pad speaker grill (A).

Use a plastic trim removal tool to prevent damage to the crash pad surface.

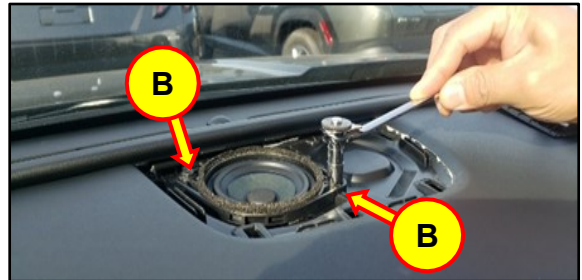
2. Remove the center speaker bolts (B).

**Tightening Torque:**

13.0 – 18.1 ft-lb (17.7 – 24.5 Nm)

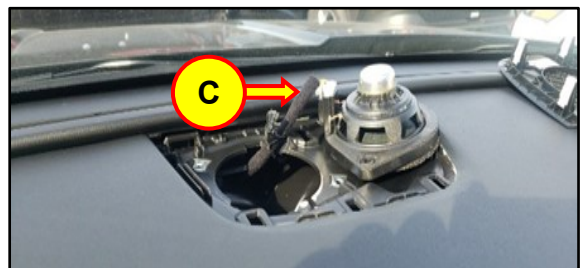
3. Disconnect the speaker connector (C) and remove the center speaker.

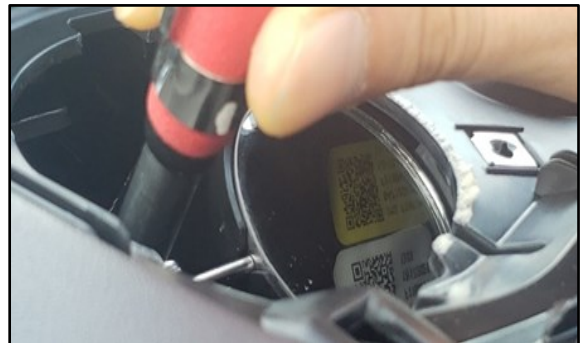
4. Insert a mirror through the speaker hole to inspect the “IMG FORMING” label.

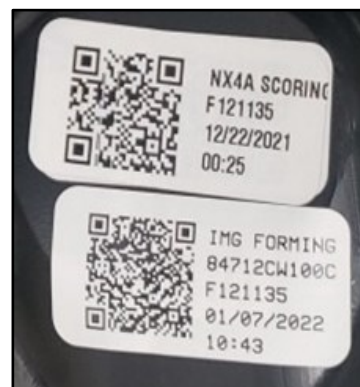
Two different labels are present under the crash pad. Only refer to “IMG FORMING” label. Do not refer to the “NX4A SCORING” label.

Incorrect label

Correct label

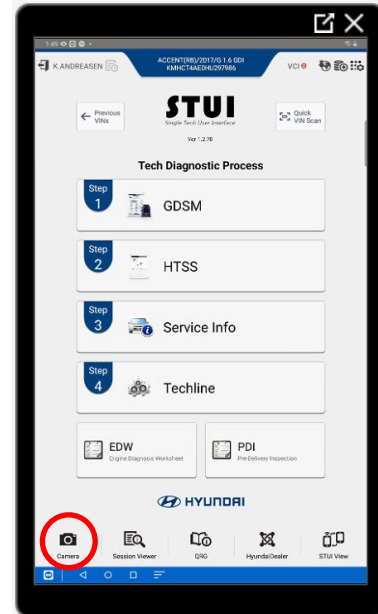
- Using STUI, take a clear picture of the “IMG FORMING” label with the mirror.

Please include the VIN or copy of the RO with the VIN in the STUI picture of the “IMG FORMING” label.

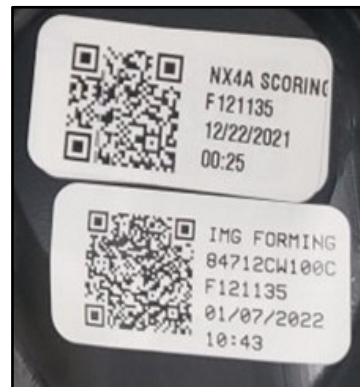
- If the date/time on the “IMG FORMING” label is between **01/07/2022 19:00 – 01/12/2022 12:00**, replace the crash pad.

If the date/time on the “IMG FORMING” label is before or after the dates/times above, no further action is necessary.

Incorrect label

Correct label

- If the crash pad needs to be replaced, refer to the shop manual section for complete service procedure:

**Body (Interior and Exterior) > Crash Pad > Main Crash Pad Assembly > Repair Procedure**
