Boss Radio (AM/FM/CD/DVD) Installation

Bulletin Type:	TSB	Publication Date:	June 2022
Bulletin #(s):	22-045	Make(s):	Jayco & Entegra Coach
Job Code(s):	9803574	Model(s):	Ethos, Launch Swift, Terrain
Flat Rate(s):	.10 Inspection only .30 Remove Radio bezel screws	Model Year(s):	2021-2022

Incident:	Boss Radio CD/DVD ejection function issue
Affected Units:	Certain 2021-2022 Jayco Swift & Terrain; Certain 2021 -2022 Entegra Coach Ethos & Launch
Parts Kit:	Parts Kit #: N/A
	Parts Kit Contents: N/A
Misc. Tools & Supplies:	- Screw gun with square head bit
Parts Return Information:	N/A

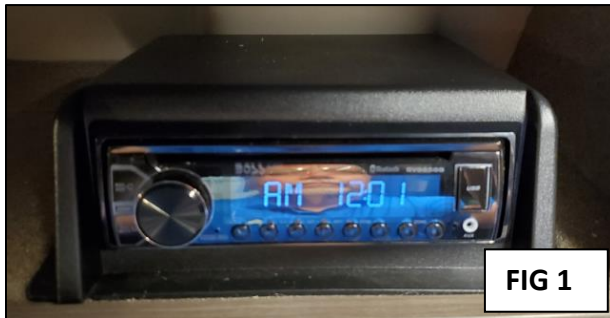
1. Check radio to ensure CD/DVD is functioning properly. File under inspection only if radio does not have the CD/DVD ejection function issue. Complete the following repair if radio the CD/DVD is not function properly.
2. Locate radio
 - A. Launch/Terrain units – radio installed in driver front overhead (Fig. 1)
 - B. Ethos/Swift units – radio installed under overhead either front or rear depending of floor plan (Fig. 2)

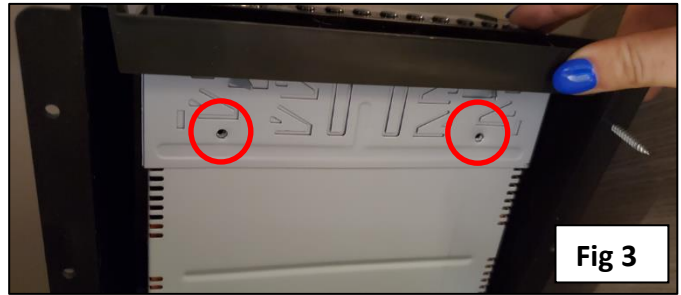
Fig 3

4. Remove and discard screws from metal radio mounting bezel and radio. (Fig. 3)

3. Remove six screws from along each side of the black radio bezel to expose screws which need to be removed.
