## **Preliminary Information**

# PIT5788C Slow or No Crank, Low Battery Voltage, Parasitic Draw, Dead Battery

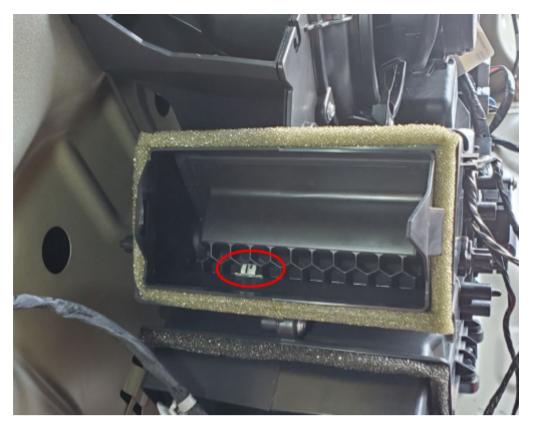
If one of the rear HVAC doors is not able to move through its full travel, the door learn procedure will be incomplete. If the door learn procedure is incomplete the vehicle will try to perform a relearn procedure after the vehicle is turned off. If the relearn still does not complete the vehicle will continue to perform the relearn procedure until the battery is depleted.

- Connector X251A/X418 (depending on model year) not fully connected.
- Rear HVAC mode or temp actuator connector not fully connected and/or its CPA not locked into position.
- Foreign object that has fallen into the rear HVAC case, as shown above.
- An issue with either the power, ground or LIN bus circuits to one of the rear HVAC mode or temp actuators.
- A faulty rear HVAC actuator

Check the rear HVAC mode and temperature door operation. Make sure the rear mode operates from roof to floor and the temperature from full hot to full cold. If either door does not function properly, then access the rear HVAC case. Inspect the rear HVAC doors for any mechanical issues that may limit or prevent the door from moving smoothly or moving through its full range of travel and repair as necessary. Inspect for any electrical issues to each rear HVAC actuator. In some cases, we have seen:
