Preliminary Information

PIP5851 Replacement DEF Tank Harness Connector Does Not Match Body Harness Connector

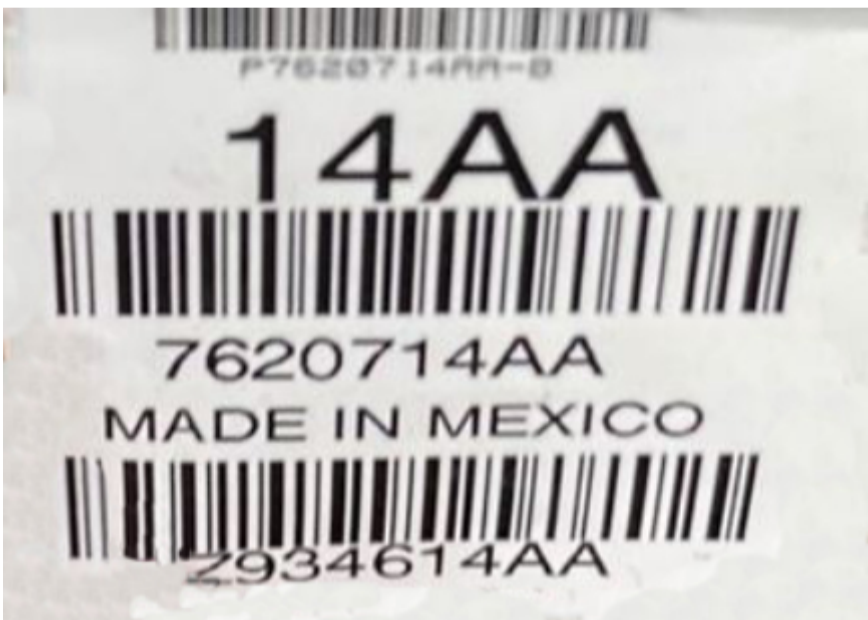
If it is gray in color instead of black, the tank was assembled with the incorrect harness and it will not match the body harness connector.

The picture below is what the tag on the harness will display if it the incorrect one.

Prior to replacing the DEF tank on the involved vehicles, check the replacement tank harness connector X143 on the replacement unit.

If the original harness is damaged, it will be necessary to order a replacement harness through normal parts department channels.
