## Service Campaign 480 M161– Phone Box Lid potential failure in opening spring

MAY 9 2022

Certain Maserati Levante MY22 listed in ModisCS+ are involved in a Service Campaign concerning a Physical Inspection of the Phone Box Lid opening mechanism.

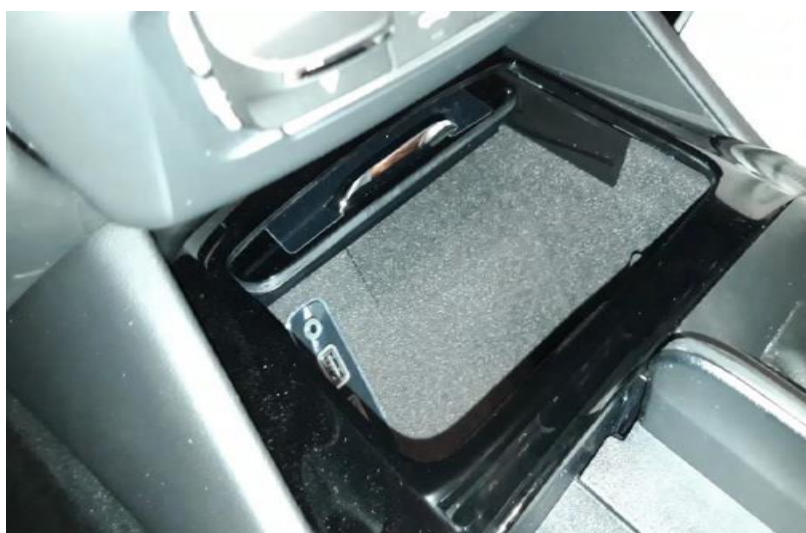
The Inspection procedure consists of a 20 times opening/closing cycle. Only in case after the cycle the lid cannot be opened anymore due to a failure into the internal mechanism breakage, the phone box must be replaced.

1. Always check in ModisCS+ to see if the vehicle is involved in this campaign and if the campaign has not been previously performed.
2. Apply light pressure and push the phone box Lid down and allow the Lid to open automatically. Once opened, gently pull the lid closed and repeat up to 20 times as shown below:
  - **OK** -> No failure found during the opening and closing of the Phone Box Lid. The inspection is finished. No other actions are required.
  - **NOT OK** -> The lid cannot be opened anymore due to a failure into the internal mechanism breakage, the phone box assembly must be replaced following the procedure: 9.51.080.0 TUNNEL TELEPHONE

**NOTE: Do not force the Lid open. The Lid should automatically open completely on its own. If it does not, then it will need to be replaced.**
