Thor Motor Coach Technical Service Bulletin

TSB #	TSB 22-08		
Description/Title:	Gemini/Compass		
Affected Product Line(s):	Certain model year 2022 – 2023 Gemini/Compass		
Service Campaign # :	RC000269	Released Date:	
Codes:	Inspect Only: Inspect with Repair:	Document Date:	6/15/2022
Time Allowed:	Inspect Only: 0.1 Inspect with Repair: 0.3	Document Revision:	A

Gemini/Compass E-start is not wired correctly.

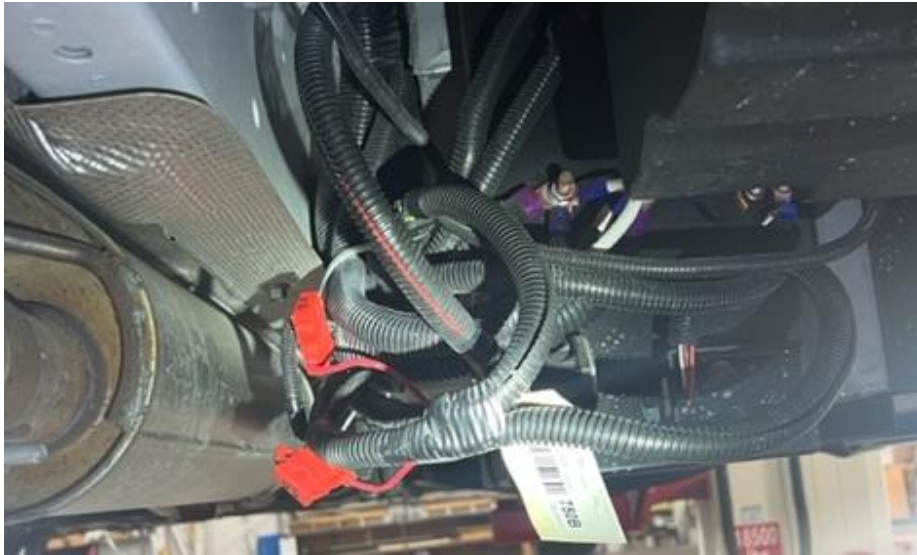
1. Locate the wire bundle for the E-start wiring under the passenger side of the unit near the entry door. Cut the zip tie holding the wire bundle so you can easily inspect the wires/fuses.

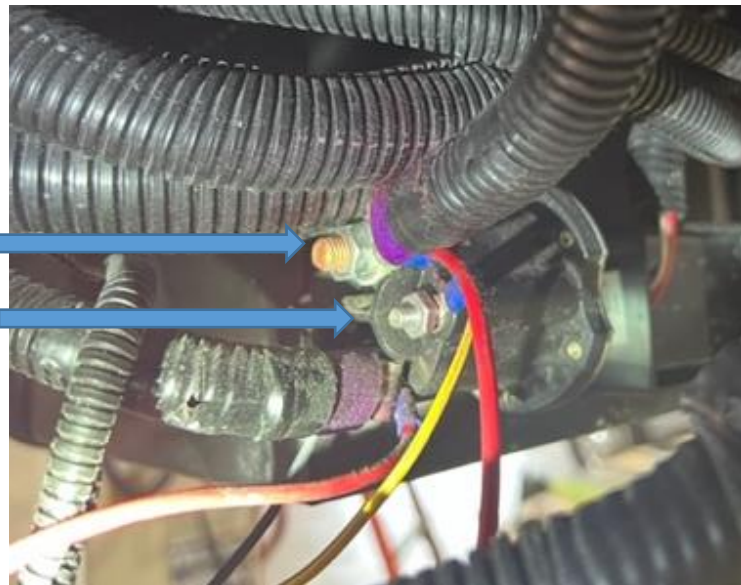
Check the solenoid wires to confirm proper installation.

2. Reference the attached print to confirm if the wires are in the correct position on the solenoid and move wires to correct location if needed.

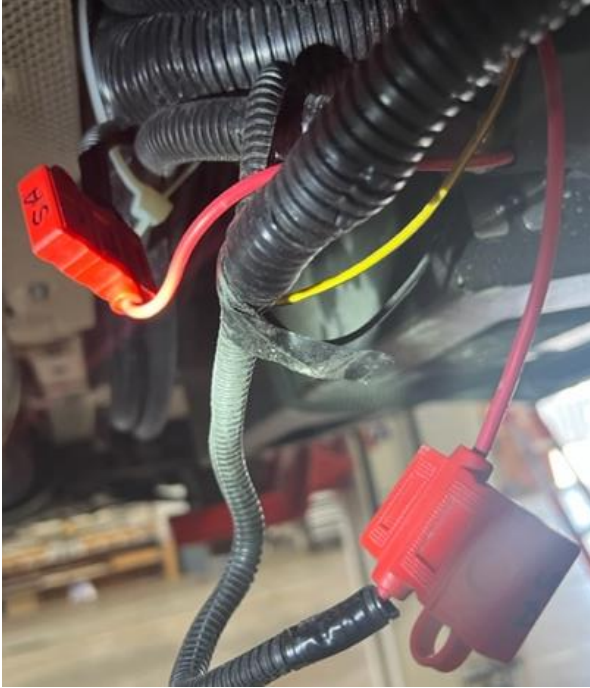
3. Inspect the fuse holders to confirm they are labeled for a 5 amp fuse and relabel if necessary. Check fuses inside the fuse holder and confirm they are 5 amp fuses and replace if needed.

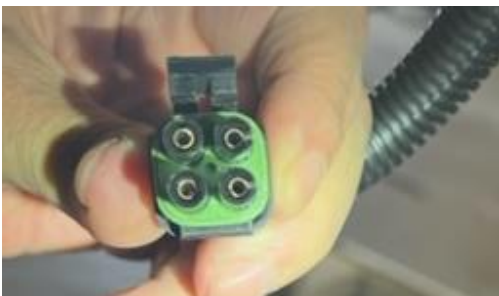
4. Disconnect the 4 pin connector and inspect the male side of connector to ensure proper wire location. Pull back wire loom to inspect which wire is going into what location on the pin. Reference attached print to confirm the location and use pin connector tool to remove and rewire the connector if needed.

5. Reinstall the 4 pin connector and use zip ties to secure the bundle back up in place and test to ensure proper operation.
