Service Bulletin

Bulletin No.: 21-NA-254

Subject: Whistle or Squeak or Squeal Noise from the Engine Compartment Area

Brand:	Model:	Model Year:		VIN:		Engine:	Transmission:
		from	to	from	to		
Chevrolet	Blazer	2019	2020			LGX

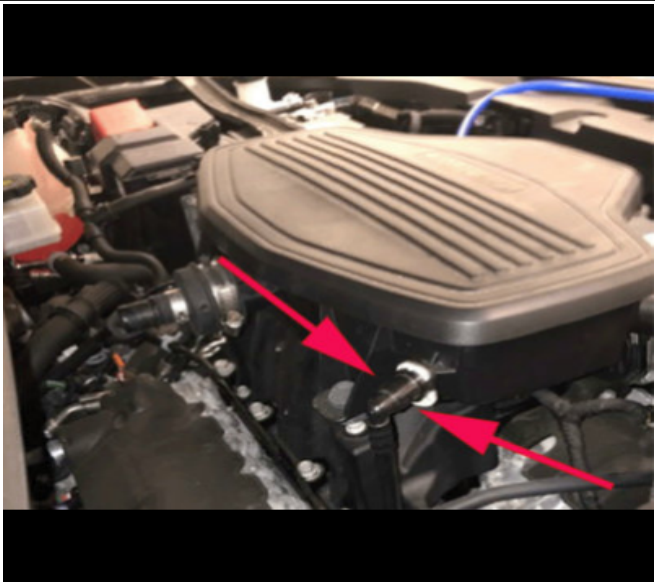
Involved Region or Country	North America, Middle East, Israel, Palestine, Chile (West), Colombia (West), Ecuador (West), Peru (West)
Condition	Some customers may comment that a whistle, squeal, or squeak noise from the engine area. – This noise may get more noticeable after driving for a while.
Cause

<p style="text-align: right;">5921953</p> <p>This condition may be caused by plastic flashing restricting the clean air-port on the air cleaner duct on top of the engine as shown below. – The restriction or flashing will appear that the hole is not drilled out completely and can be seen about 2 inches inside the tube.</p>
Correction	To correct this condition, replace the air cleaner duct and reevaluate for a noise concern. Run the engine long enough to build up crankcase pressure during testing to ensure correction.

Service Procedure

Refer to *Air Cleaner Outlet Duct Replacement* in SI.
