Service Bulletin

TECHNICAL

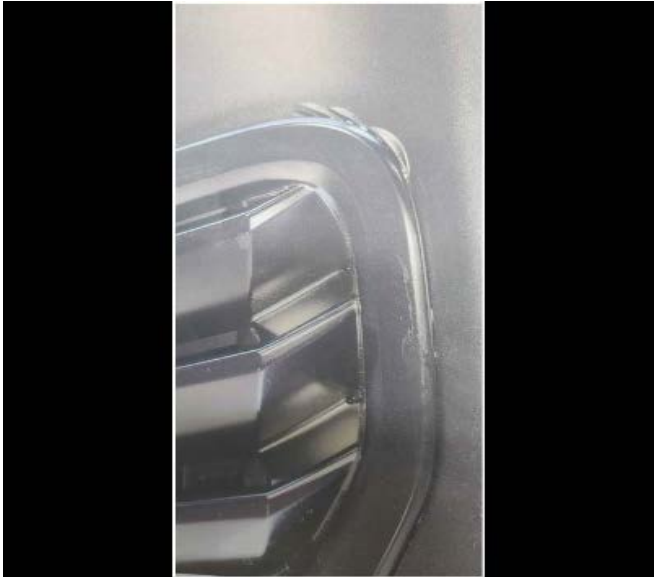
</div> <p style="text-align: right; font-size: small;">5937945</p> <p>Some customers may comment on a wrinkle or bubble in the stripe or hood wrap forming around the outer edges of the hood air scoop.</p>
Cause	This condition may be caused by edges on the bottom of the hood air scoop pressing deep into the stripe or hood wrap, causing air pockets to form over time.
Correction	If you encounter a vehicle with the above concern, refer to the Service Procedure below.

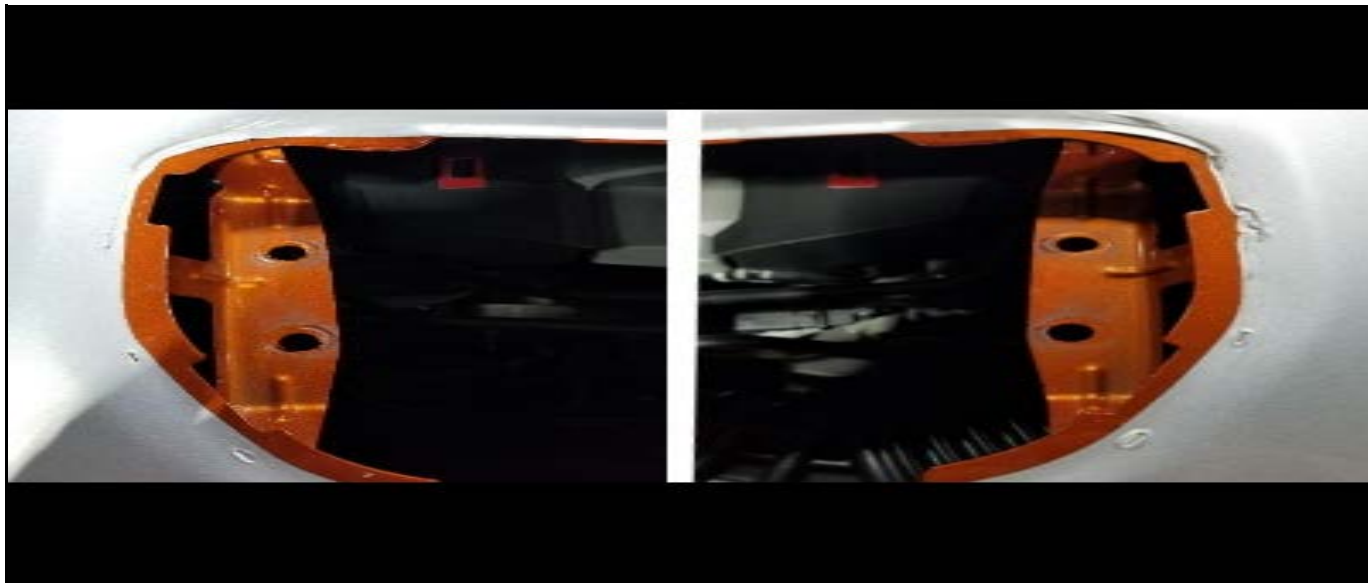
5937948

1. Remove the hood air scoop from the hood. Refer to *Hood Air Scoop Replacement (ZL1 with A1Y)* in SI.

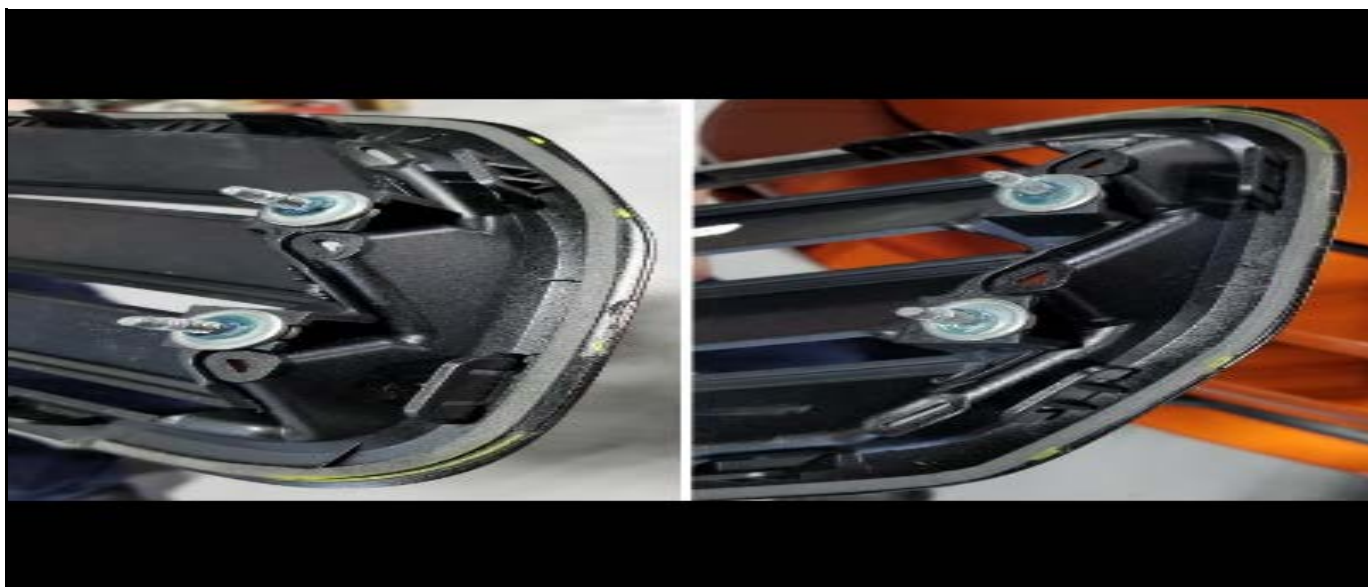
5938040

2. With the hood air scoop facing downward, locate the inner and outer tuning ribs.

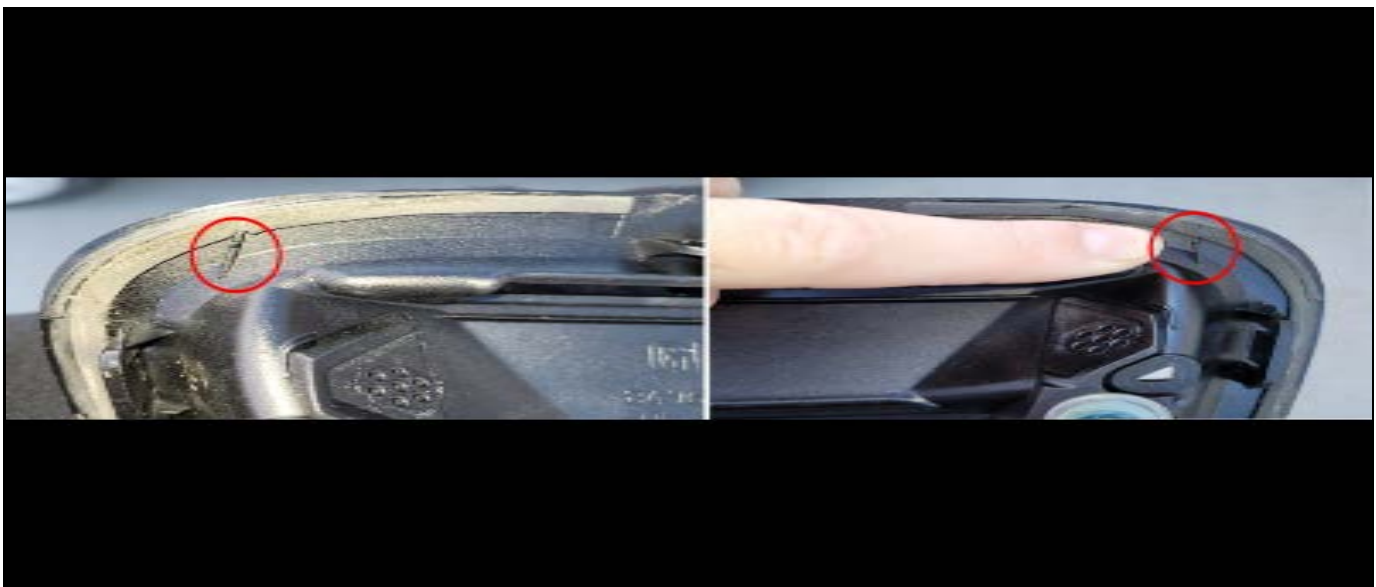
5938000

3. Using sandpaper, sand down the ribs.
 4. For better clearance between the air scoop and the hood, add an additional layer of foam tape on top of the existing tape.
- Note:** Before wrapping the edges where the hood air scoop is mounted, mix a chemical solution that will contain 70% Isopropyl alcohol mixed to a ratio of 25% alcohol to 75% water. Use this to spray the adhesive side and then wrap it over the edges. This will help provide extra adhesion.
5. Remove the decal striping or wrap from the hood in preparation for the new striping or hood wrap to be installed.
 6. Install the new striping or hood wrap.
 7. Once the striping or hood wrap is installed, wait 30 minutes to allow for curing.
 8. Re-install the hood air scoop. Refer to *Hood Air Scoop Replacement (ZL1 with A1Y)* in SI.
