Service Bulletin

Bulletin No.: 21-NA-230

Subject: Whining/Whirring, Whistle, Squeaking, Groaning/Growling Noise Coming from Front Wheel/Engine Area

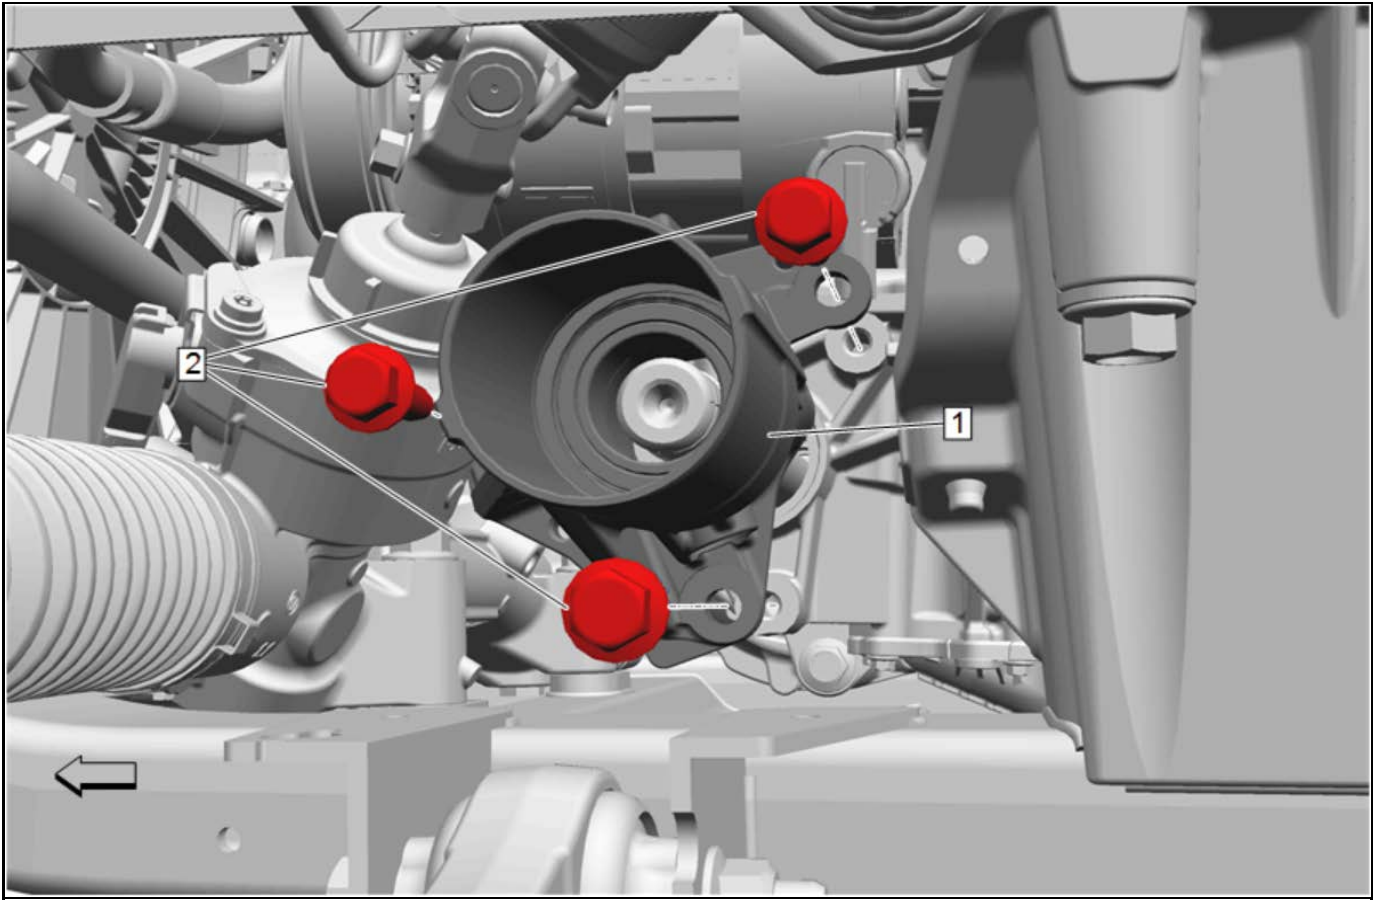
1. Remove the Front Wheel Drive Intermediate Shaft Housing (1). Refer to *Front Wheel Drive Intermediate Shaft Housing Replacement* in SI.

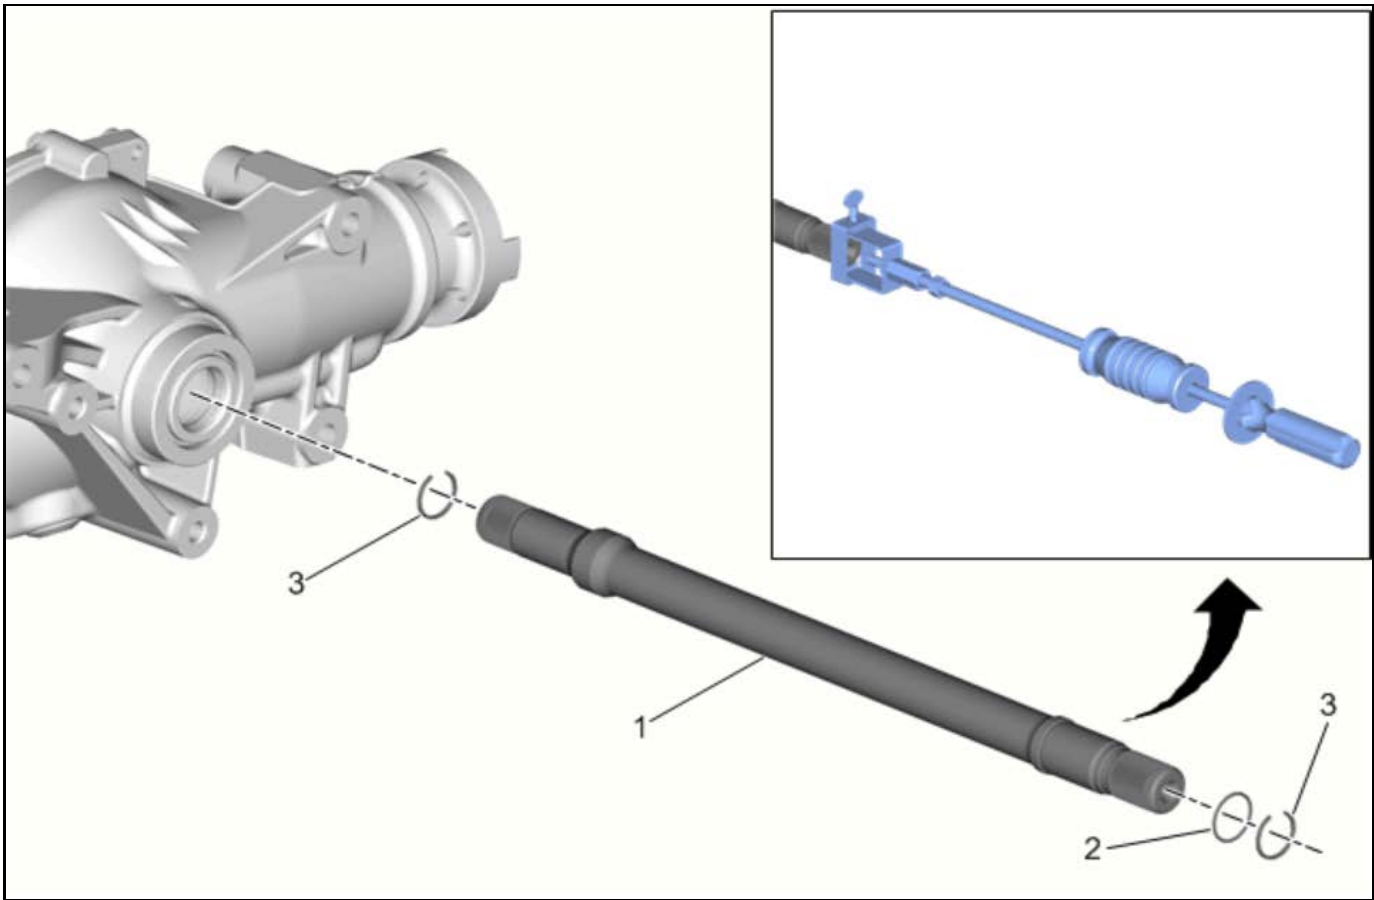
4234084

2. Attach the DT-44467 Output Shaft Assembly Remover/Installer to the shaft (1).
3. Attach the GE-6125-1B Slide Hammer to the DT-44467 Output Shaft Assembly Remover/Installer.
4. Utilizing the tool, remove the Front Wheel Drive Intermediate Shaft from the front differential carrier.

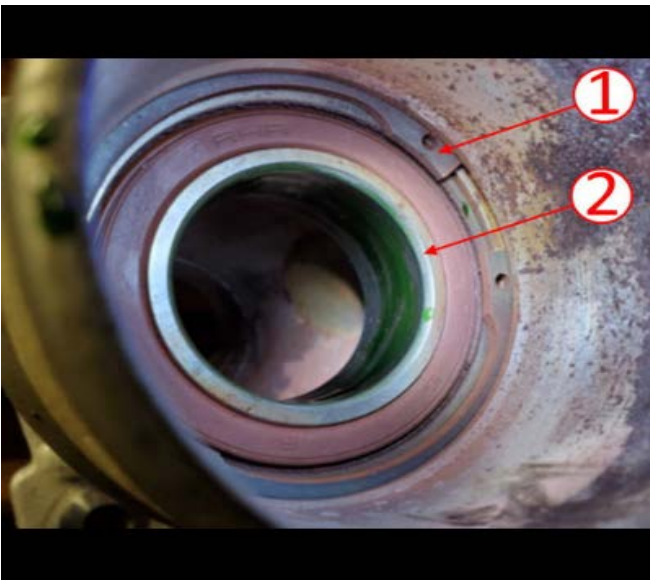
5906520

5. Remove the support bearing snap ring (1).

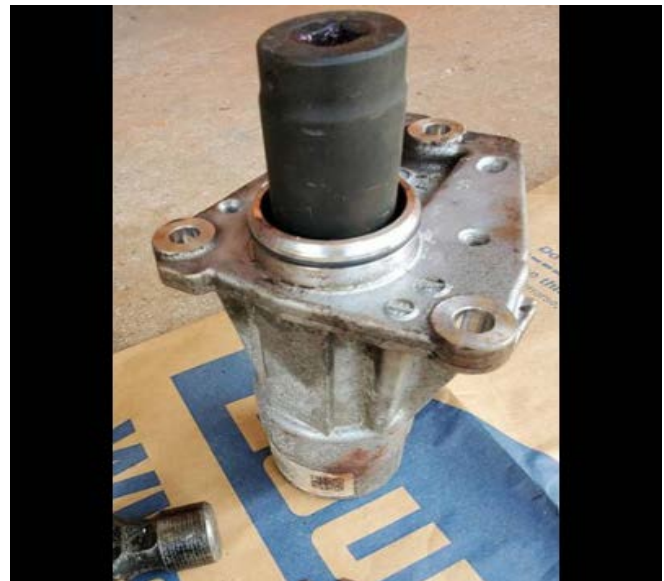
5906523

6. Using Bearing tool J-06133-A, press the bearing from housing/bracket.
7. Position the new bearing to the housing/bracket.
8. Using Bearing tool J-41736, press the bearing into the housing/bracket until seated.
9. Install the new snap ring.

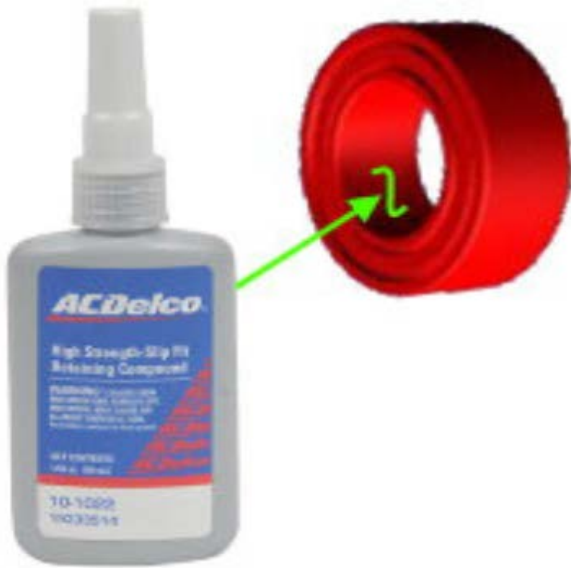
5902626

10. Using High Strength Slip Fit Bonding Compound (P/N 19333514), apply a thin coating to cover the new inner bearing race.

Note: For proper curing, allow the vehicle to sit overnight (12 hours).

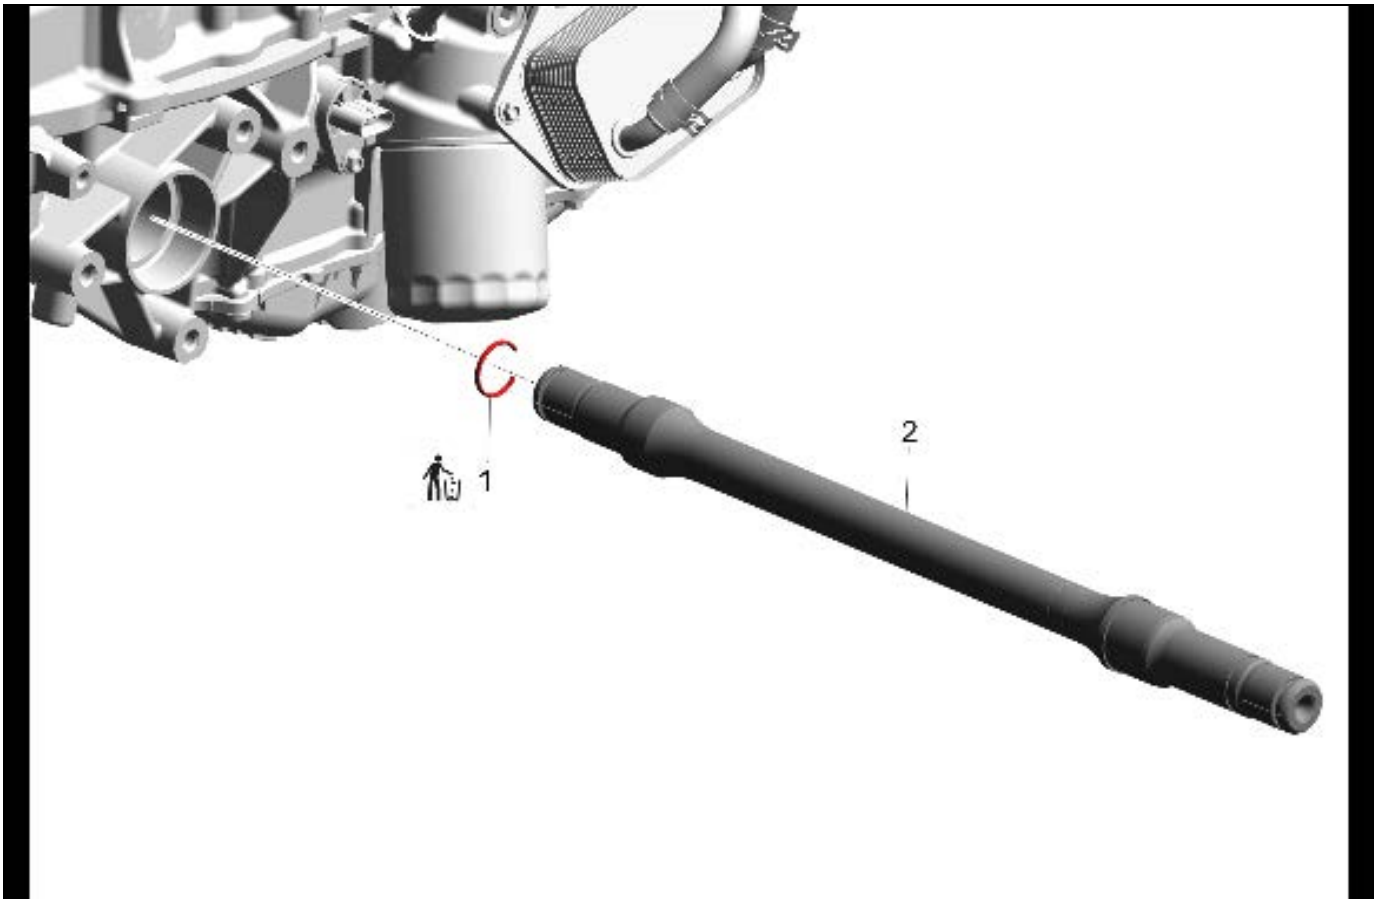
5502695

11. Install the New IDS Shaft (2). Refer to *Front Wheel Drive Half Shaft Replacement - Left Side* in SI.

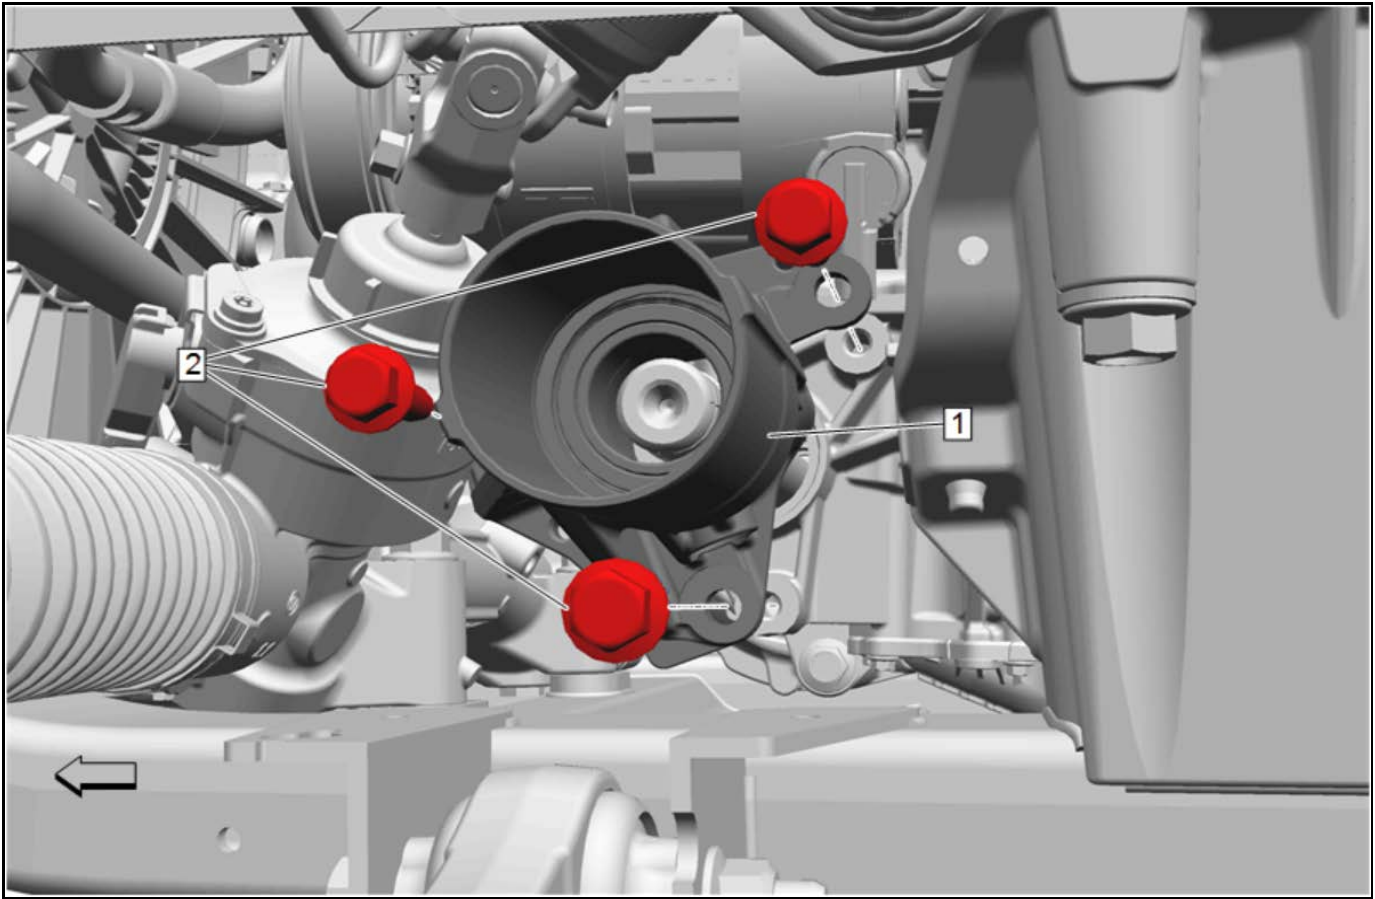
5344068

12. Install the new IDS Housing (1). Refer to *Front Wheel Drive Intermediate Shaft Housing Replacement* in SI.

Torque the mounting bolts (2) to 58 N•m (43 lb ft).
