**SIB 17 01 22**

**SERVICE ACTION: INSPECT AND MODIFY OPTIONAL ACCESSORY COOLER GUARD**

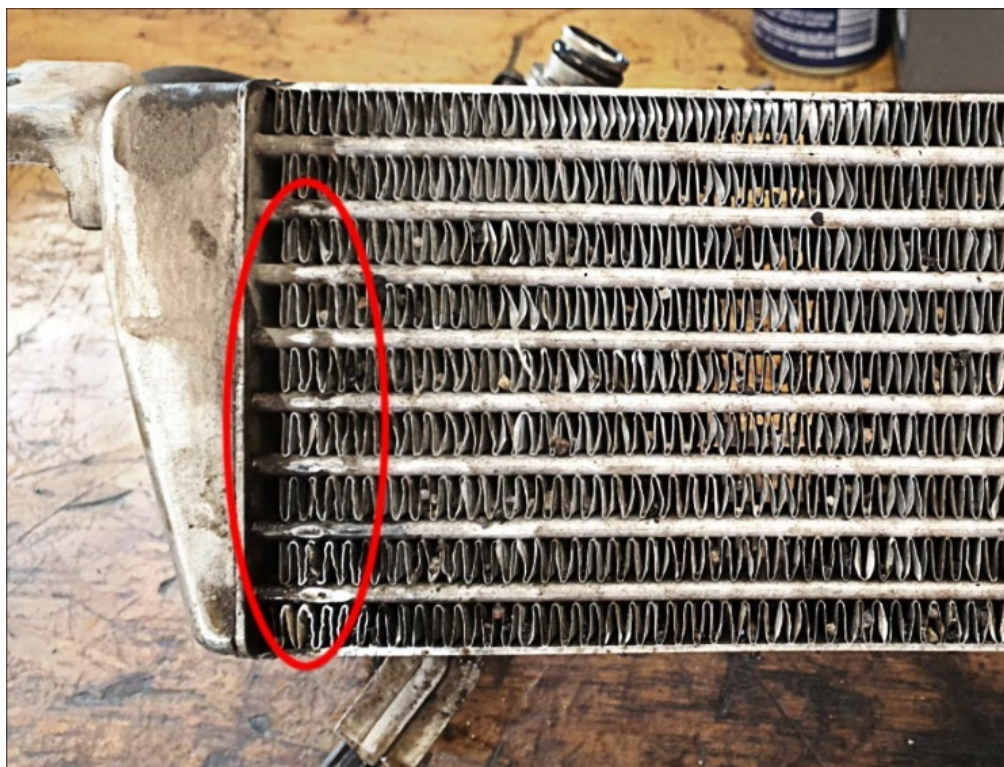
Installation of the accessory oil cooler guard from the BMW Motorrad Special Accessories Catalog may result in chafe marks on the cooler.

New installation instructions require use of special spacers to prevent chafing marks on the oil cooler.

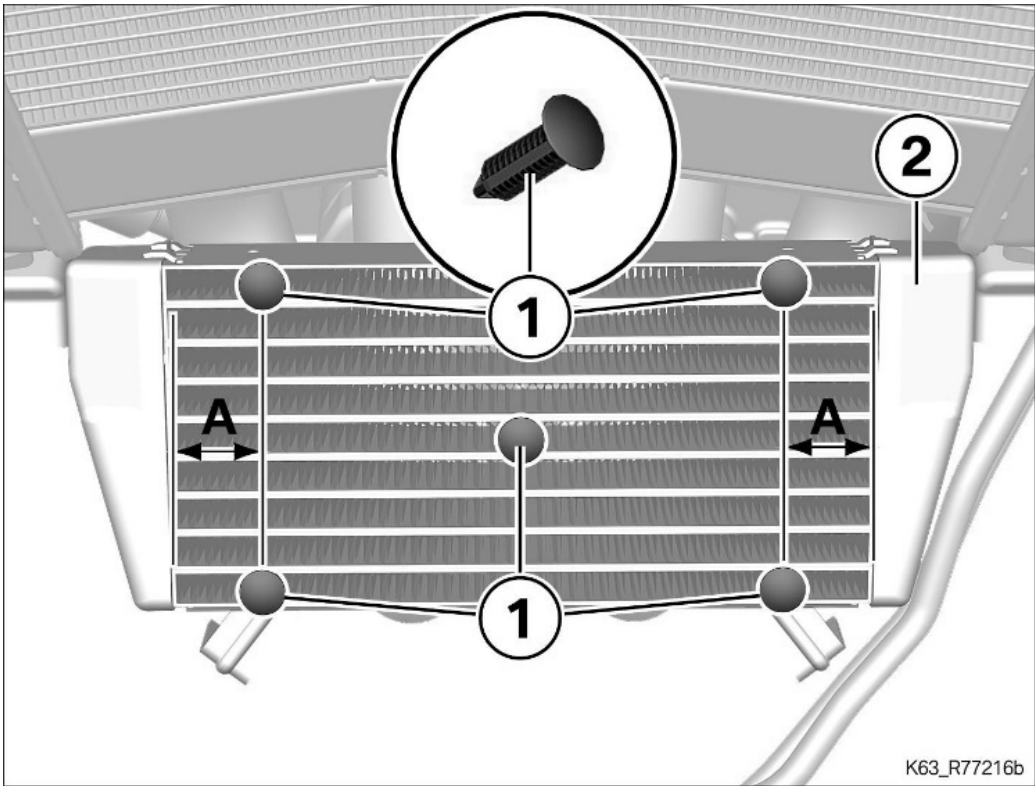
If the accessory oil cooler guard is installed, please reinstall it with five (5) spacers, part number below. Follow instructions “77 14 006 – Installing the radiator protection” in AIR, which were updated in February 2022.

Once the oil cooler guard is re-installed with spacers, please confirm that the guard is not touching the oil cooler.
